Impacts of Liquefaction on the Potable Water System of Christchurch in the 2010-2011 Canterbury (NZ) Earthquakes

M. Cubrinovski*, M. Hughes** and T.D. O'Rourke***

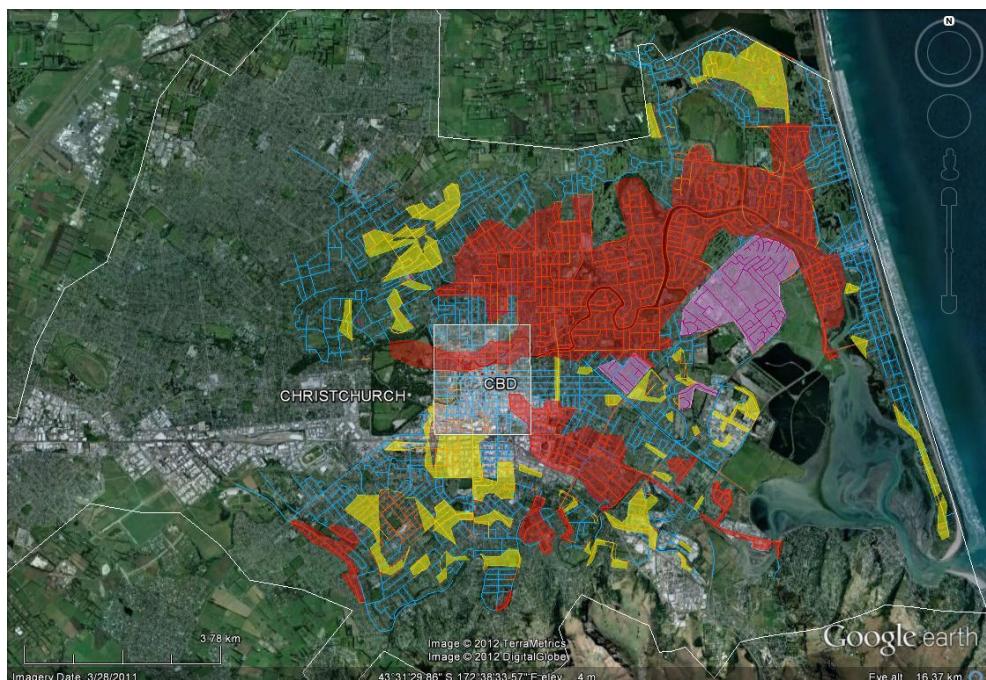
Figure 1. Liquefaction map of Christchurch after the 22 February 2011 earthquake (Cubrinovski and Taylor, 2011); the map covers only parts of Christchurch and is area-based (i.e. it cannot be used on property basis)

The liquefaction resulted in excessive and non-uniform ground deformation including large vertical displacements (settlement), lateral displacements, cracks and fissures in the ground, ground distortion and large volumes of sand/silt/water ejecta on the ground surface. The land damage was particularly pronounced in areas affected by lateral spreading along the Avon River (Cubrinovski et al., 2012). The permanent lateral displacements due to spreading reached up to 2.0 m at the river banks, and the zone affected by spreading extended up to a distance of 100-250 m from the waterway. The spreading induced substantial differential ground movements including large extensional deformation of the ground. For example, the extensional strains in the zone of largest ground cracks were on the order of 5-10% while the 'average' extensional strains in the area affected by spreading were approximately 0.5% - 1.0%. The spreading was often accompanied by slumping of the river banks (large settlement/subsidence), which was particularly noticeable at the approaches of bridges (Cubrinovski et al., 2013). Both lateral and vertical ground displacements induced by spreading were spatially non-uniform resulting in large localized deformation, stretching, tensile cracking and shearing of the ground. Such non-uniformity of the ground deformation was further exacerbated by the spatial variability in the severity of liquefaction, soil-structure interaction, and seepage action during water flow and dissipation of excess pore water pressures. Clearly, the buried pipes were subjected to very large, and highly non-uniform ground deformation and seismic loads which were often above the available capacity of the pipe network to sustain such movements/loads, hence resulting in widespread damage and numerous failures/breaks.

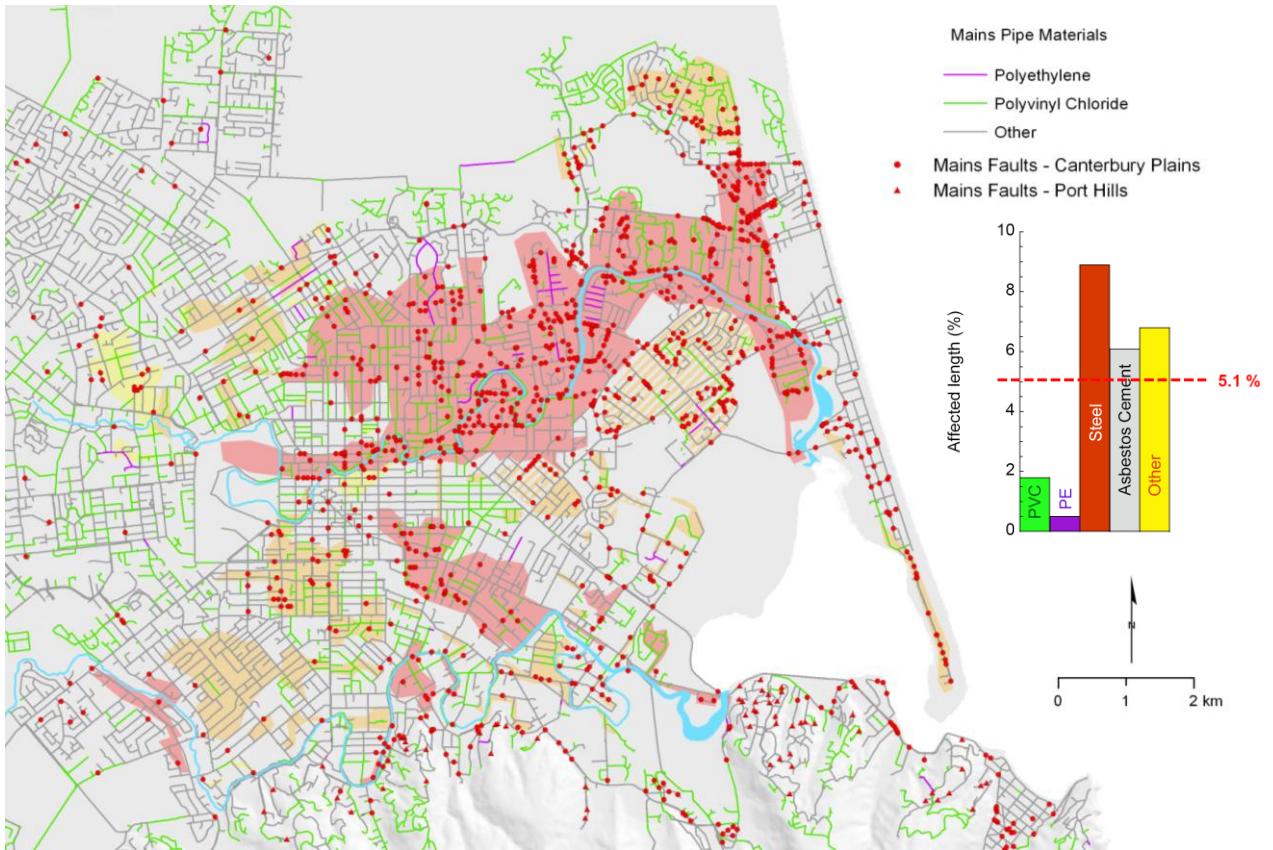
Figure 3. Locations of breaks/repairs (red symbols) of the watermains network of Christchurch caused by the 22 February 2011 earthquake (the background colours show the liquefaction map given in Figure 1)

Watermains. Figure 3 shows the location of repairs/faulds on the watermains network following the 22 February 2011 earthquake (red symbols). In the inset of the figure, the performance of different pipe materials is summarized in a bar chart (for areas in the plains, excluding the hills). It shows that 5.1% of the total length of watermains was damaged, or 77.5 km out of 1511 km considered in the analysis. Steel pipes suffered the largest damage (8.9%), followed by AC pipes and other material pipes (6.1% and 6.8%, respectively), whereas much better performing were the PVC (1.8%) and PE (0.5%) pipes. It is noted that the sample lengths of PE and S pipes are considered insufficient for a robust statistical analysis and hence the respective results should be treated with caution.

Figure 3 also indicates in the background (with red, orange and yellow colours) the liquefaction map shown in Figure 1. Using this setup in the GIS framework, it was possible to correlate the reported pipe damage with the observed severity of liquefaction. The analyses indicated that 34 km of the damaged pipes or 58% of the damaged length in the area covered by the ground surveying were in areas of moderate to severe liquefaction, 20.2% were in areas of low to moderate

liquefaction, 2.5% in areas where traces of liquefaction were observed and 19.3% in areas where no signs of liquefaction were observed. Thus, there is a clear link between liquefaction severity and damage to the pipe network. To further scrutinize the correlation between the damage to pipes and liquefaction severity, the results were summarized in Table 1 and in a series of bar charts shown in Figure 4. These results indicate that: (a) For all pipe materials, there is a clear increase in the affected length (percentage of damage) with increasing liquefaction severity; (b) for S, AC and other materials pipes, the percentage of damaged pipes in areas of severe liquefaction was very high, between 15% and 22%, and (c) PVC pipes suffered two to four times less damage than S, AC and other material pipes.

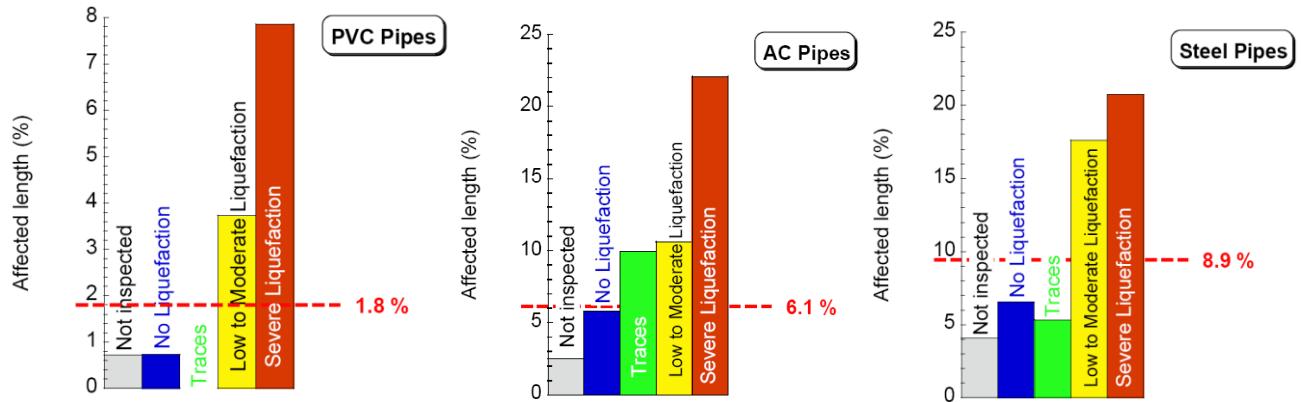
Figure 4. Percentage of damaged length of watermains in the 22 February 2011 earthquake as a function of pipe material and liquefaction severity

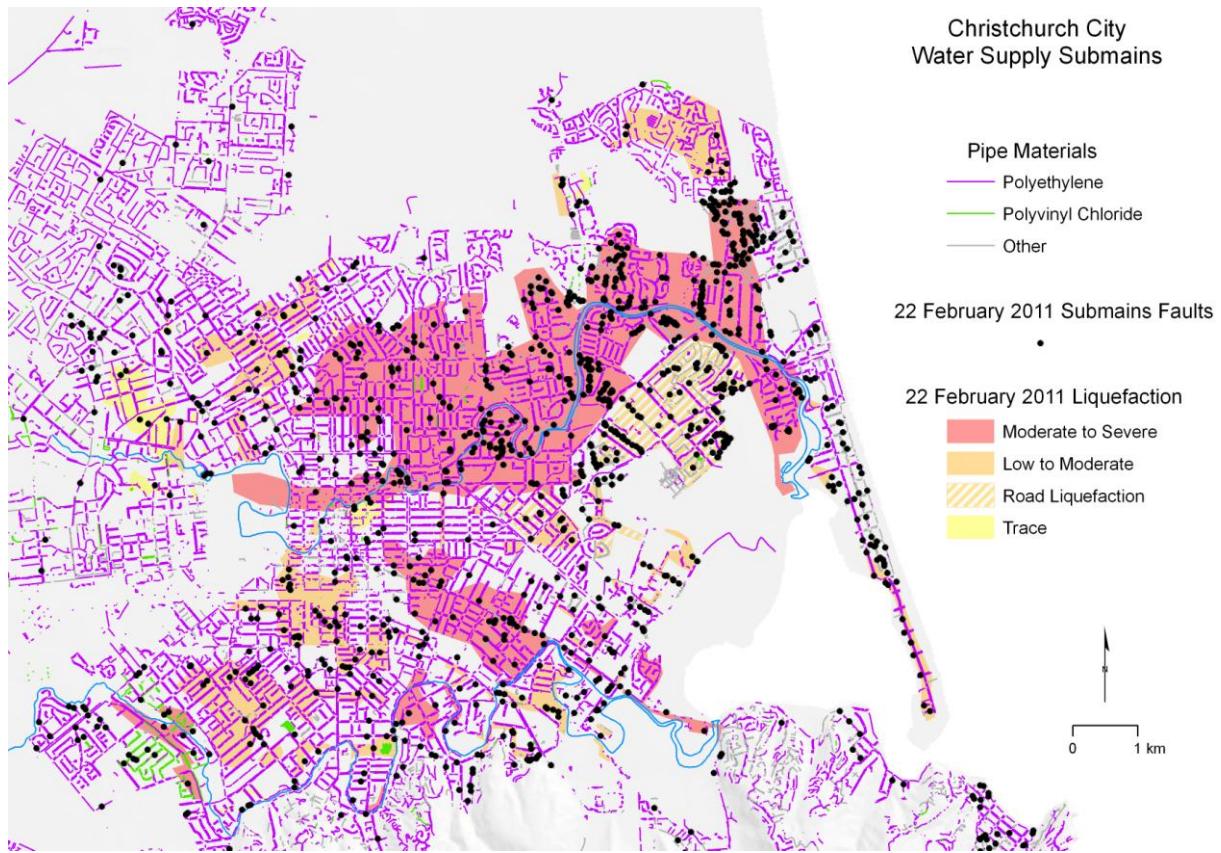
Submains. The submains network is shown in Figure 5 together with the locations of pipe breaks/repairs caused by the 22 February 2011 earthquake. Equivalent GIS based analyses to that presented above were also conducted for the submains network, the results of which are summarized in Figure 6. Key findings from these analyses include: (a) For PE pipes, the percentage of damaged length ranged between 1.4% (not inspected areas) and 5.2% (areas of severe liquefaction). Again, there was a clear increase in damage with liquefaction severity; (b) PE pipes suffered, on average, five to six times less damage than GI pipe; (c) GI pipes performed poorly with 17% damaged length in low to moderate liquefaction areas and 26% in areas of severe liquefaction,

Figure 5. Locations of breaks/repairs (red symbols) of the submains network of Christchurch caused by the 22 February 2011 earthquake (the background colours show the liquefaction map given in Figure 1)

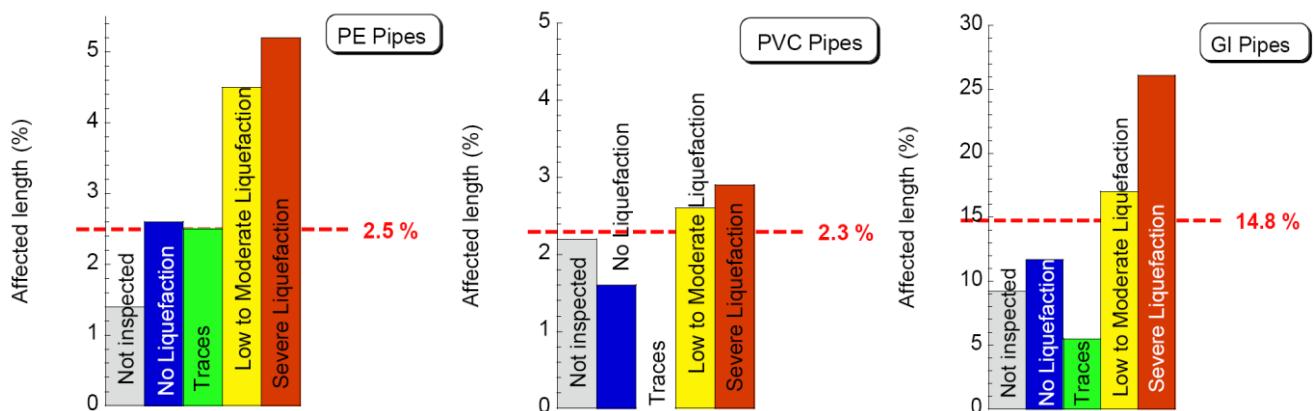
and (d) Comparing the repairs to watermains and submains, it appears that for each pipe material the percentage of affected submains was larger than the respective percentage of the affected mains. The total damaged length of submains was smaller, however, because over 80% of the submains were comprised of the well performing PE pipes.

It is important to emphasize that even though in these preliminary analyses the damage is always associated with a certain pipe material, the nominally defined ‘failures’ include (and probably are dominated at least for the PE pipes) by failures of particular components (joints, connections, fire hydrant details, crossovers, laterals) rather than actual failures of the pipe itself.

Figure 6. Percentage of damaged length of submains in the 22 February 2011 earthquake as a function of pipe material and liquefaction severity

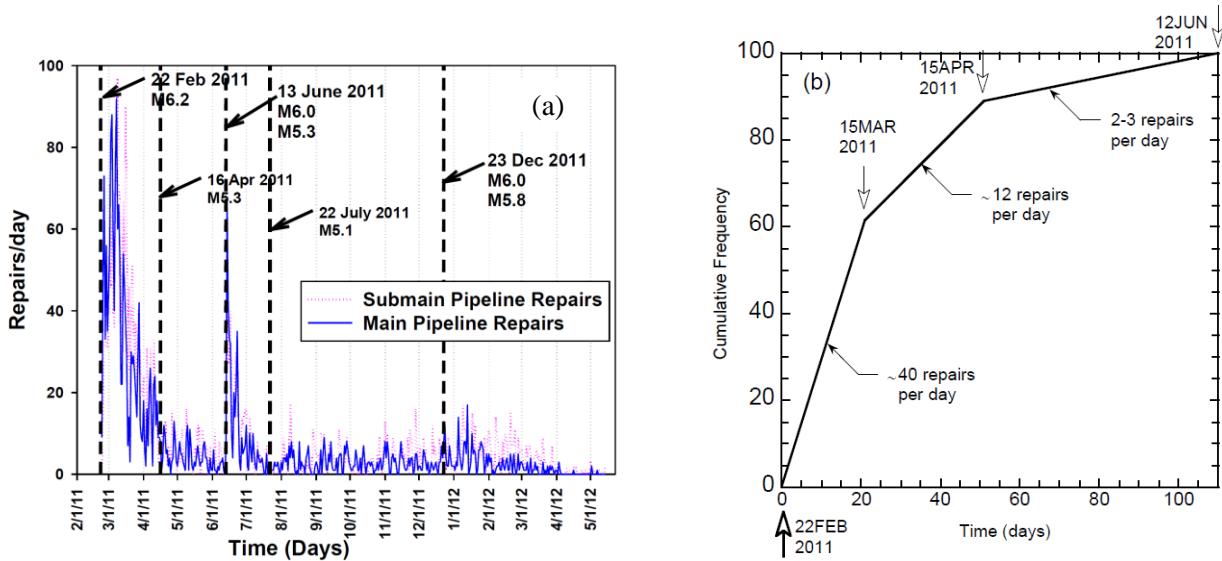
The repair database for the potable water system provided by CCC (Christchurch City Council) and SCIRT (Stronger Christchurch Infrastructure Rebuild Team) included continuous daily repair records. O'Rourke et al. (2012) summarized these records as shown in Figure 7. The daily repair rates as a function of time are shown in Figure 7a in which several major earthquake events are indicated. Figure 7b shows the cumulative frequency of mains repairs derived from Figure 7a, from the 22 February 2011 earthquake to just before the 13 June 2011 earthquake. It can be seen that the initial frequency of repairs was very high (on average 40 repairs per day in the first three weeks after the earthquake), which through a transitional period (with 12 repairs per day) reduced after 50 days to a post-quake steady state repair rate of about 2-3 repairs per day. Note that the pre-quake repair rates for the potable water network of Christchurch were about 0.5 repairs per day on average.

Figure 7. Mains and submains repairs with respect to time after the 22 February 2011 earthquake (after O'Rourke et al., 2012)

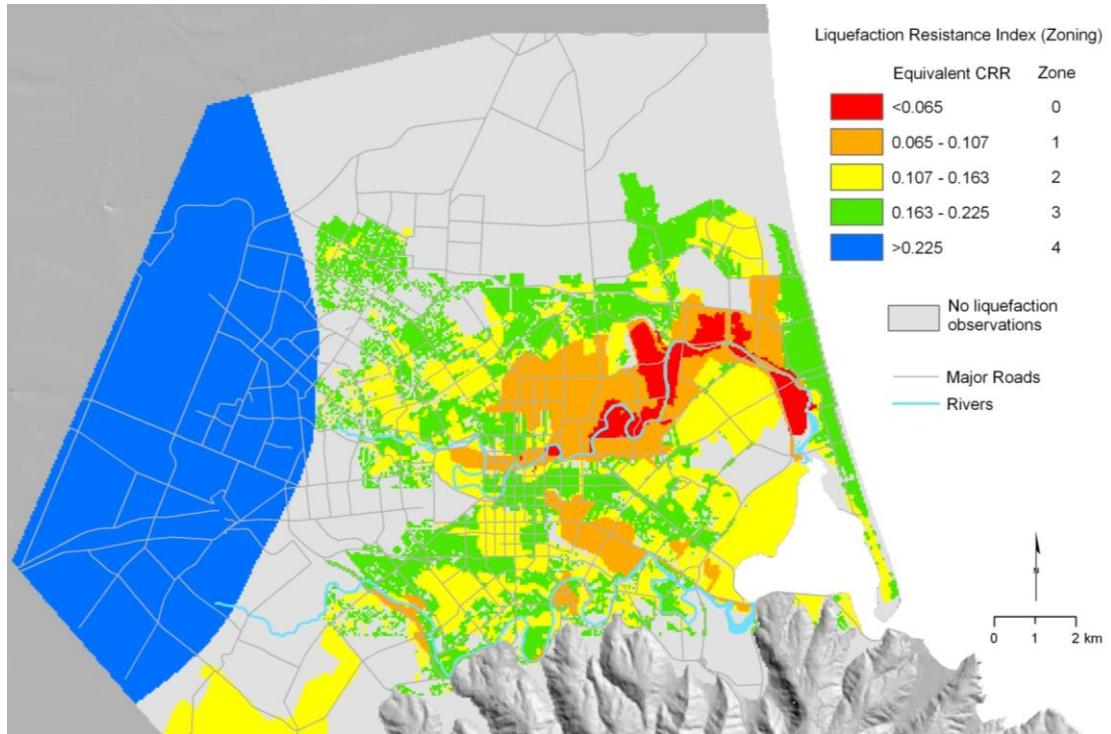
Note that the liquefaction resistance is defined in relative terms (e.g. Zone 3 has, on average, three times greater resistance than Zone 1), and that it specifically refers to shallow depths of the deposits (from the water table to 2 m below the water table) in which the pipelines are buried. For each LRI

zone, characteristic ranges of ground deformation (i.e. strains, settlements and lateral displacements) were also specified thus providing means for quick assessment and preliminary design considerations when rebuilding the pipe networks. Details of the methodology used in the development of the LRI map are given in Cubrinovski et al. (2011).

Figure 8. Liquefaction Resistance Index Map of Christchurch at water table depth based on observed liquefaction manifestation and recorded ground motions in the 2010-2011 earthquakes (Cubrinovski et al., 2011)
