Water Year 2024 (Oct. 2023 – Sept. 2024)

Island County Surface Water Quality Report

**ISLAND COUNTY DEPARTMENT OF PUBLIC HEALTH
DIVISION OF NATURAL RESOURCES
SURFACE WATER QUALITY MONITORING PROGRAM**

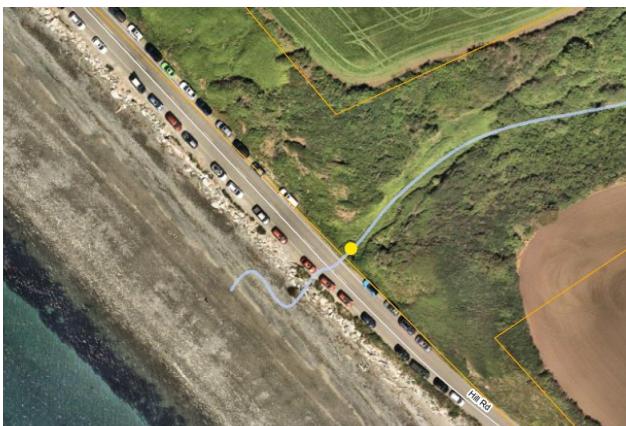
Stream Report Card 58a – Ebey's Landing

Ebey's Landing is a designated fish stream where surface waters are captured in roadside catch basins and field drain tiles then piped, subsurface, across agricultural fields before daylighting in a ravine where it forms a stream channel that outfalls on Ebey's Landing beach. The area immediately upstream of the sampling location is zoned for commercial agriculture and is currently being used for agriculture.

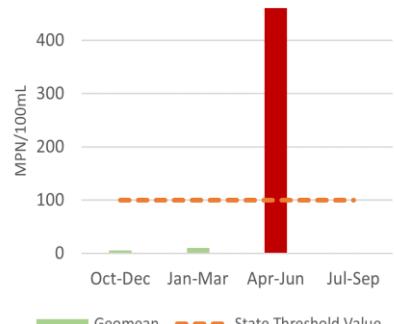
E. coli Seasonal Geomeans

- Water quality was Poor based on *E. coli* data collected in WY2024.
- Annual geometric mean was below the state standard (32 MPN/100 mL); however seasonal geometric means exceeded standards April through June and 17% of samples exceeded 320 MPN/100 mL (1 out of 6 samples).
- E. coli* levels higher than previous year, failed both Parts of state standard with high hits observed in Quarter 3.
- Maximum stream temperatures over WY2022-WY2024 consistent around 13°C; WY2024 max temp was 13.32°C, met state standard of 17.5 °C.
- Minimum and annual mean Dissolved Oxygen met state standard of 8.0 mg/L: Min 8.74 mg/L, and annual 9.70 mg/L.
- Stream Flow: January to June, Max discharge: 1.51 cfs, Min: 0.0 cfs

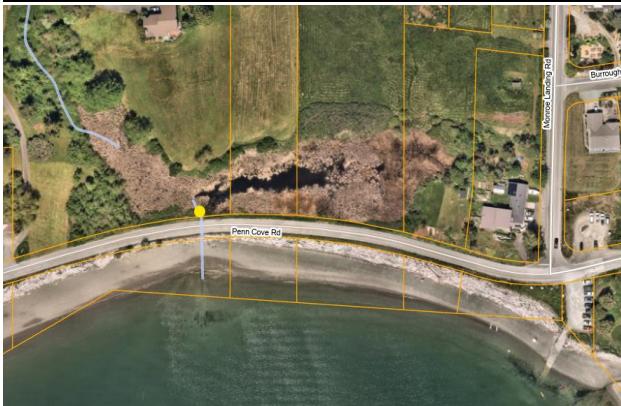
Stream Report Card: 37b Monroe's Landing

This is a designated fish stream site located on the north side of Scenic Heights Rd, just west of Monroe Landing that is the outlet of a large wetland area. Surrounding land uses are limited with the contributing area consist of a small commercial center, a very small alpaca farm, and few single-family residences.

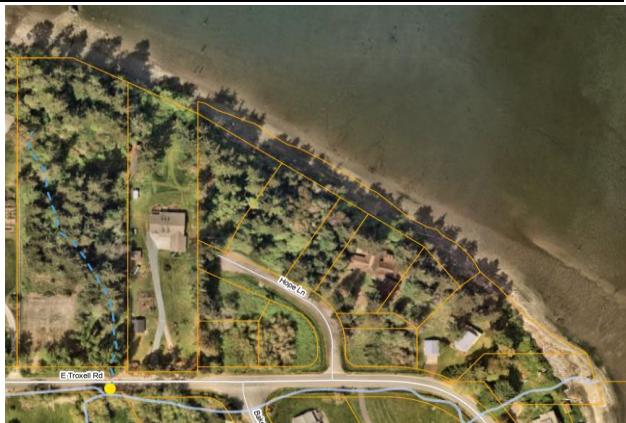
Stream Report Card: 5a Ala Spit

Ala Spit is designated as a non-fish stream that has been channelized through a pasture originating from upland wetlands. A narrow buffer (approx 2 ft) of willow and alder borders the stream passing across the pasture area from the south. After crossing E. Troxell Road through a culvert, the stream then flows through forest and field to the shoreline northwest of Ala Spit into a large estuary that is important habitat for juvenile salmon. Local land use includes agriculture and rural residential.

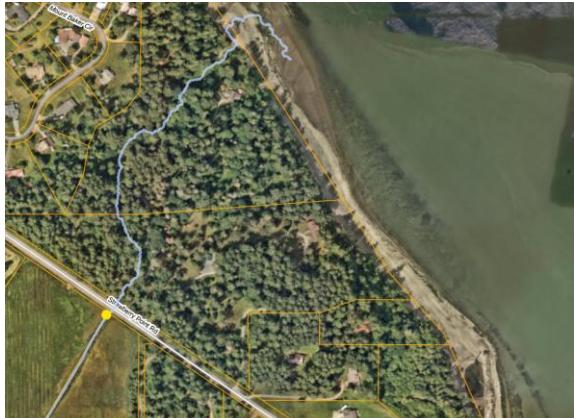
Stream Report Card: 18a N Strawberry Point

This site is a seasonal fish stream that passes through a culvert crossing about 700ft south of junction of Silver Lake Road and Green Road, on Strawberry Point Road. The site is formed from a series of seasonal wetlands above a pasture area that drain into a channeled stream that then flows down through a forested area to the shoreline. The shoreline mouth of the stream was included in recent research to provide evidence of juvenile salmon use of small seasonal streams.

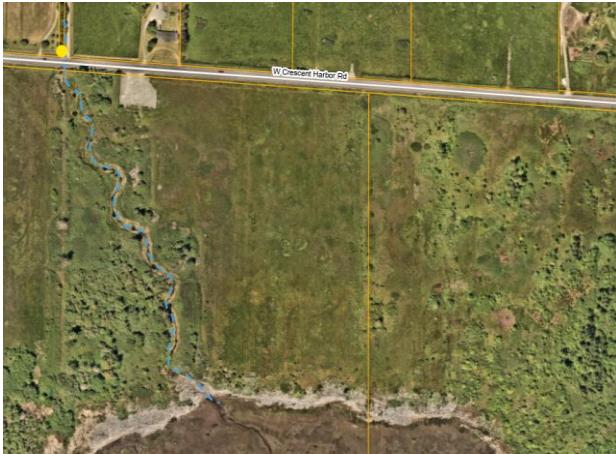
Stream Report Card: 13a Crescent Creek

Samples taken for the North Crescent Bay Crescent Creek site are pulled upstream from the main channel that flows under Crescent Harbor Road, west of the intersection with Hunt Road. Crescent Creek is a designated fish stream and has documented historical use by both adult and juvenile salmon. The area immediately upstream from the sampling site is zoned for rural commercial agricultural use. Proposals have been submitted for habitat restoration in this area and salmon restoration projects near the sample site are ongoing.

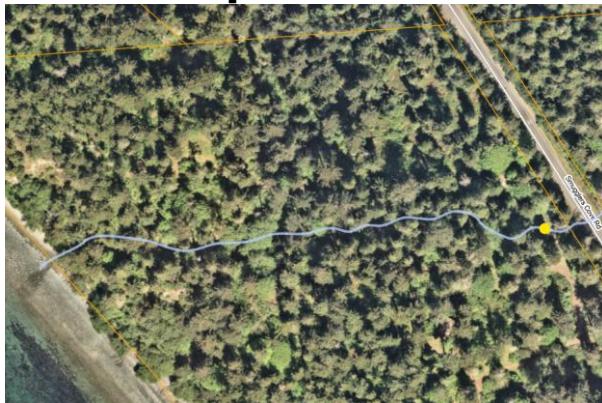
Stream Report Card: 112a N Smuggler's Cove

The sampling location for N Smuggler's Cove is located on a designated fish stream north of the South Whidbey State Park office just south of where Wilbert trail crosses Smuggler's Cove. The surrounding area upstream of the sampling location is a protected old-growth forest filled with lush undergrowth and is designated as one of the surface water quality program's natural baseline monitoring sites.

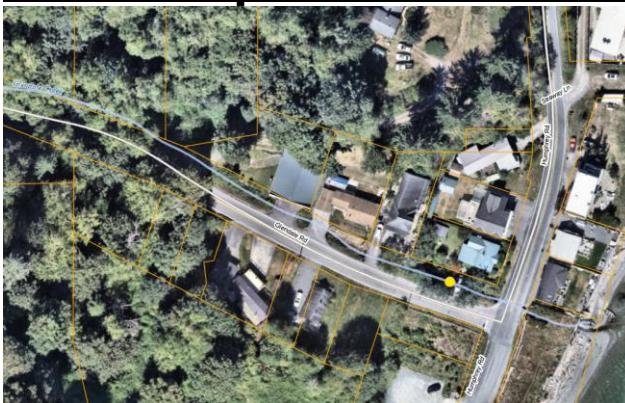
Stream Report Card: 149a Glendale Creek

The sample location for Glendale Creek is located above the second driveway crossing up from Humphrey Road. This is a historical salmon bearing stream that is immediately bordered by roads and houses at the pour point with little to no vegetative buffers. The area immediately upstream of the sampling location is zoned rural and designated for rural land use.

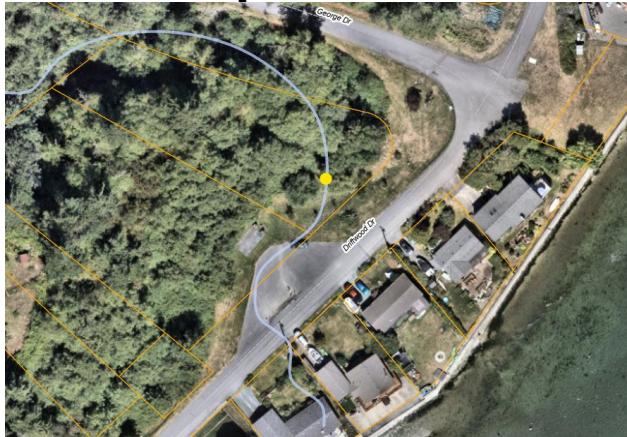
Stream Report Card: 157a Scatchet Creek

This site location is a year-round designated fish stream that runs through the Scatchet Head Community Park. It then enters a culvert under Driftwood Road before draining into Puget Sound. The area immediately upstream of the sampling location is zoned rural and its designated use is rural land.

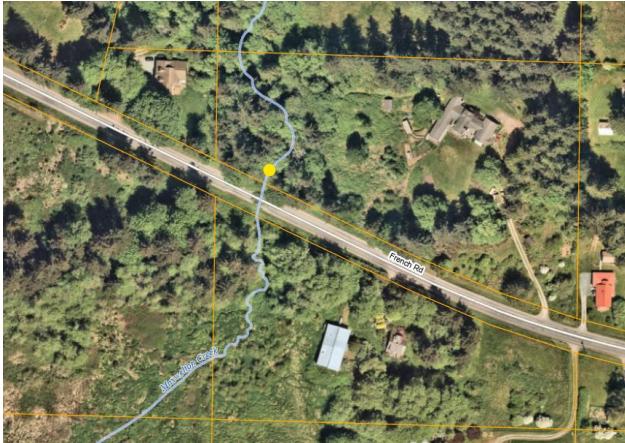
Stream Report Card: MWA2 Maxwelton Creek

This sampling location is a designated fish stream on the north side of French Road on Maxwelton Creek. The site has extensive riparian vegetation cover and year-round flow. The area immediately upstream of the sampling location is zoned rural and designated to be rural lands. Parcels zoned Rural Agriculture exist just north of where the stream passes under Maxwelton Road.

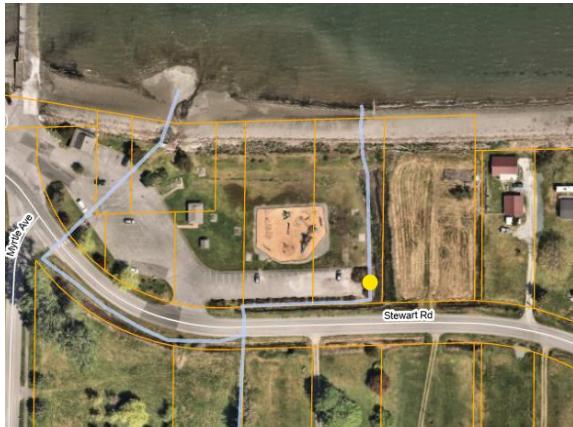
Stream Report Card: Hhab East Freeland Park

This sampling location is at the pour point of a tidally influenced stream at the east end of the parking lot of Freeland Park. The area immediately upstream from the sampling site is zoned for rural residential and designated to be an urban area.

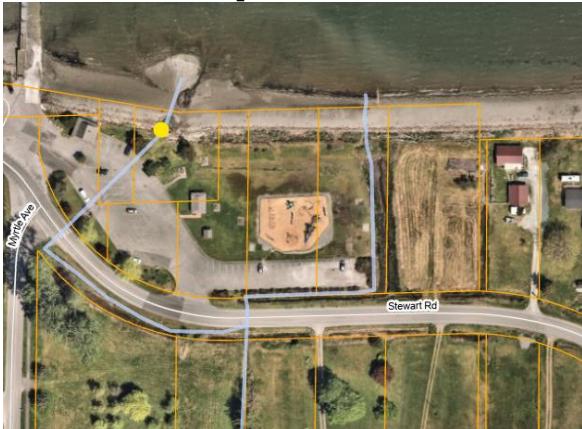
Stream Report Card: 134a Freeland Catch Basin

This sampling site is at the stormwater catch basin outfall in Freeland Park. The area immediately upstream from the sampling site is zoned for rural residential and designated to be an urban area. The site is located near a beach and swim site called Freeland County Park which is placed under a swimming advisory due to high Enterococcus levels from Memorial Day to Labor Day.

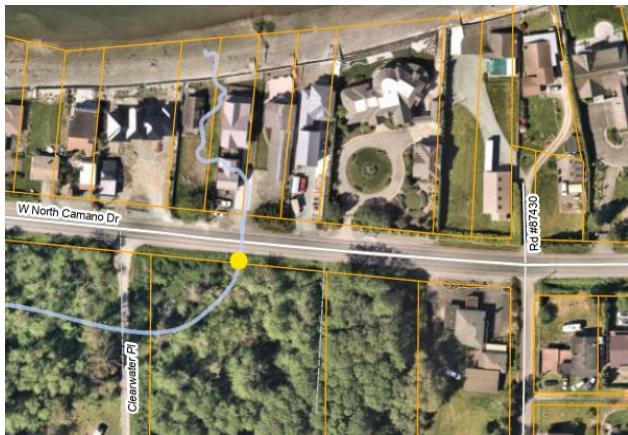
Stream Report Card: 45a N Camano @ Nellie

The sampling location is a designated fish stream at the outlet of a forested wetland. Water exits through a culvert passing under W North Camano Drive which then drains under houses to the Sound. This site is site is zoned for rural residential and designated to be an urban area.

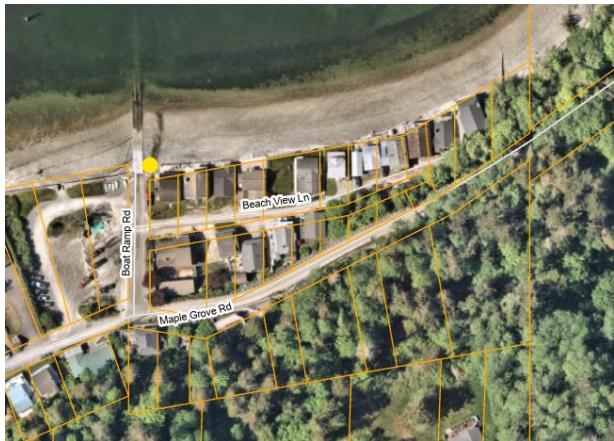
Stream Report Card: MG5 Maple Grove

This site is located at the outflow of stormwater culverts at Maple Grove Boat Launch. Wetlands and hillside seeps occur above the site and the area upstream is zoned RAID, or Residential Area of Intensive Development. This site has a history of fecal pollution and septic issues and has had funding allocated to connect homes to a communal septic system. Historically, the site has shown high E. coli levels and was chosen as one of the PIC focus areas with the goal to conduct intensive Source ID investigation to identify and correct sources of fecal pollution and reopen shellfish beds.

During the previous water year, monitoring was reinstated at Maple Grove area on Camano Island and continued into the current WY2024. Maple Grove is a prime example of the importance of AMAT and the adaptive management process. The Maple Grove boat launch on Camano Island is surrounded by residential and vacation homes, many of which are many decades old. Some of these homes have old and/or failing septic systems which can allow fecal pollution to reach the nearby marine waters. Water quality samples taken at Maple Grove boat launch during WY2024 again showed exceedances of *E. coli* levels nearly all year. In following standard procedures, the SWQ team bracketed up the waterway at several other sample sites in the vicinity but were unable to pinpoint the exact source of pollution. The OSS team with Public Health conducted dye testing at an owner’s request which led to identification of a failing system that was pouring fecal matter directly onto the beach. The team simultaneously sent letters out to residents advising them to bring septic inspections up to date as they may also be contributing to the problem. In response, many residents called the County and discussed options and received helpful information on how to address their systems. With recent funding for reinstatement of the Island County PIC program, there will be better tools and resources, including outreach events and ongoing Source ID investigations, to be able to more effectively pinpoint the source of pollution in this area as exceedances are ongoing.

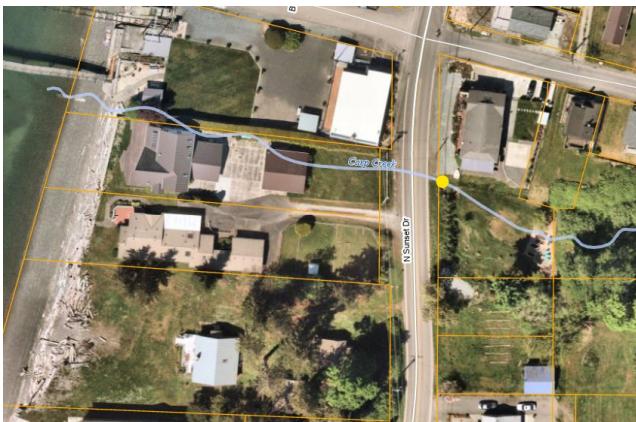
Stream Report Card: 55a Carp Creek

The sampling site for Carp Creek is located at the junction of two streams that flow into ditches near Sunset and Olympic Road. One stream is feed from mostly wetlands and the other is feed from Carp Lake and other wetlands. Carp Lake drains through mostly privately owned forested lands to developed waterfront properties.

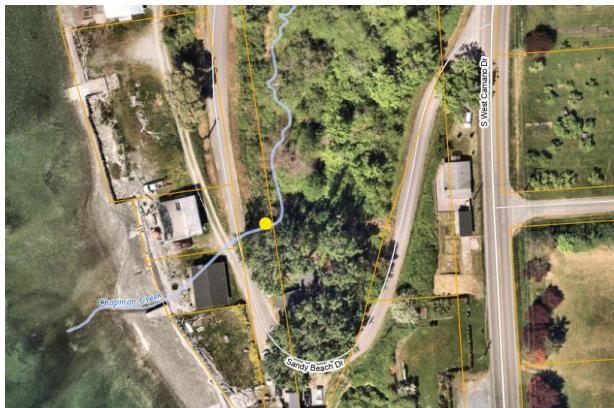
Stream Report Card: 69a Chapman Creek

This sampling site is located on the upstream (east) side of Sandy Beach Road, just before the stream flows in culverts into Saratoga Passage. The designated land use upstream from the sampling site is zoned for rural residential.

There are several culvert replacement projects currently being monitored: Race Road, Chapman Creek, and Kristoferson Creek culvert replacements. Race Road is still in the development phase, so we will continue to track the progress. Pictures from left to right: Chapman Creek, Kristoferson Creek

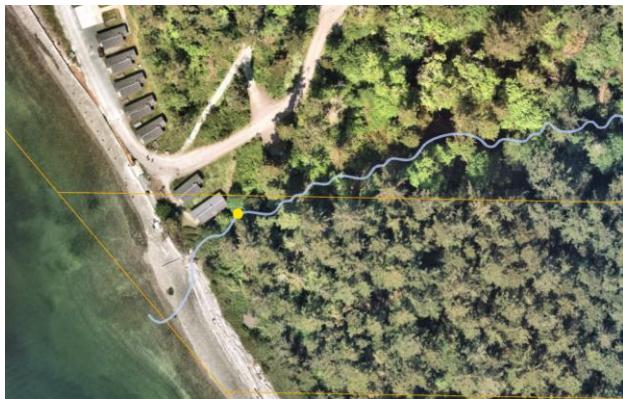
Stream Report Card: 81a Cama Beach State Park

This site is located on a designated fish stream within Cama Beach State Park behind the beach cabins. The area upstream is primarily native habitat and stream buffers are well-vegetated with native plants and trees. The stream is seasonal and has varying flow in the drier summer months.

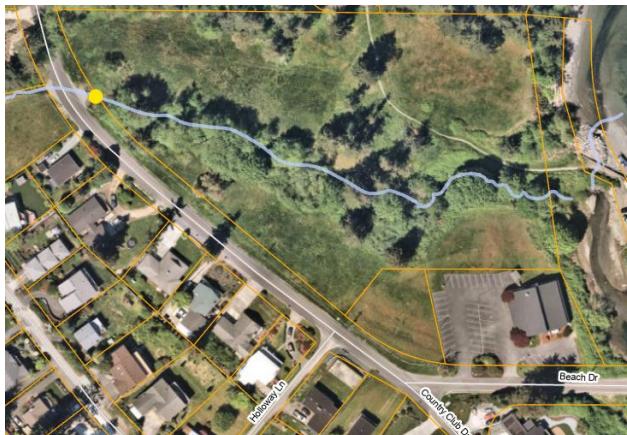
Stream Report Card: 74a Cavalero Creek

This perennial stream begins as a series of ponds then drops into a forested ravine between dense developments with two road crossings before discharging into Port Susan. The area immediately upstream from the sampling site is zoned for rural residential and designated to be an urban area.

Water quality has improved since WY2023. For WY2024, this site met both parts of the state standard for *E. coli* with no high hits recorded. Cavalero Creek is a fish bearing stream and passes through one of the newer fish passage box culverts installed in the summer of 2021. This stream flowed throughout the year and was consistently sampled. The Cavalero watershed and boat launch area are part of a proposed metals testing pilot program, data will be shared upon review.

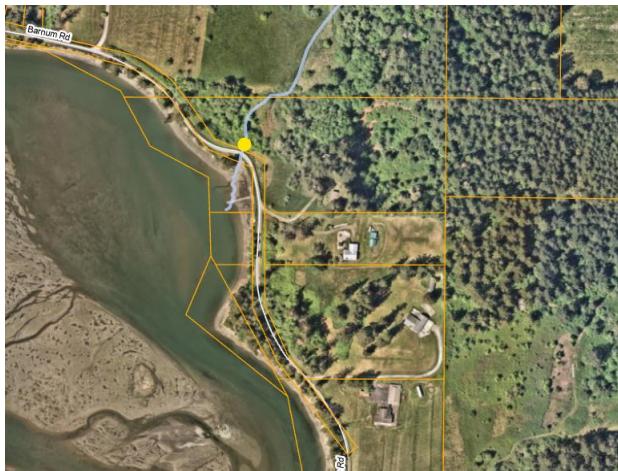
Stream Report Card: TC5 Barnum Point

This site is the outpour of a seasonal designated fish stream on the northeast side of Triangle Cove. The site passes through a series of wetlands before crossing Barnum Road in Watershed 67. The stream flows from an area with blackberries, then into native forest. Roadside ditches and farm ponds contribute. The designated land use upstream from the sampling site is mixed use, zoned rural, and designated for agriculture.

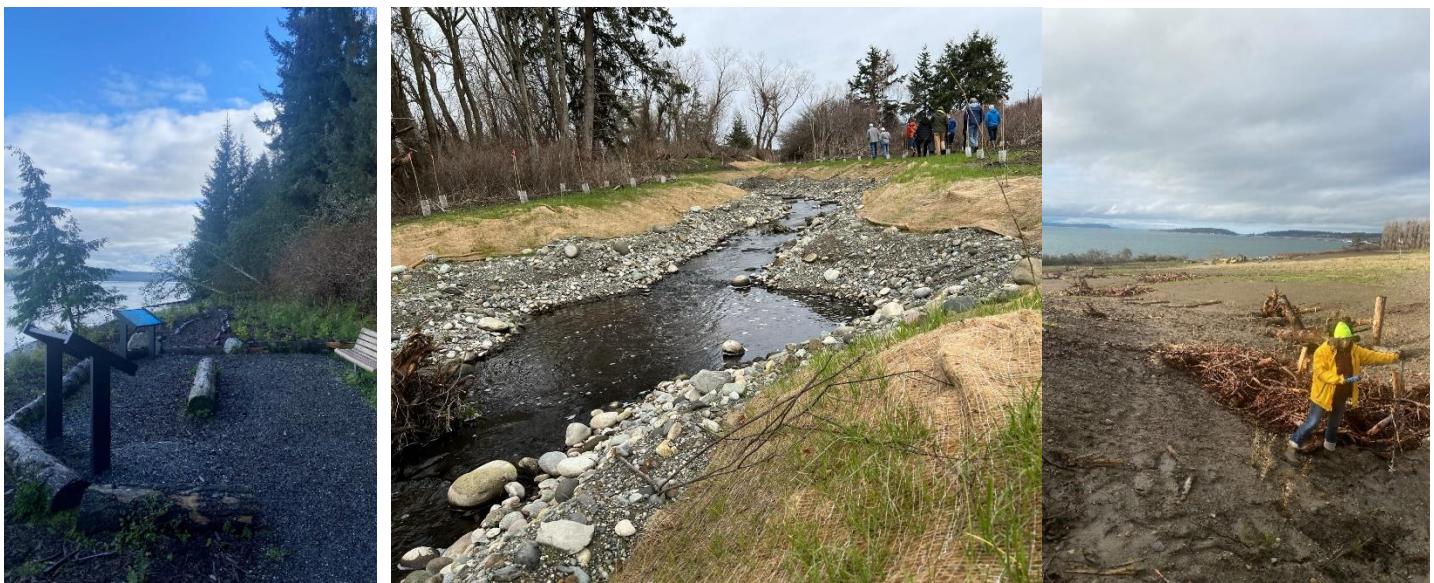
From left to right: Cornet Bay, Crescent Creek, and Keystone Restoration areas.

Restoration areas such as the Keystone Farm restoration, Cornet Bay restoration, Crescent Harbor Land Trust salmon restoration, and the Ala Spit restoration were monitored to determine the effect of restoration on water quality. Restoration is a multi-year process, and it is still early in the process for most of these sites. Data will continue to be collected to monitor the overall effects of restoration to determine next steps.
