Water Year 15 (Oct. 2020 – Sept. 2021) Island County Surface Water Quality Report

ISLAND COUNTY PUBLIC HEALTH
DEPARTMENT OF NATURAL RESOURCES
SURFACE WATER QUALITY MONITORING PROGRAM

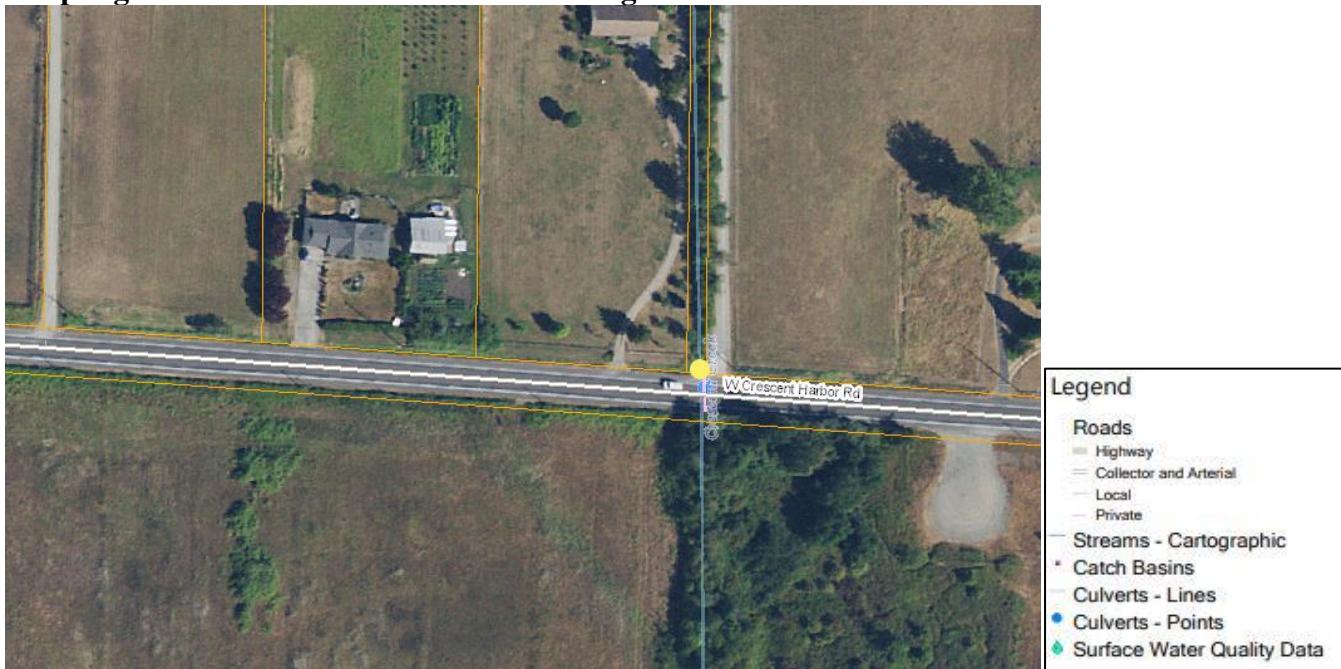
13a – North Crescent Bay

- Water quality was **moderate** based on data collected in WY15.
- Though the Geomean was not over state limits, the percentage of samples that exceeded the state limit was over 10%.

Samples taken for the North Crescent Bay site are pulled from the main channel that flows under Crescent Harbor Road, west of the intersection with Hunt Road about a half-a-mile east of Torpedo Road. The sample site is upstream of Crescent Harbor Road. The area immediately upstream from the sampling site is zoned for rural commercial agricultural use.

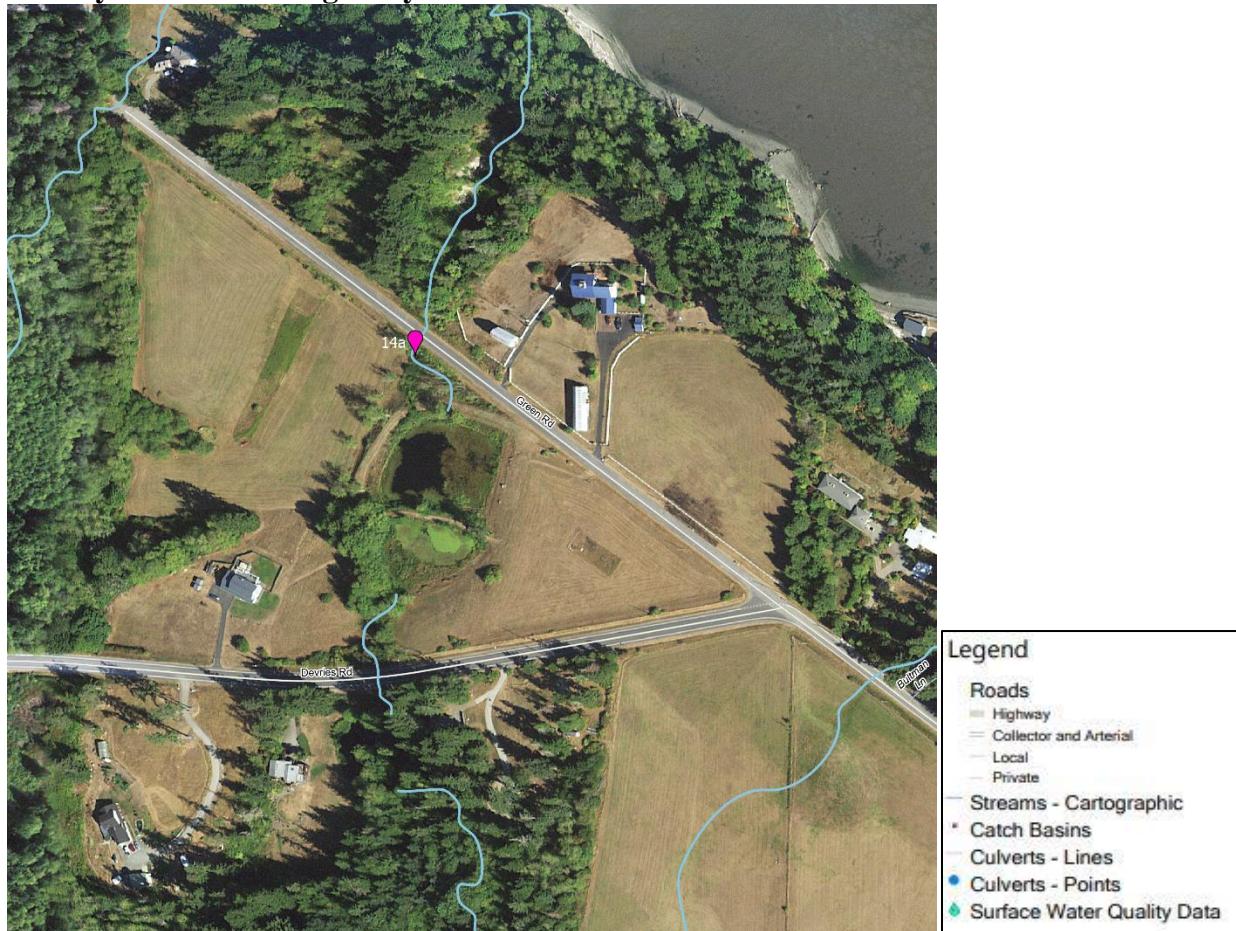
14a – Green Road

- Water quality was **good** based on data collected in WY15.
- The Geomean was not over state limits and the percentage of samples that exceeded the state limit was under 10%.

Samples taken for this site are on Green Road in North Whidbey, east of Oak Harbor. Creek flows directly into North Skagit Bay.

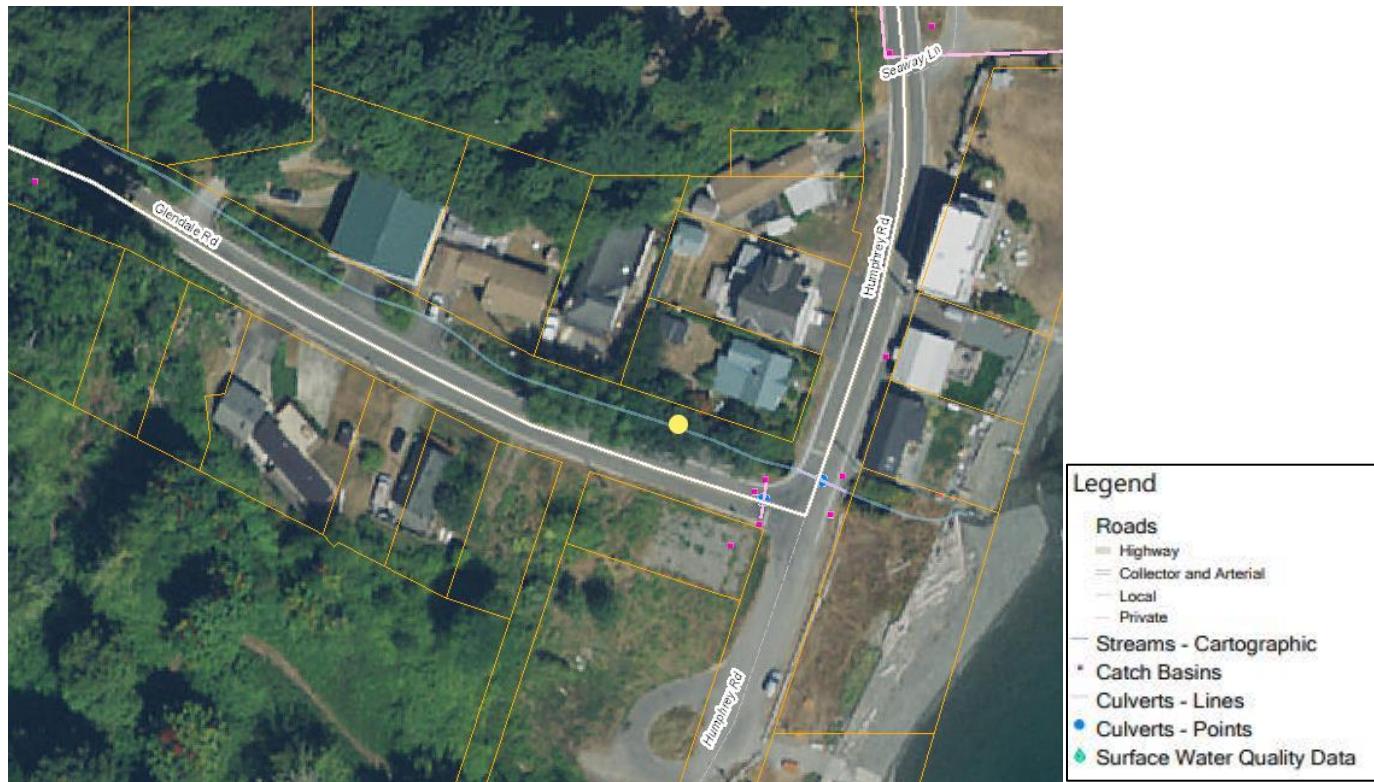
149a – Glendale

- Water quality was **good** based on data collected in WY15.
- The Geomean was not over state limits and the percentage of samples that exceeded the state limit was under 10%.

The sample location for Glendale Creek is located above the second driveway crossing up from Humphrey Road. This is a salmon bearing stream that is near roads and houses at certain points. The area immediately upstream of the sampling location is zoned rural designated for rural land use. In these areas with fewer buffers, the stream is more susceptible to pollution and thus residential and roadway practices likely have a more direct impact on the stream's water quality.

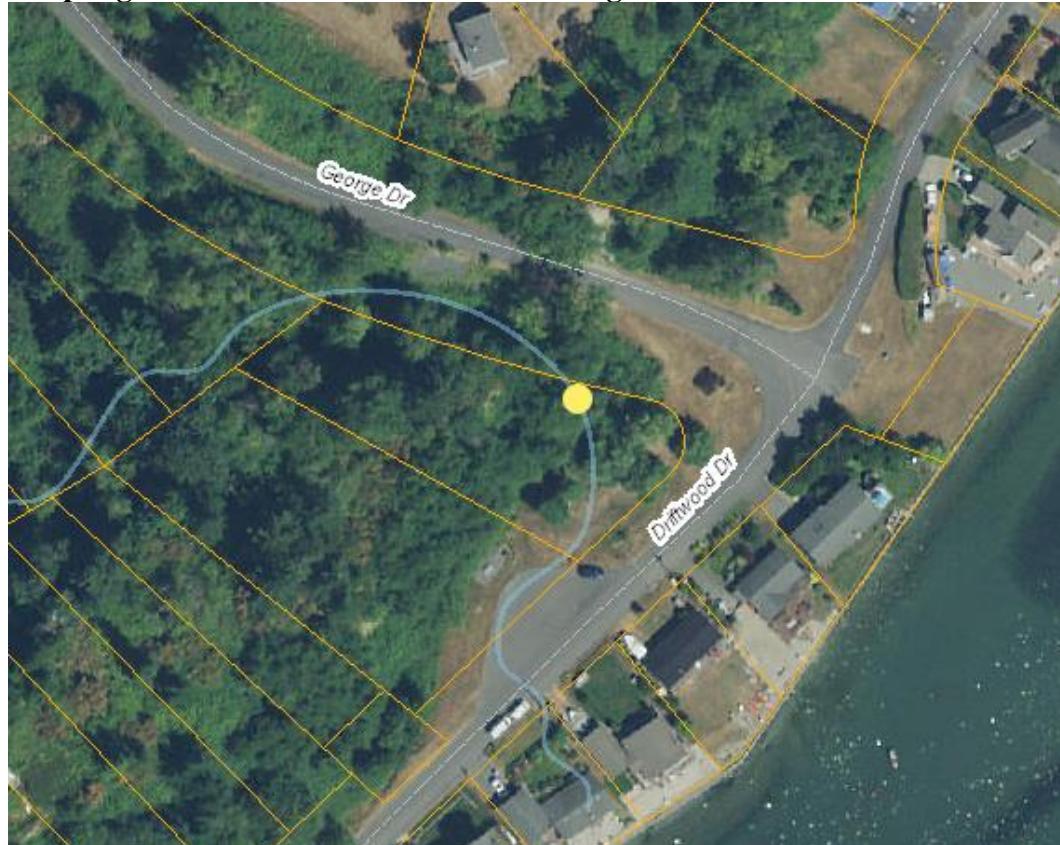
157a – Scatchet Head

- Water quality was **good** based on data collected in the WY15
- The Geomean was not over state limits and the percentage of samples that exceeded the state limit was under 10%.

This site location is a stream that runs through the Scatchet Head Community Park. It then enters a culvert under Driftwood Road before draining into Puget Sound. The area immediately upstream of the sampling location is zoned rural and its designated use is rural land.

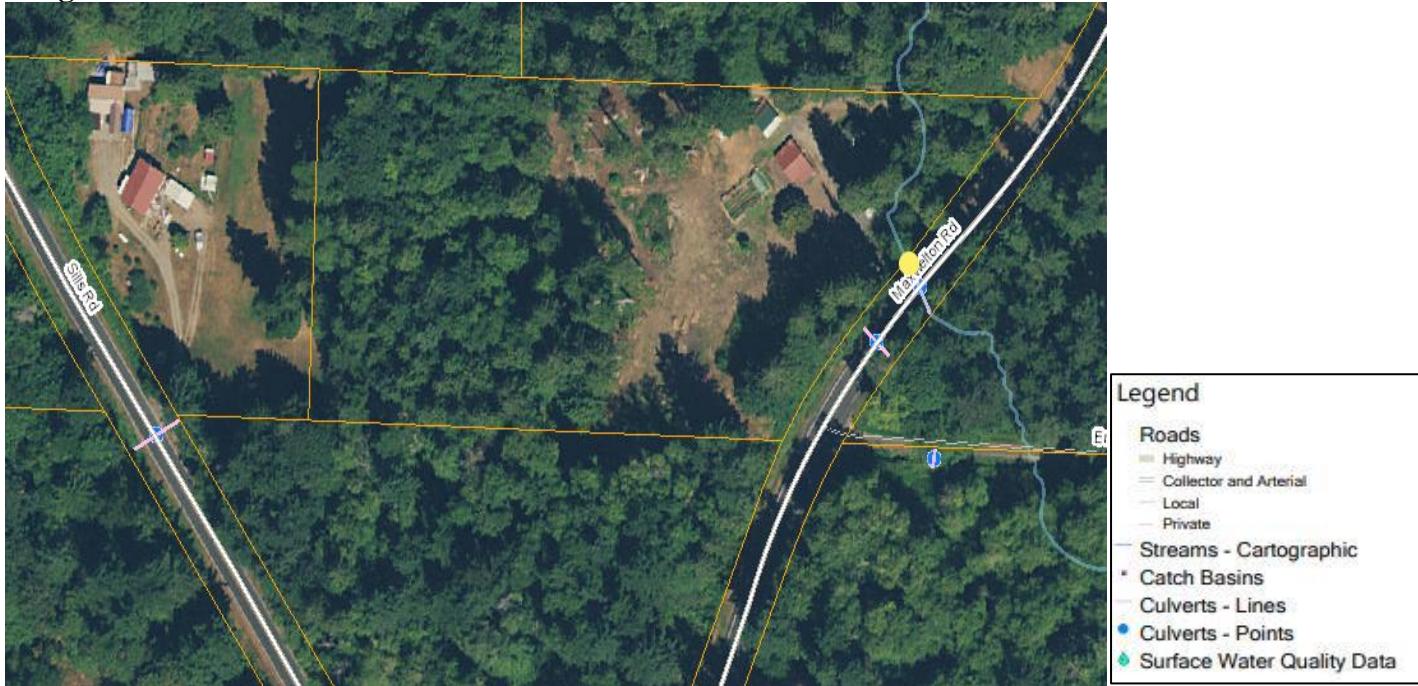
MWA2 – French Road

- Water quality was **moderate** based on data collected in WY15.
- Though the Geomean was not over state limits, the percentage of samples that exceeded the state limit was over 10%.

This sampling location is on the north side of French Road. This site has extensive riparian vegetation cover and year-round flow. The area immediately upstream of the sampling location is zoned rural and designated to be rural lands.

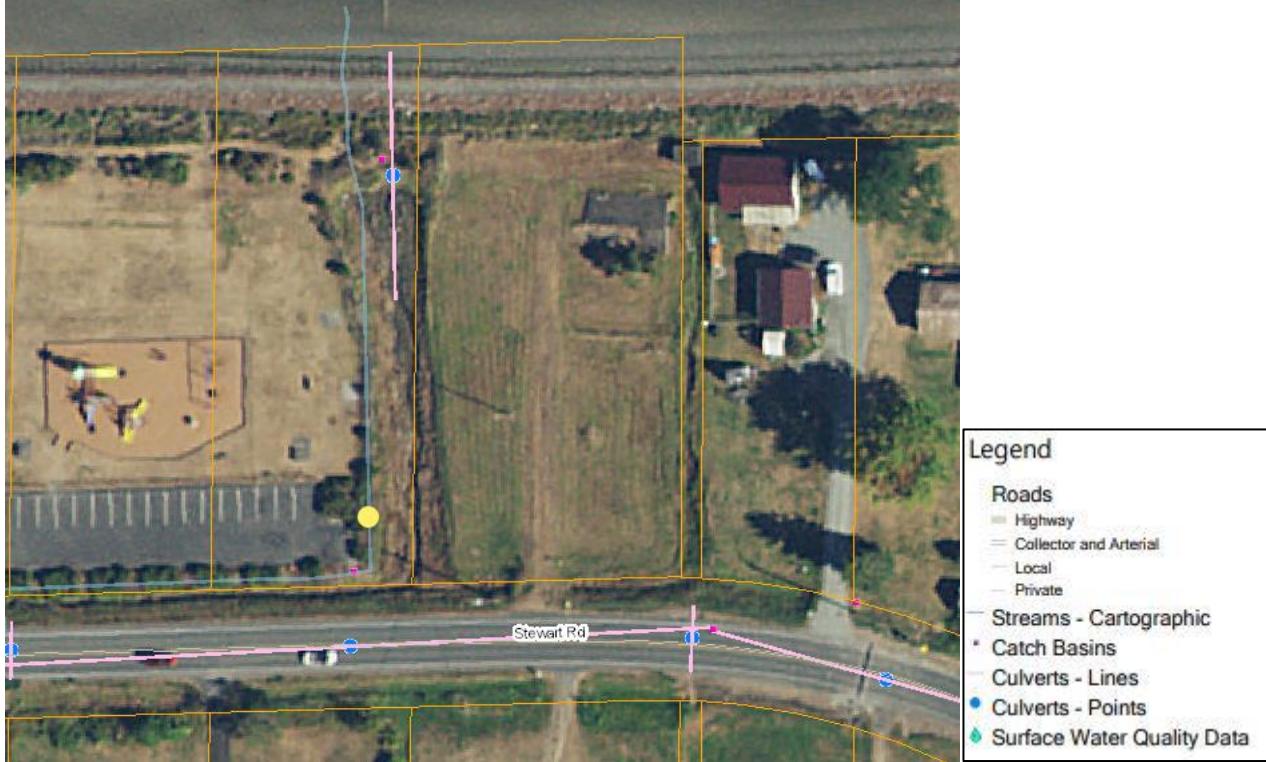
Hhab – East Freeland Park

- Water quality was **poor** based on data collected in WY15.
- Though the Geomean was over state limits, the percentage of samples that exceeded the state limit was over 10%.

This sampling location is in a tidally influenced stream near the parking lot of Freeland Park. The area immediately upstream from the sampling site is zoned for rural residential and designated to be an urban area.

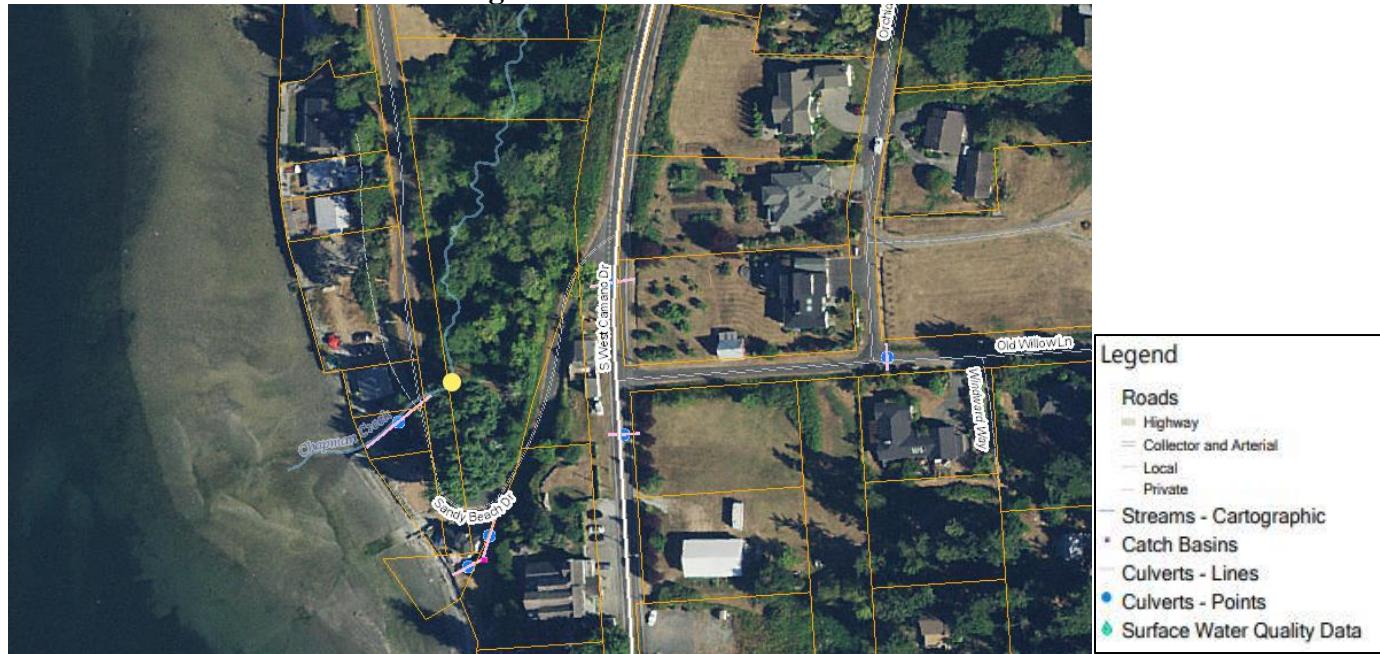
69a – Chapman

- Water quality was **moderate** based on data collected in WY15.
- Though the Geomean was not over state limits, the percentage of samples that exceeded the state limit was over 10%.

This sampling site is located on the upstream (east) side of Sandy Beach Road, just before the stream flows into Saratoga Passage. The designated land use upstream from the sampling site is zoned for rural residential and designated use is to be a RAID.

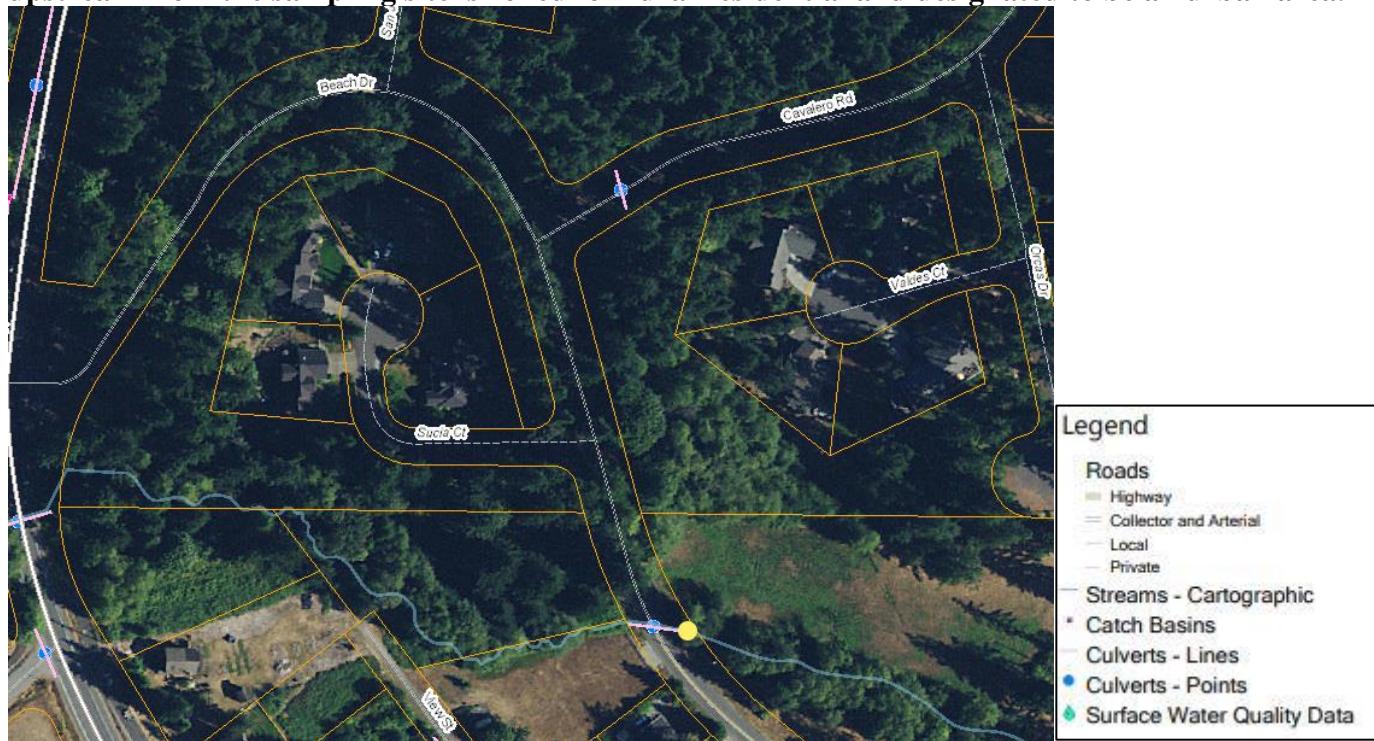
74a – Cavalero Creek

- Water quality was **good** based on data collected in the WY15
- The Geomean was not over state limits and the percentage of samples that exceeded the state limit was under 10%.

This perennial stream begins as a series of ponds then drops into a forested ravine between dense developments with two road crossings before discharging into Port Susan. The area immediately upstream from the sampling site is zoned for rural residential and designated to be an urban area.

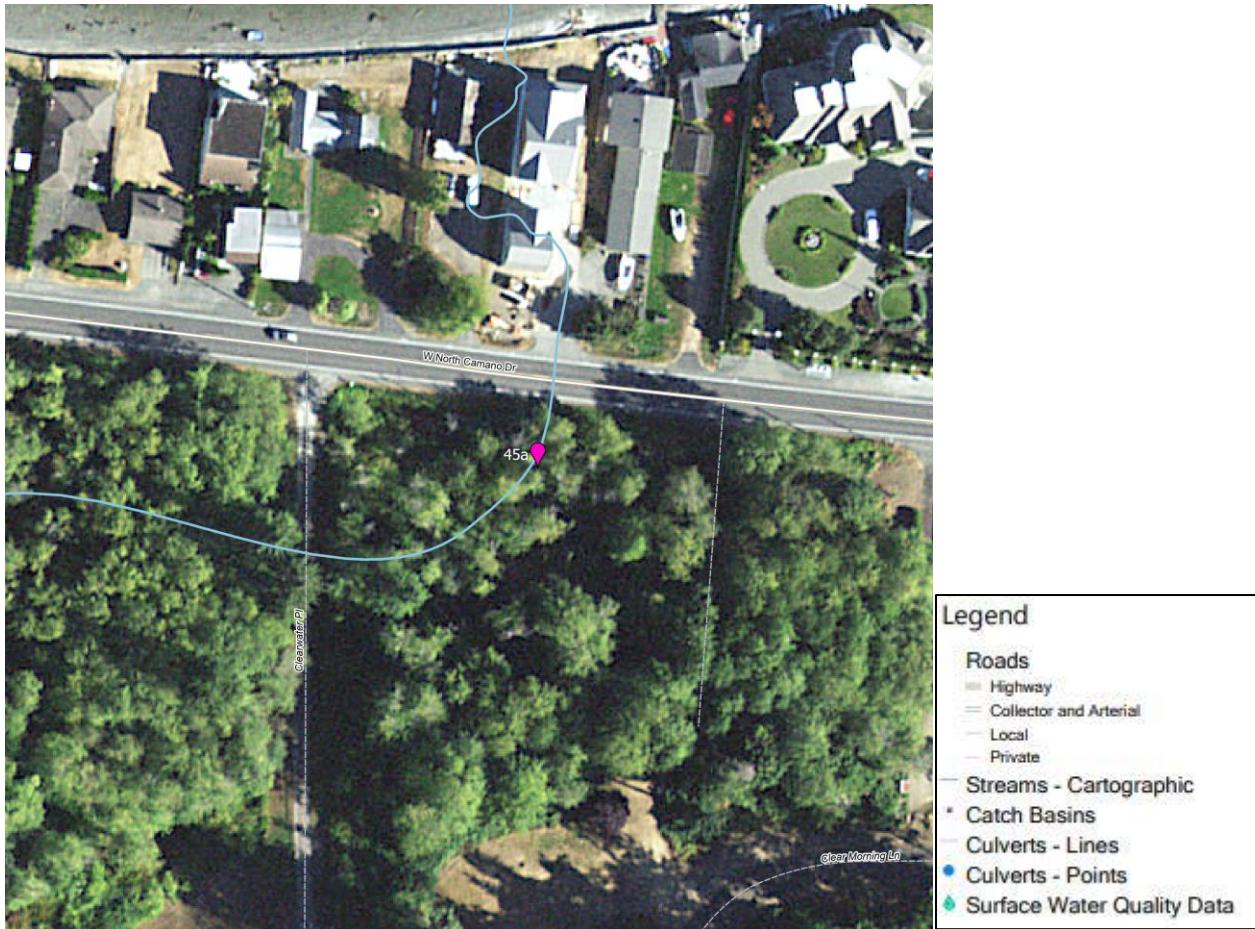
45a –Nellie

- Water quality was **good** based on data collected in the WY15
- The Geomean was not over state limits and the percentage of samples that exceeded the state limit was under 10%.

This seasonal stream is one that drains into the Saratoga Pass. Zoned predominately rural. This is a rotational site.

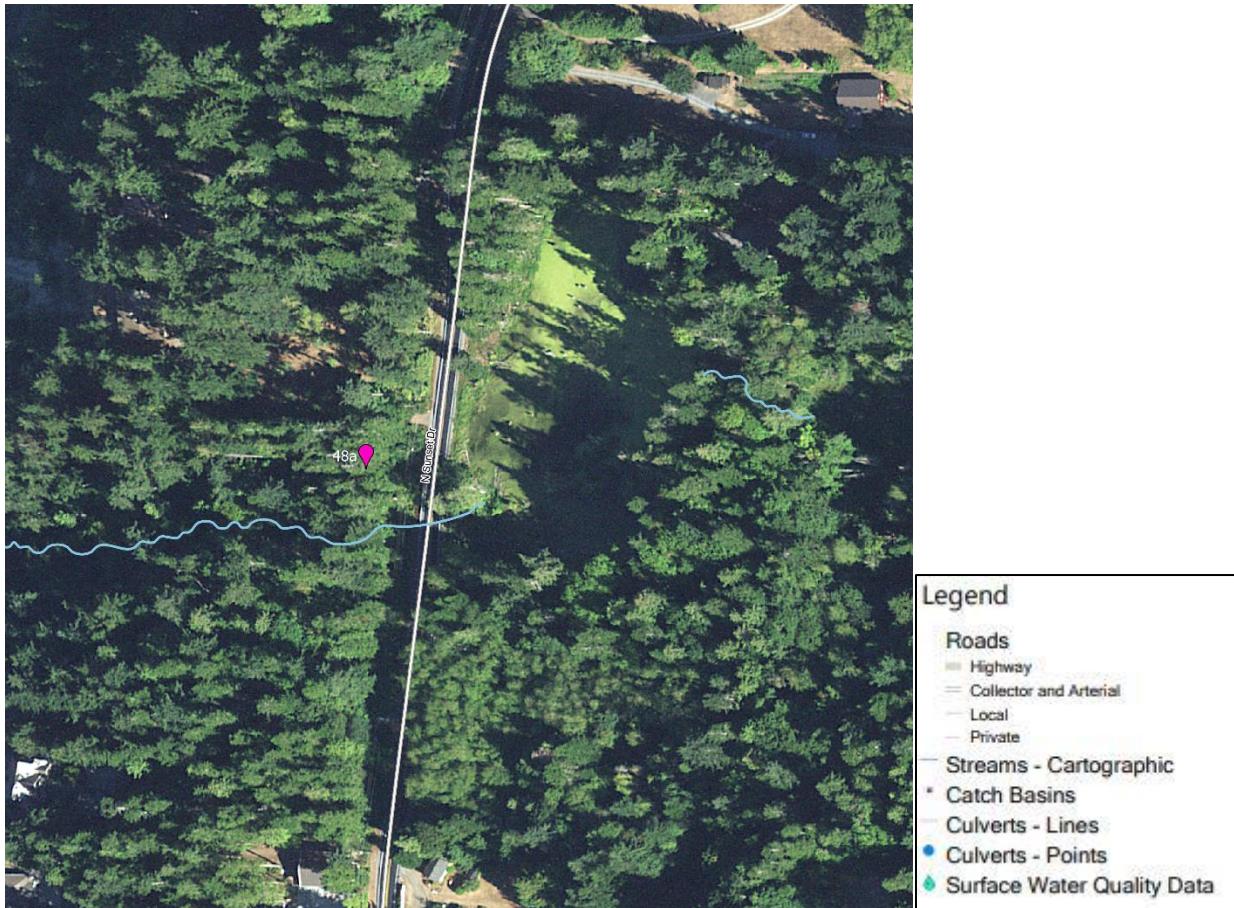
48a –North Sunset

- Water quality was **good** based on data collected in the WY15
- The Geomean was not over state limits and the percentage of samples that exceeded the state limit was under 10%.

This seasonal stream is one that drains into the Saratoga Pass. Zoned predominately rural. This is a rotational site.

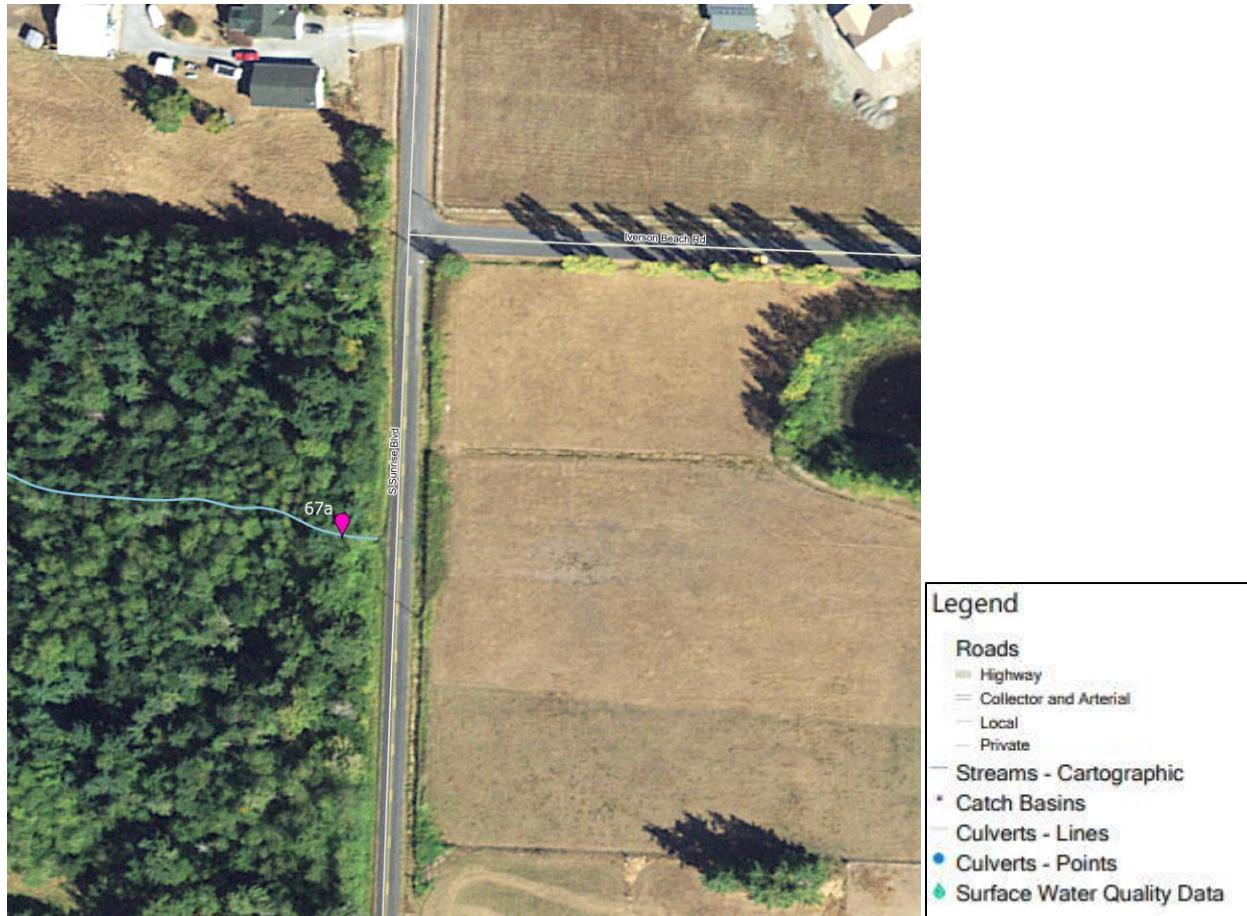
67a –Iverson

- Water quality was **good** based on data collected in the WY15
- The Geomean was not over state limits and the percentage of samples that exceeded the state limit was under 10%.

This seasonal stream is one that drains into the Saratoga Pass. Zoned predominately rural. This is a rotational site.
