Water Year 2023 (Oct. 2022 – Sept. 2023)

Island County Surface Water Quality Report

ISLAND COUNTY DEPARTMENT OF PUBLIC HEALTH
DIVISION OF NATURAL RESOURCES
SURFACE WATER QUALITY MONITORING PROGRAM

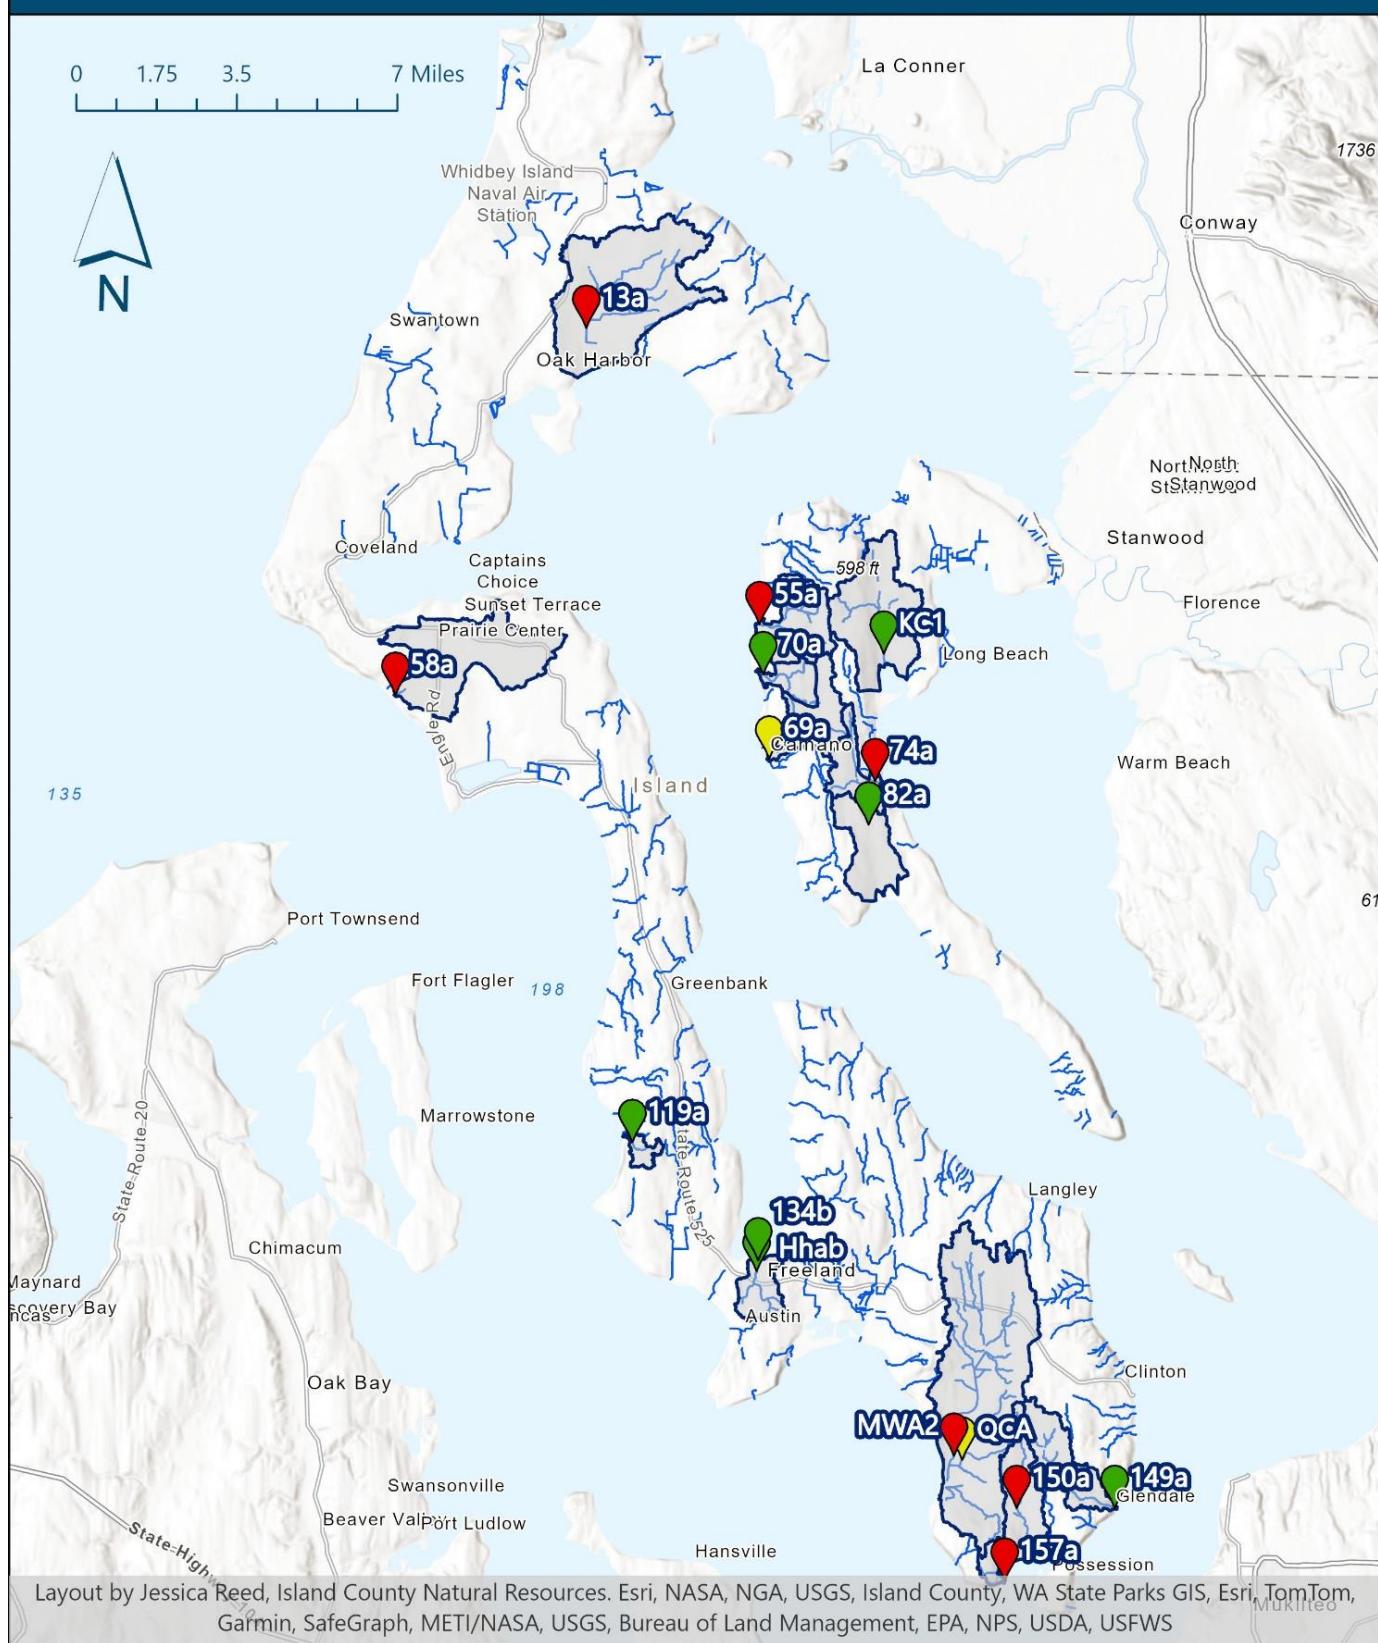
Figure 1. Island County Watershed and Sample Site Map for WY2023 (WY17)

Island County Watershed & Sample Site Map Water Year 2023 (WY17)

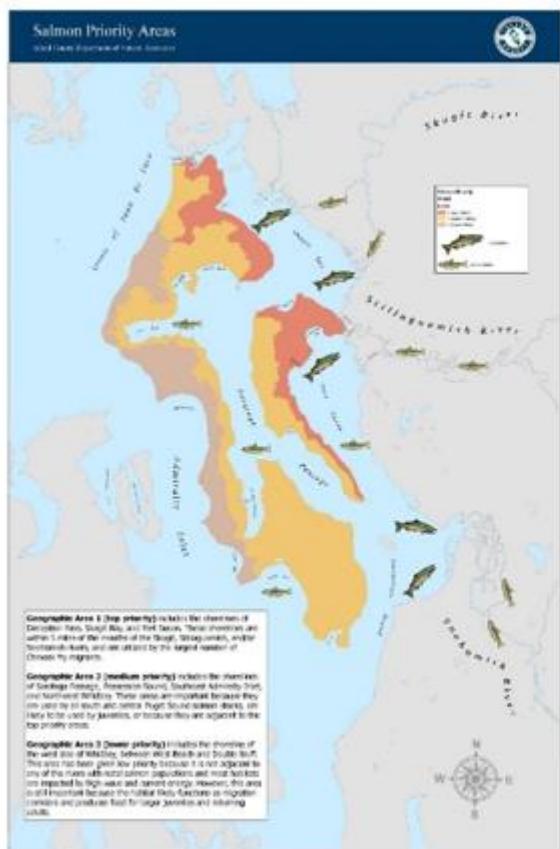
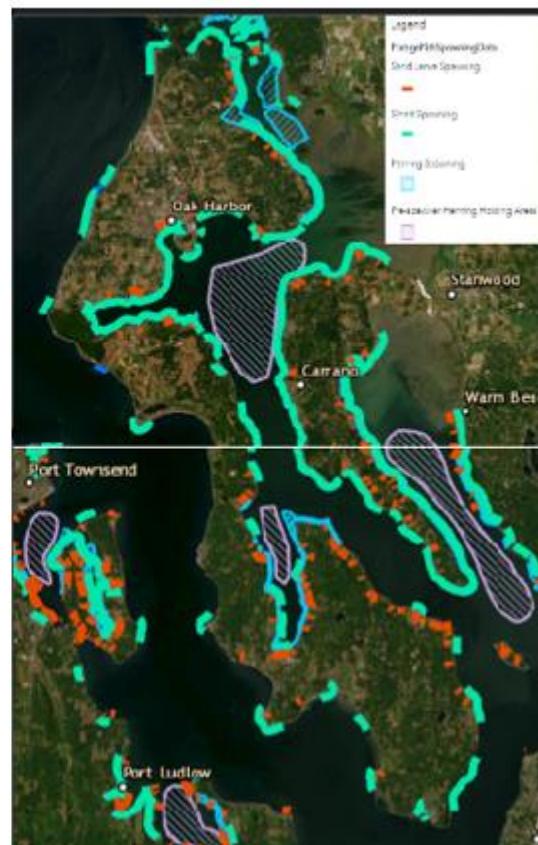
Figure 2a & 2b: a) Island County salmon priority area map; b) WDFW forage fish survey area map

Also of importance to watershed prioritization listings are forage fish survey maps and salmon priority areas (See Figures 2a and 2b). These areas are often found at the pour points of watersheds and are of critical importance to juvenile salmon habitat and overall Puget Sound and Washington State salmon restoration efforts. Attention is given to these watersheds by way of reporting their contributions to salmon recovery and identifying connections between their health and possible sources of pollution found during Source ID and future Pollution Identification and Correction (PIC) investigations.

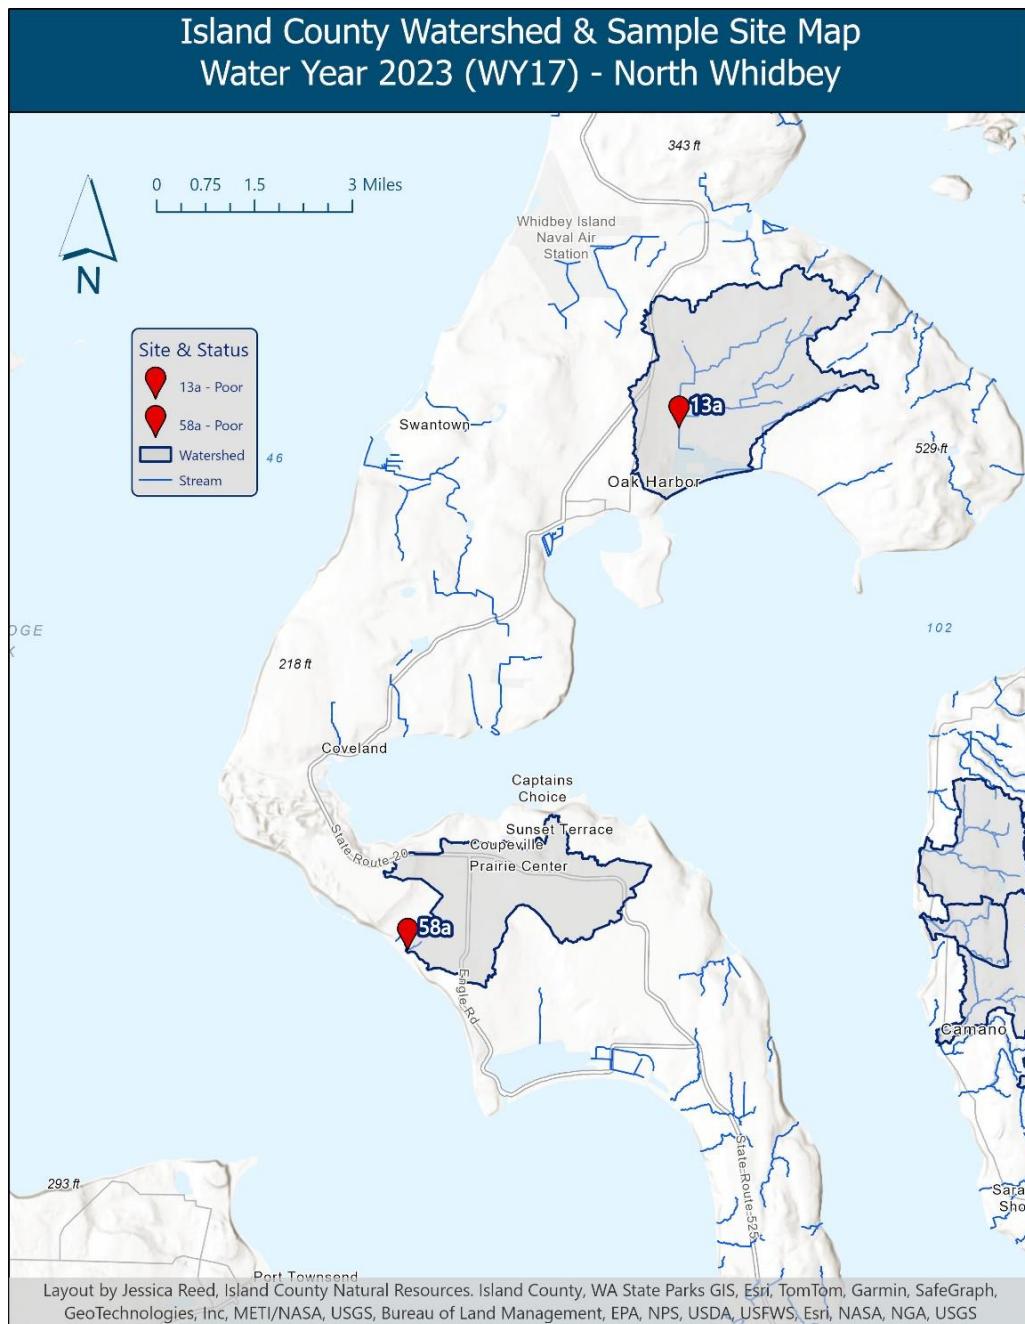
Figure 3. Location of North Whidbey samples sites and their water quality status

Figure 3 shows the location of North Whidbey samples sites and their water quality status.

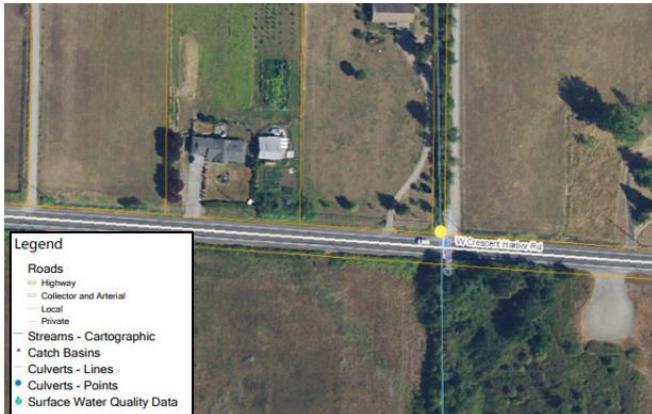
Stream Report Card: 13a – Crescent Creek (North Crescent Bay)

Samples taken for the North Crescent Bay site are pulled upstream from the main channel that flows under Crescent Harbor Road, west of the intersection with Hunt Road. The area immediately upstream from the sampling site is zoned for rural commercial agricultural use. Proposals have been submitted for habitat restoration in this area and salmon restoration projects near the sample site are ongoing.

This site was inconsistently sampled due to water stagnation and dry conditions during Quarters 3 and 4. A beaver dam was found above the sample site; property owners observed the beaver dams have helped to extend the duration of flow in the drier summer months. *E. coli* levels have increased since the prior water year and continue to show seasonal high hits. During the winter and spring months (November through July) *E. coli* levels often exceeded the state standard. SWQ staff bracketed above the sample site with inconclusive results so the source of the high hits will continue to be investigated.

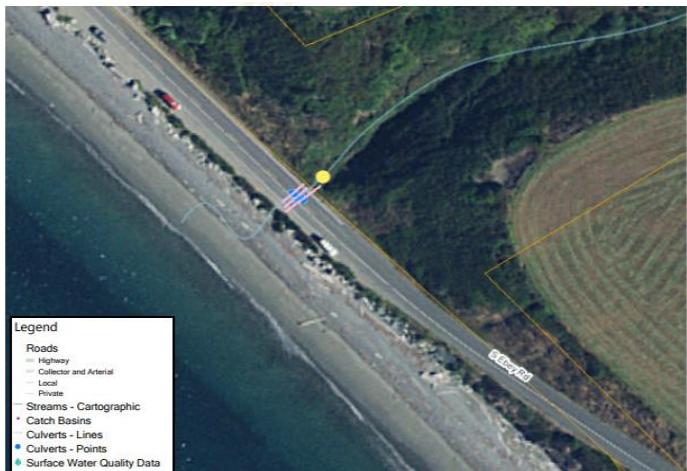
Stream Report Card 58a – Ebey's Landing

Surface waters are captured in roadside catch basins and field drain tiles then piped, subsurface, across agricultural fields before daylighting in a ravine where it forms a stream channel that outfalls on Ebey's Landing beach. The area immediately upstream of the sampling location is zoned for commercial agriculture and is currently being used for agriculture.

This location was able to be consistently sampled except for March when high conductivity levels were recorded due to tidal influence. Multiple high hits for *E. coli* led to Source ID bracketing upstream at culverts along and near the conservation easement as well as along Engle Rd with inconclusive results. Water quality based on levels of *E. coli* levels has worsened since the previous water year, and seasonal geomeans show distinct trends of high hits during the spring and summer months, April through September. Historically this site has shown high levels of fecal coliform during these months. Additional Source ID bracketing will be required to identify the source of fecal pollution.

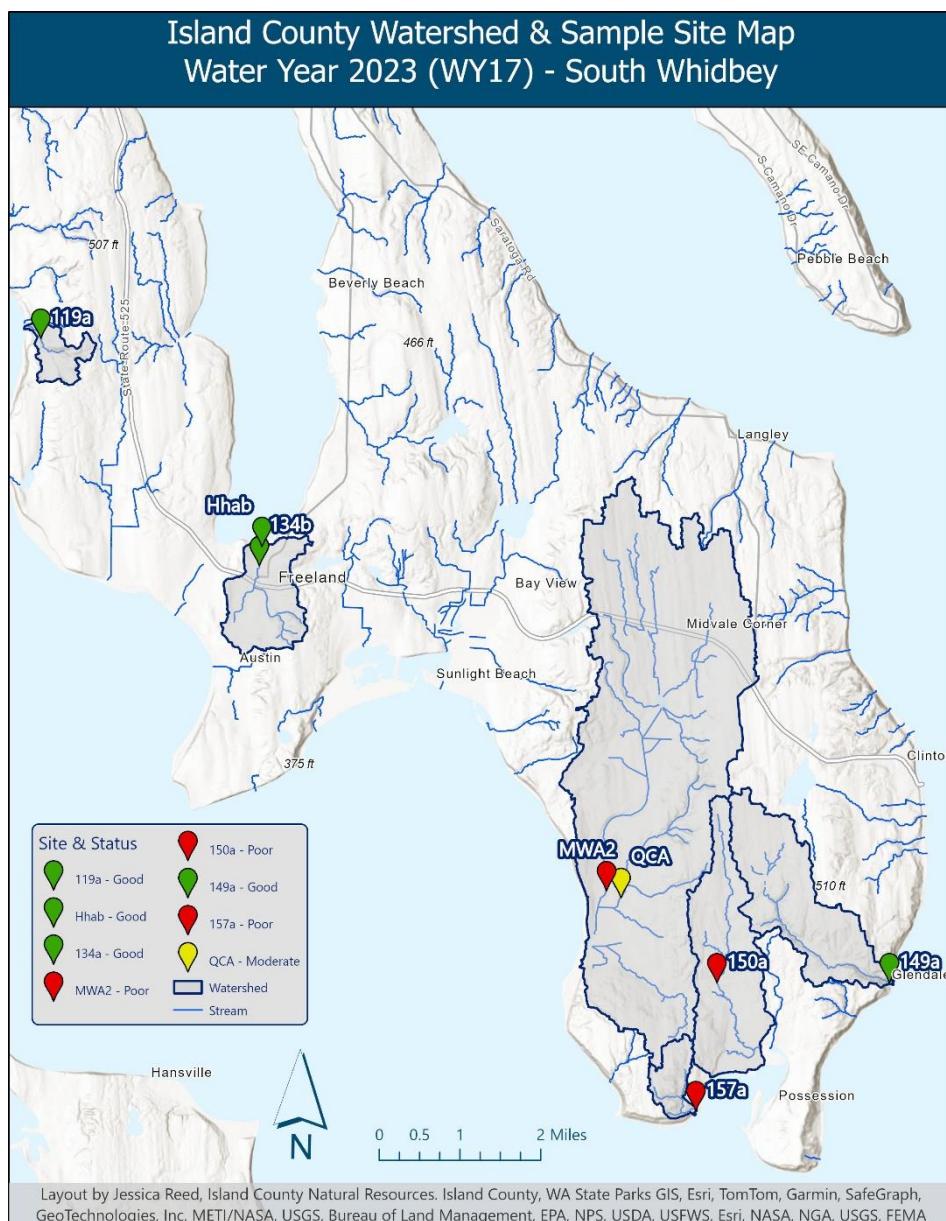
Figure 4. South Whidbey sample sites and their water quality status

Figure 4 shows the location of South Whidbey samples sites and their water quality status.

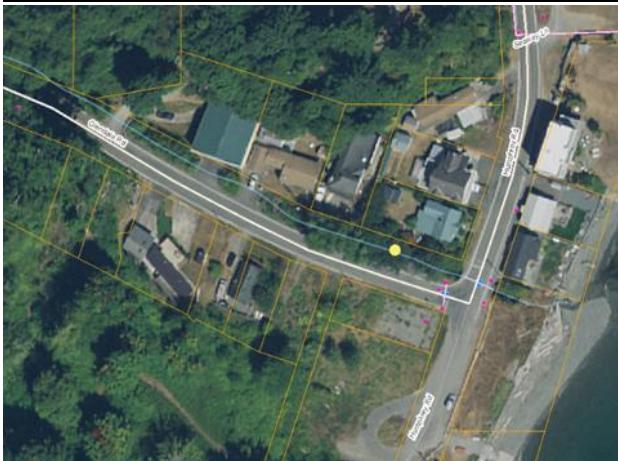
Stream Report Card: 149a – Glendale Creek

The sample location for Glendale Creek is located above the second driveway crossing up from Humphrey Road. This is a historical salmon bearing stream that is immediately bordered by roads and houses at the pour point. The area immediately upstream of the sampling location is zoned rural designated for rural land use.

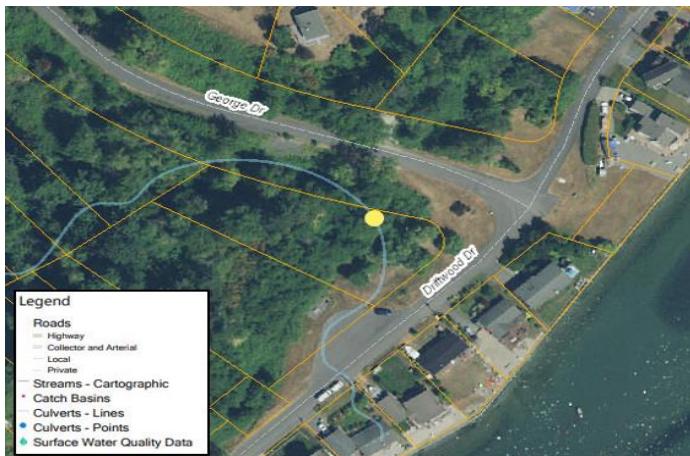
Stream Report Card: 157a – Scatchet Creek

This site location is a stream that runs through the Scatchet Head Community Park. It then enters a culvert under Driftwood Road before draining into Puget Sound. The area immediately upstream of the sampling location is zoned rural and its designated use is rural land.

Repeated high hits in July instigated bracketing upstream, however, a clear source could not be identified before levels decreased. The current site has formerly tested high for fecal coliform and there is a history of bracketing at sites upstream. This site has a history of septic challenges related to pumping of effluent to different parcels. In the past dye tests have been performed in the community to identify possible sources of pollution through the PIC program.

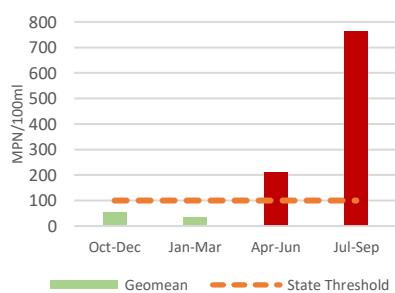
Cultus Creek
E. coli Seasonal Geomeans

The annual geomean was 86 MPN/100 mL which was not over state limit, but seasonal geomeans exceeded state standards during the months of April through September. Due to the many high hits at this site, Source ID was conducted at three sites upstream. Two culverts located on Adobe Road were sampled, and when results showed additional high hits, another culvert on Springwater Lane was sampled. Resampling showed consistent high hits, but additional Source ID could not be conducted due to dry conditions upstream. Since the main site still showed higher hits, the area was referred to AMAT and letters were sent to surrounding property owners advising them of the exceedances and encouraging them to have their septic systems inspected according to Island County Code. Even though not on the rotation cycle until 2026, this site will periodically be sampled as part of the Source ID process, with any ongoing issues referred to the Environmental Health department for any potential enforcement actions.

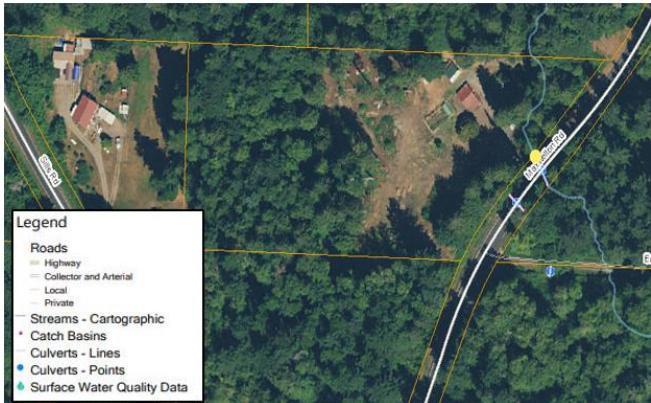
Stream Report Card: MWA2- Maxwelton Creek

This sampling location is on the north side of French Road on Maxwelton Creek. This site has extensive riparian vegetation cover and year-round flow. The area immediately upstream of the sampling location is zoned rural and designated to be rural lands.

Water quality has decreased since WY2022; the annual geomean was 86 MPN/100 mL but seasonal geomeans showed a distinct trend towards higher hits during the summer and fall months. Repeated high hits that exceeded standards at this site instigated bracketing upstream. Review of bracket site data led to the search being narrowed down to six possible parcels that were the most probable source of pollution. Working collaboratively with AMAT led to discussions with OSS enforcement who identified the surrounding six parcels for septic compliance and sent letters to those property owners.

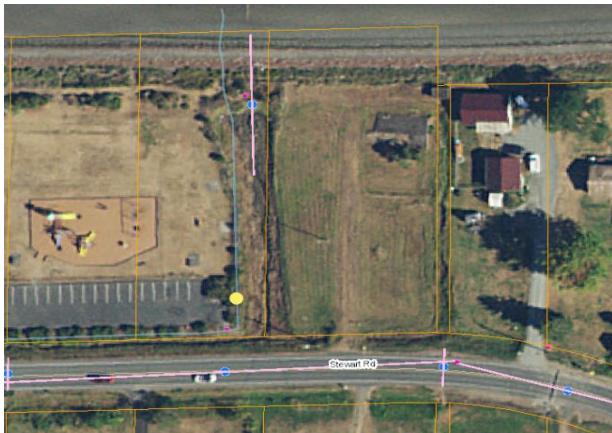
Stream Report Card: Hhab- East Freeland Park

This sampling location is in a tidally influenced stream near the parking lot of Freeland Park. The area immediately upstream from the sampling site is zoned for rural residential and designated to be an urban area.

The sampling at this site was inconsistent with tidal influence and low flow which led to upstream bracketing. Hhab had issues with high salinity and tidal exchange, and many samples fell outside the conductivity threshold making most of them inviable based on definitions of surface water vs. marine water. Water quality has improved since WY16 with the annual geomean of 35 MPN/100 mL, but seasonal geomeans show a trend towards higher hits during the winter months. Data for this location may not have been representative of ambient water quality due to the inability to collect samples year-round. This area is also the focus of Swim Beach sampling reported to ECY.

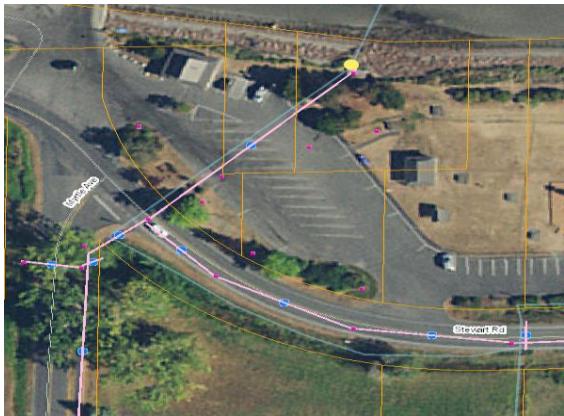
Stream Report Card: 134a- Freeland Park

This sampling site is at the stormwater outfall in Freeland Park. The area immediately upstream from the sampling site is zoned for rural residential and designated to be an urban area. The site is located near a beach and swim site called Freeland County Park which is placed under a swimming advisory due to high Enterococcus levels from Memorial Day to Labor Day.

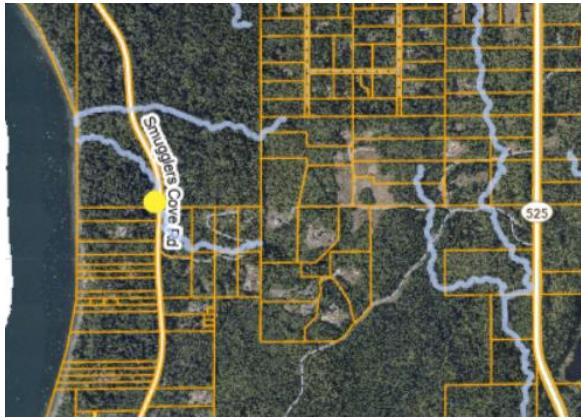
Stream Report Card: 119a- South Whidbey State Park

This is a rotational site on the boundary of South Whidbey State Park. The stream runs through primary conifer forests and is zoned rural. Stream conditions are designated as natural with native vegetation shading the stream.

This stream flowed all ten months of sampling and was able to be sampled consistently throughout the year. This is a rotational site sampled in WY2020 and again in WY2023, site conditions are considered natural. Both annual and seasonal geomeans were well under the state limit. The seasonal geomeans show minimal *E. coli* levels throughout the year.

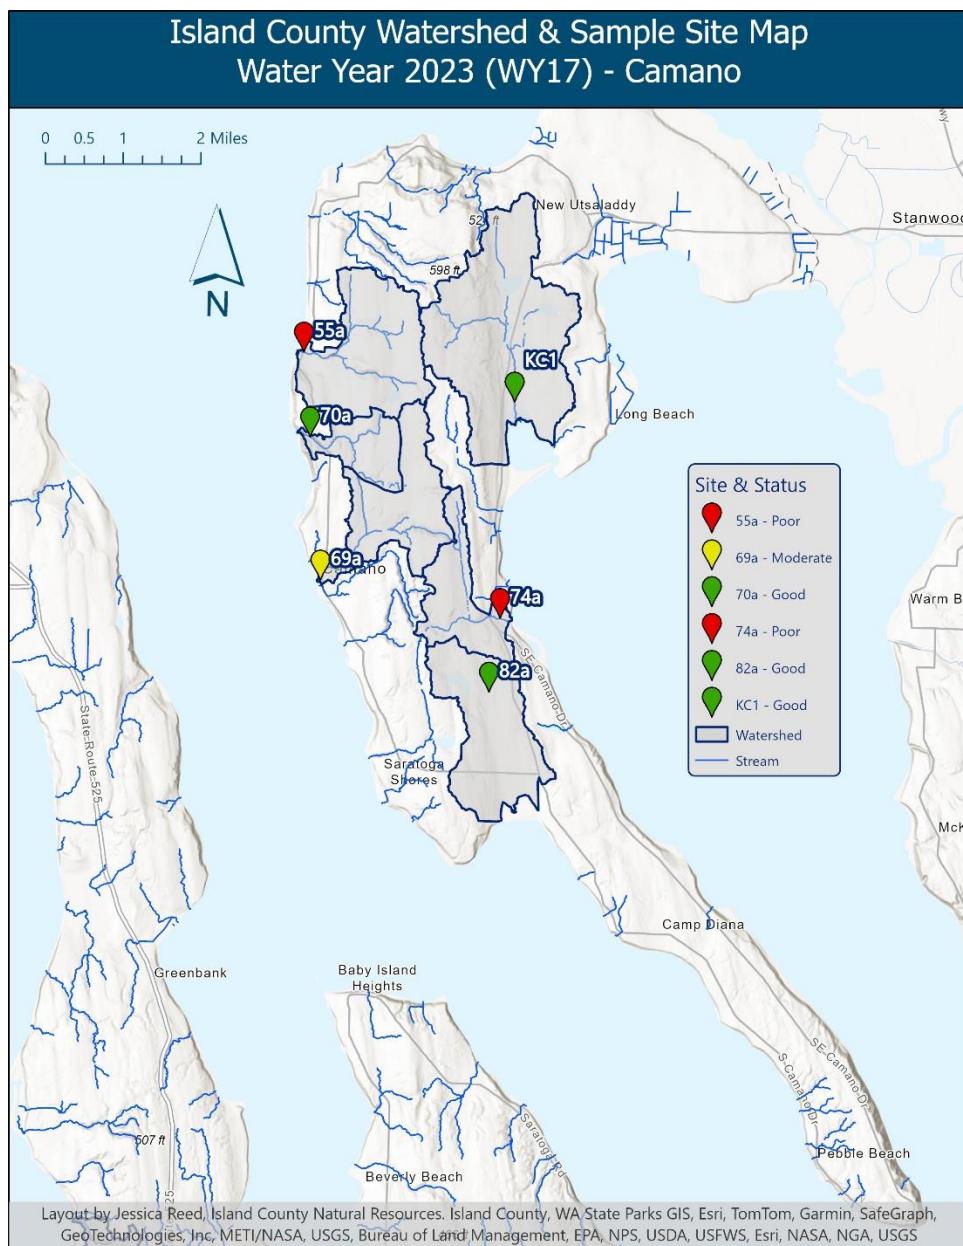
Figure 5 shows the location of Camano Island samples sites and their water quality status.

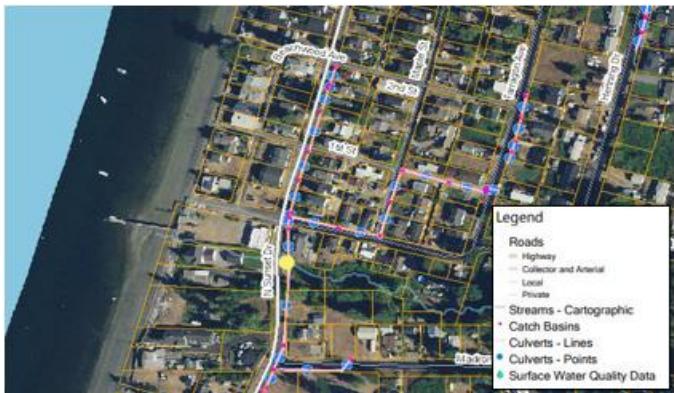
Stream Report Card: 55a- Carp Creek

The sampling site for Carp Creek is located at the junction of two streams that flow into ditches near Sunset and Olympic Road. One stream is feed from mostly wetlands and the other is feed from Carp Lake and other wetlands. Carp Lake drains through mostly privately owned forested lands to developed waterfront properties.

The geomean was 50 MPN/100 mL which is under state limits but the seasonal geomeans did exceed state standards. This stream flowed consistently throughout the year with lower flows seen in summer and fall months. Higher *E. coli* levels were seen in Quarter 1. SWQ Team bracketed this stream several times this year due to repeated high hits. Historically this site has shown higher hits of fecal coliform all throughout the year, but WY2023 showed the majority of high hits Oct thru December. Water quality has decreased since WY2022.

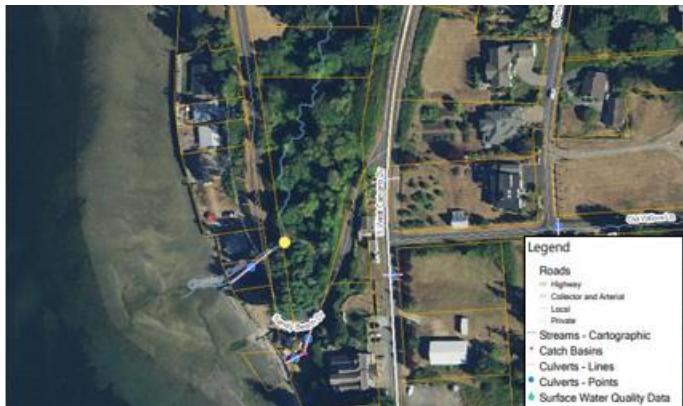
Stream Report Card: 69a- Chapman Creek

This sampling site is located on the upstream (east) side of Sandy Beach Road, just before the stream flows in culverts into Saratoga Passage. The designated land use upstream from the sampling site is zoned for rural residential.

The annual geomean was 29 MPN/100 mL which is under the state limit of 100 MPN/100 mL but the seasonal geomeans during July-September exceeded state standards. A high hit recorded in August led to bracketing upstream; however, no additional high hits were reported and by September *E. coli* numbers had gone down to below state thresholds. The SWQ team worked with Environmental Health at this site to attempt to identify the source of high hits through AMAT.

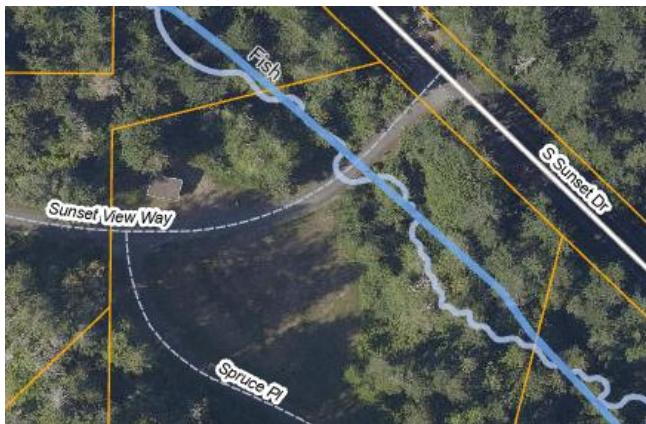
Stream Report Card: 70a- Sunset Creek

Along the southern portion of Sunset drive, just before West Camano Drive. Site is on southern side of private driveway, in ravine shaded area with large numbers of tall trees. The land upstream (southeast) of the sampling location was cleared for a new housing development beginning April, 2007. An upstream site was also monitored to determine possible effects from the development or the wetland above the site.

The annual geomean for WY2023 was 14 MPN/100 mL under the state limits and the seasonal geomeans met state standards of 100 MPN/100ml. Due to the stream not flowing in the first and fourth quarter, sampling was restricted by lack of stream flow and only conducted for four months from late December to April. Stream channel observed with defined stream edges.

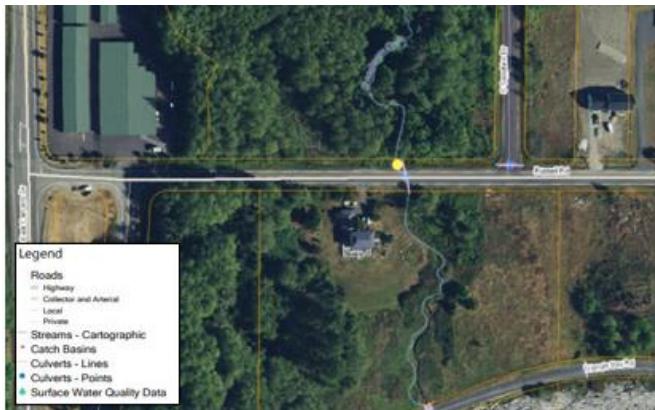
Stream Report Card: KC1- Kristoferson Creek

This site is on the north side of Russell Road at Kristoferson Creek main stem culvert. It has a long history of restoration and is considered a priority fish-bearing stream. The designated land use upstream from the sampling site is mixed use, zoned rural, and designated for agriculture and light manufacturing.

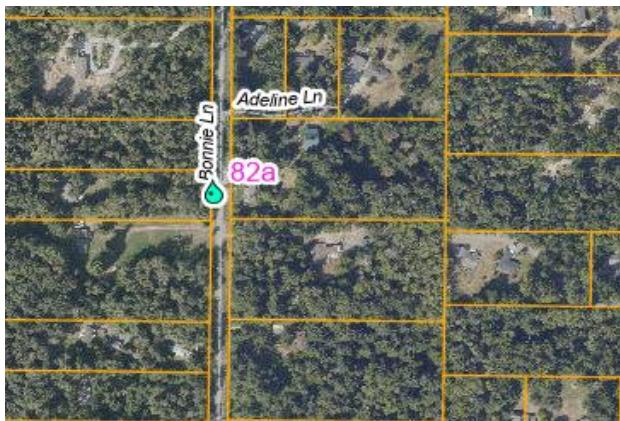
Stream Report Card: 82a- Bonnie Lane

Site is at the outlet of a channel draining through a forested wetland. After it hits Bonnie Lane, water is conveyed downstream in a road-side ditch. There is alder forest/shrub immediately around the site. Bonnie Lane is an outlet of an unmarked stream draining Lost Lake. Wetland improvement efforts are evident: clearing of non-native vegetation (blackberries) and marking of wetland areas.

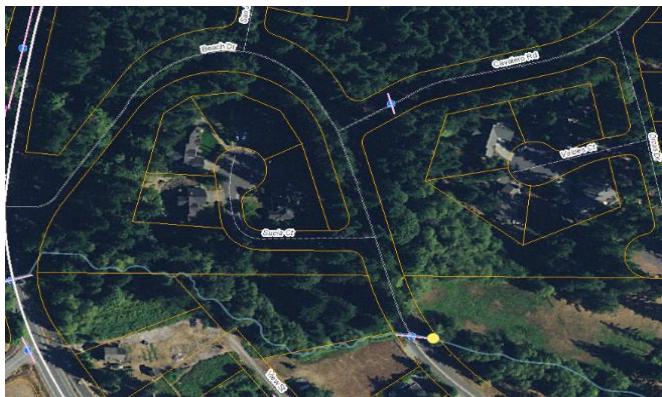
Stream Report Card: 74a- Cavalero Creek

This perennial stream begins as a series of ponds then drops into a forested ravine between dense developments with two road crossings before discharging into Port Susan. The area immediately upstream from the sampling site is zoned for rural residential and designated to be an urban area.

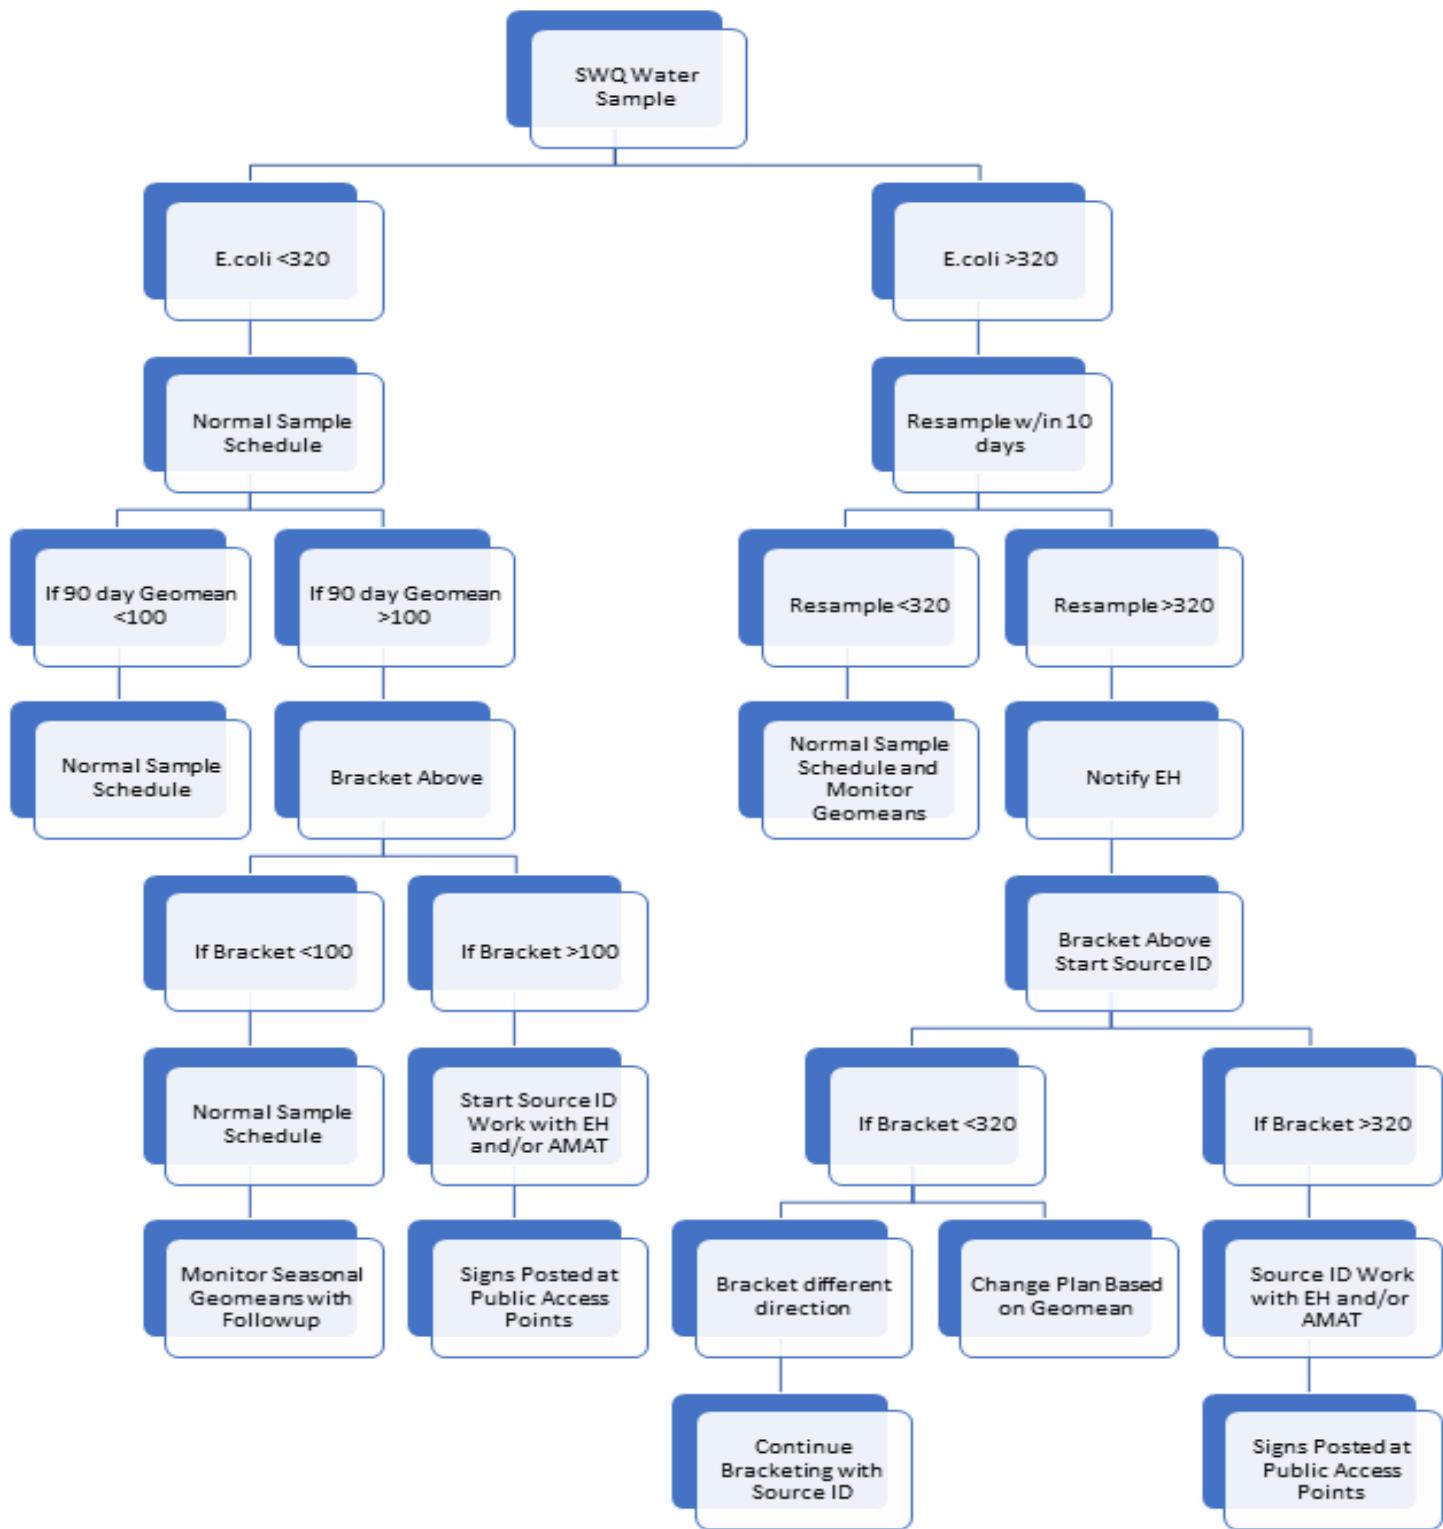
Figure 6. Island County source ID bracketing decision tree

While doing reconnaissance sampling out near Strawberry Point in Oak Harbor, high levels of *E. coli* were detected. The SWQ team resampled and bracketed in three separate directions from where the waters converged. It was determined that one of the three branches was the only one with elevated bacteria levels, so the SWQ team walked the stream path to see if there was anything easily identifiable and discovered a dead deer in the waterway. It appeared that the recent rains had washed over the dead animal and caused the contamination and would be easily removed. Subsequent sampling in that location yielded once again low levels of *E. coli*. Another example of the benefit of a Source ID process can be seen at the Maple Grove boat launch area, outlined in more detail below.
