Earthquake Impacts in the Christchurch CBD

Prof Jarg Pettinga & Dr Tom Wilson

Dept. Of Geological Sciences

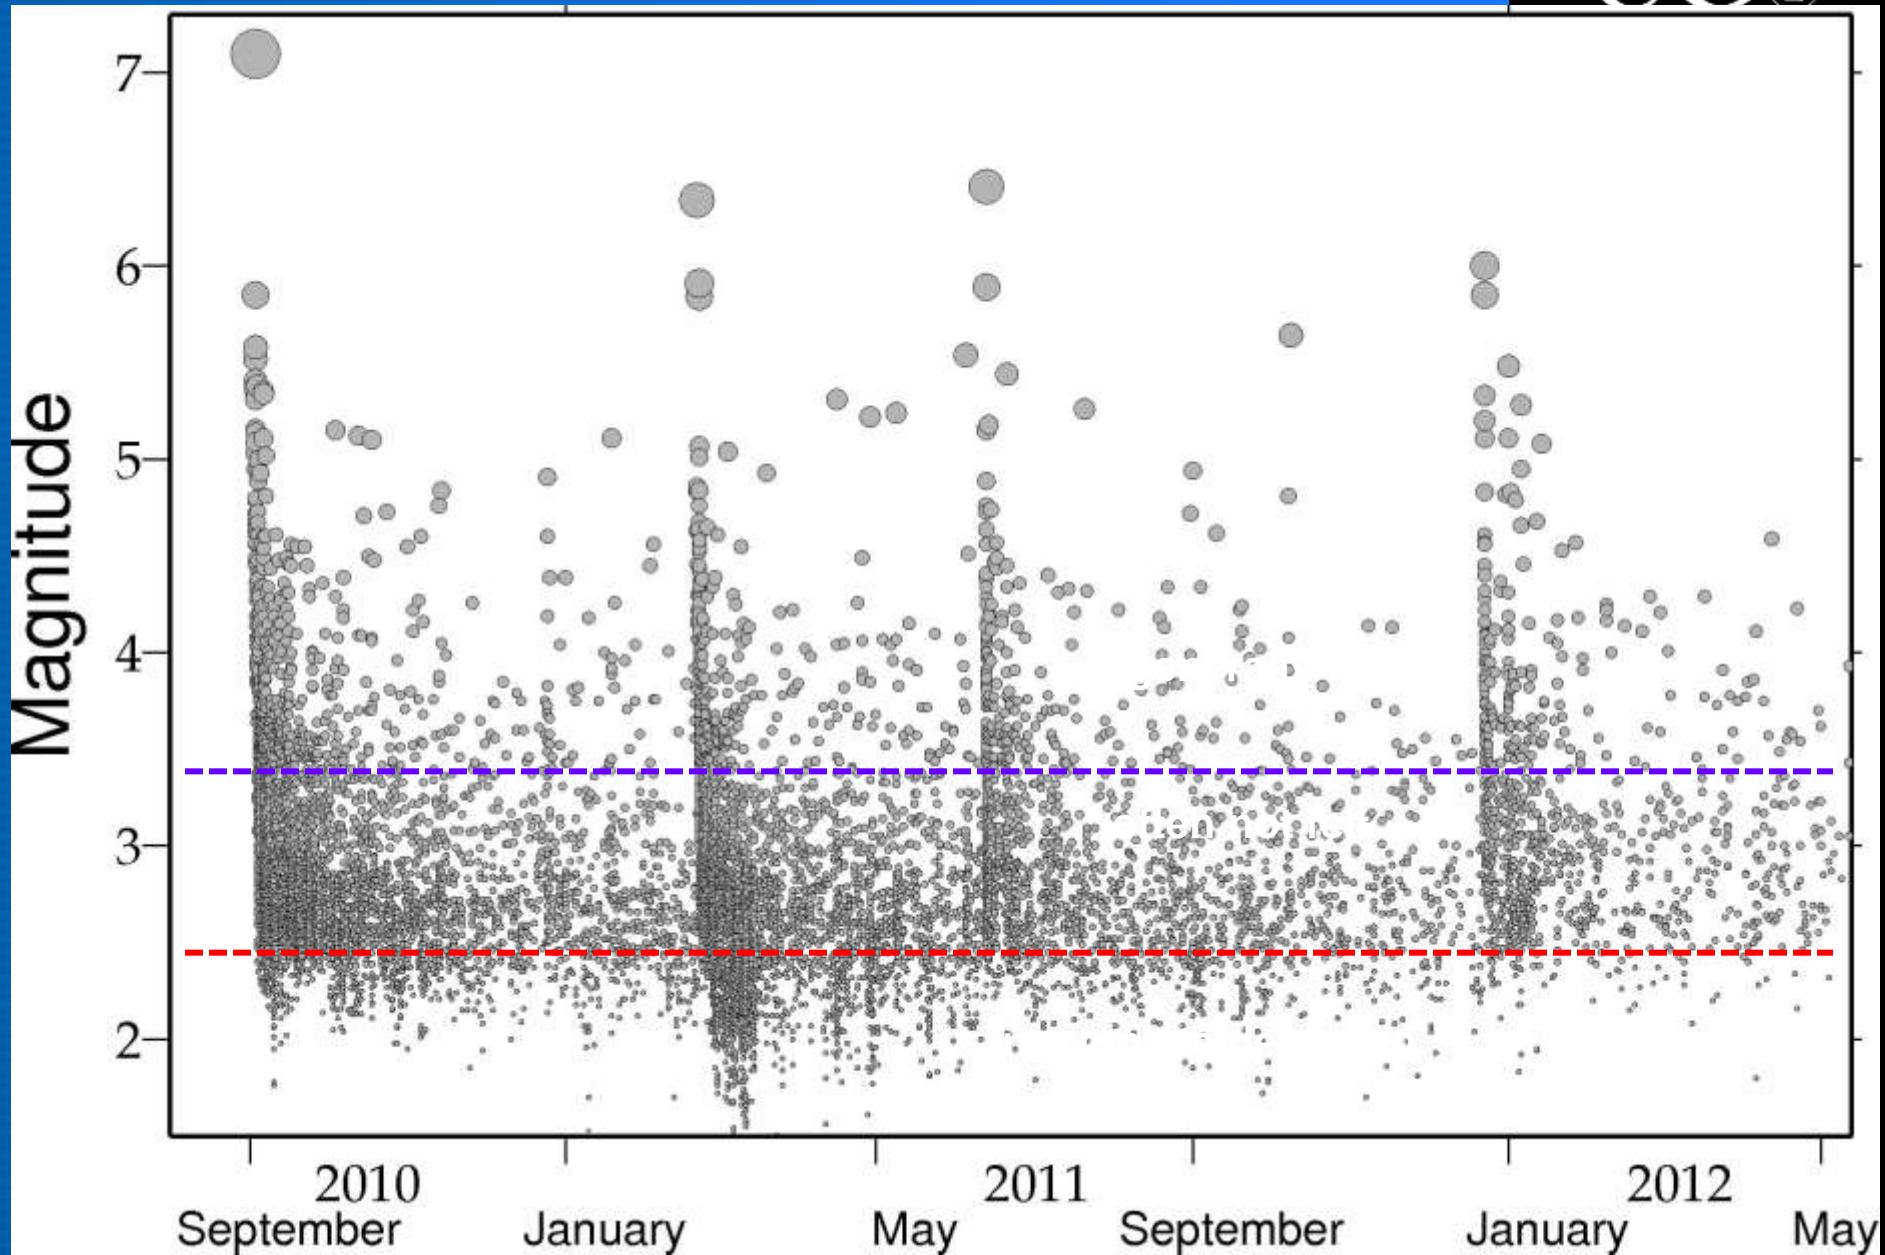
Magnitude/Time plot of the earthquake sequence

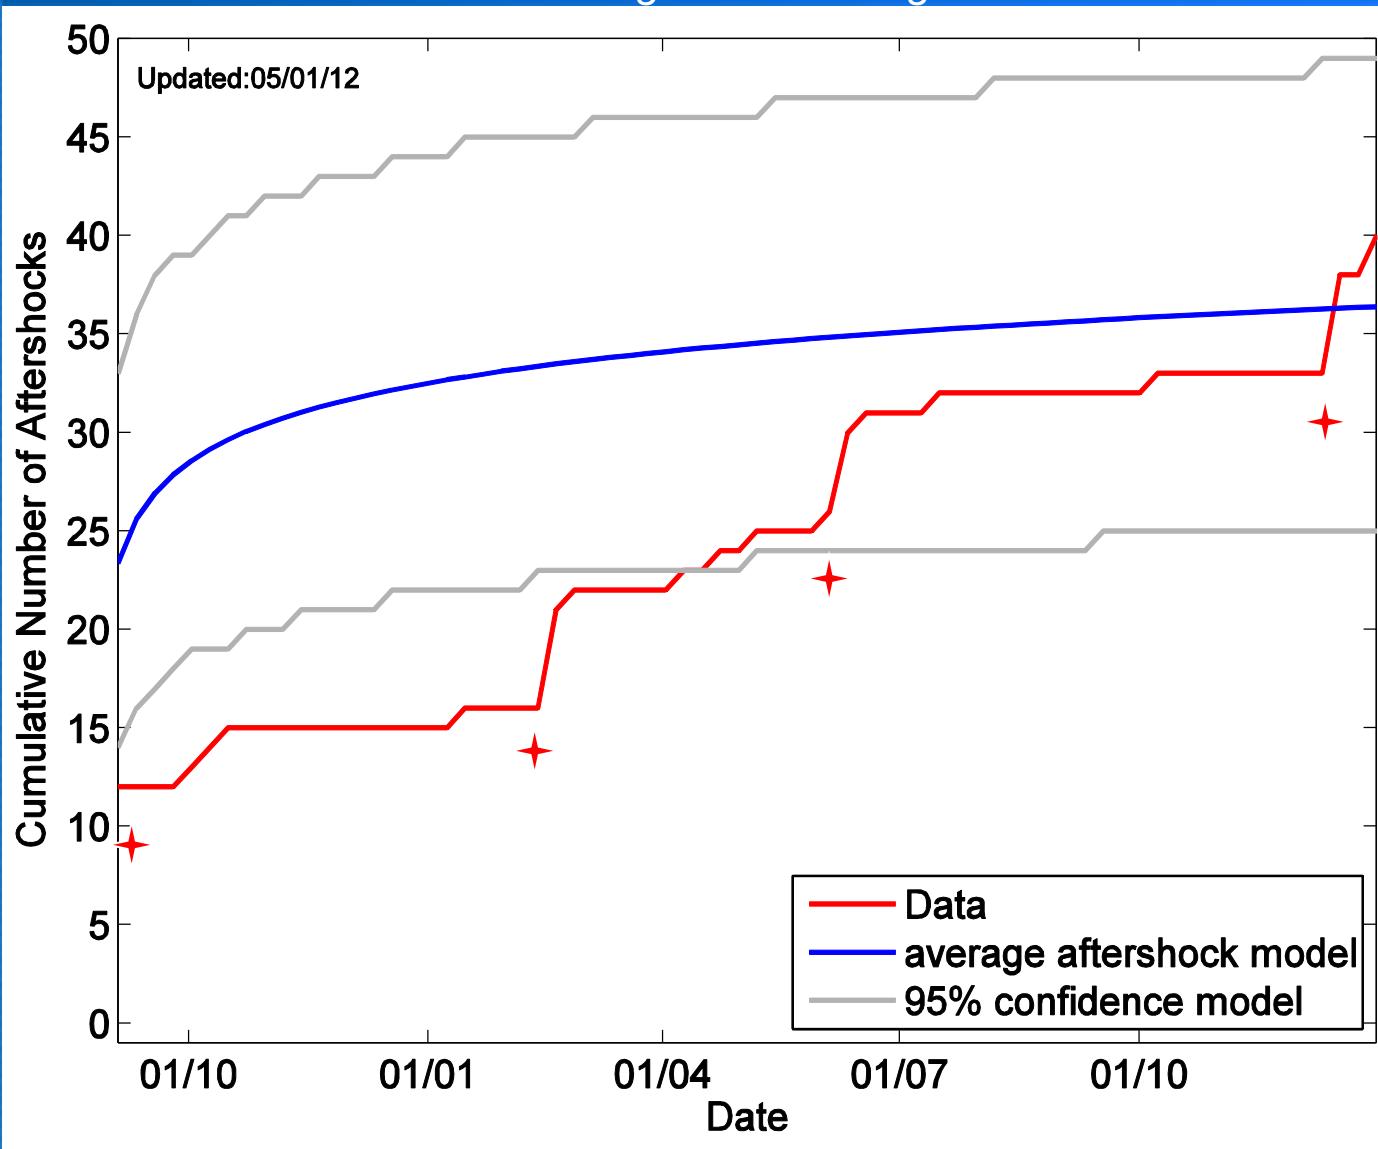
Aftershock Decay Sequence for Canterbury

- Magnitude 3 and greater

Graph depicts the significant effect of the February, June and December 2011 earthquakes re-energising the Darfield aftershock sequence (Source: GNS Science).

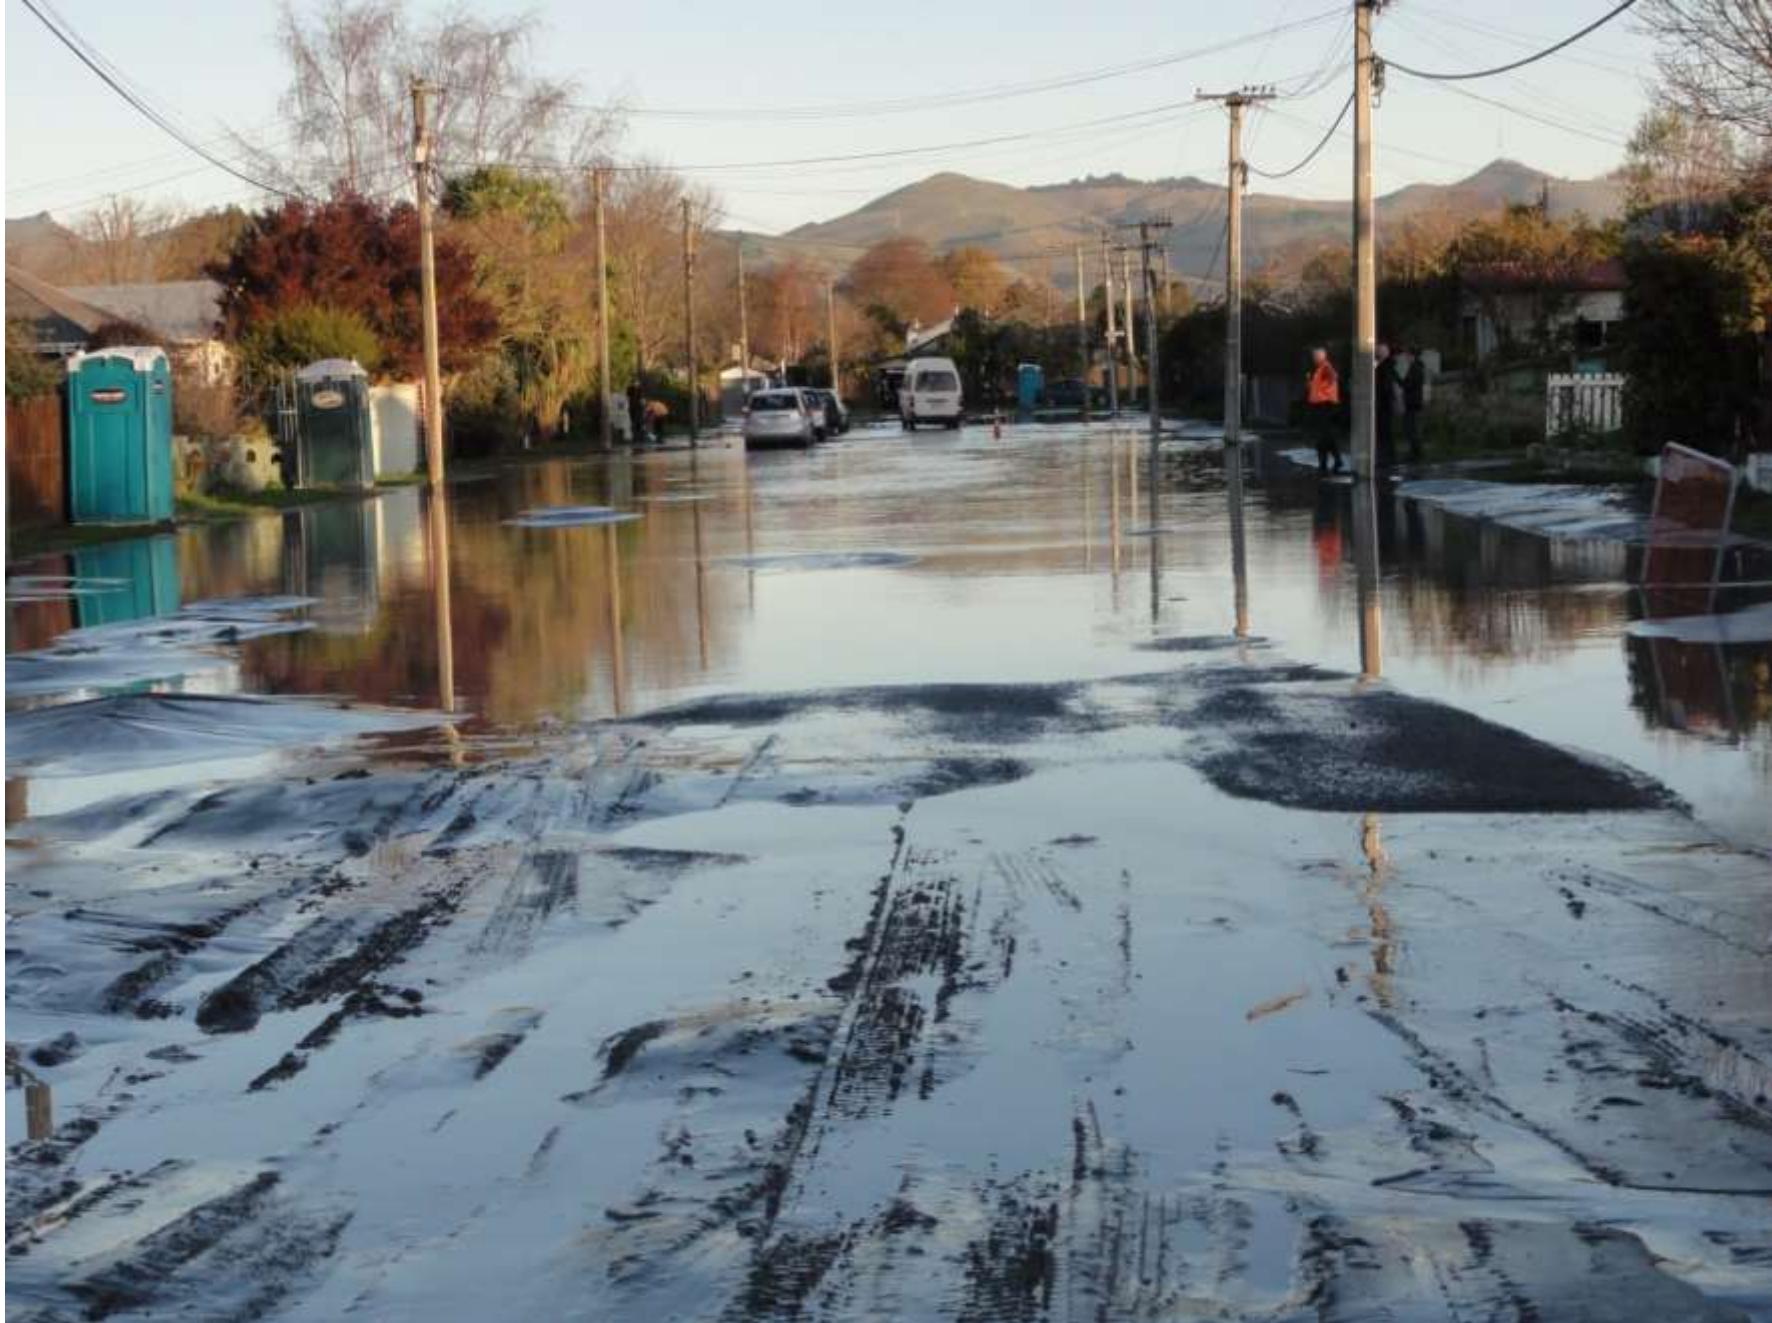
Liquefaction – Christchurch East, June 2011 (Courtesy Merrick Taylor)

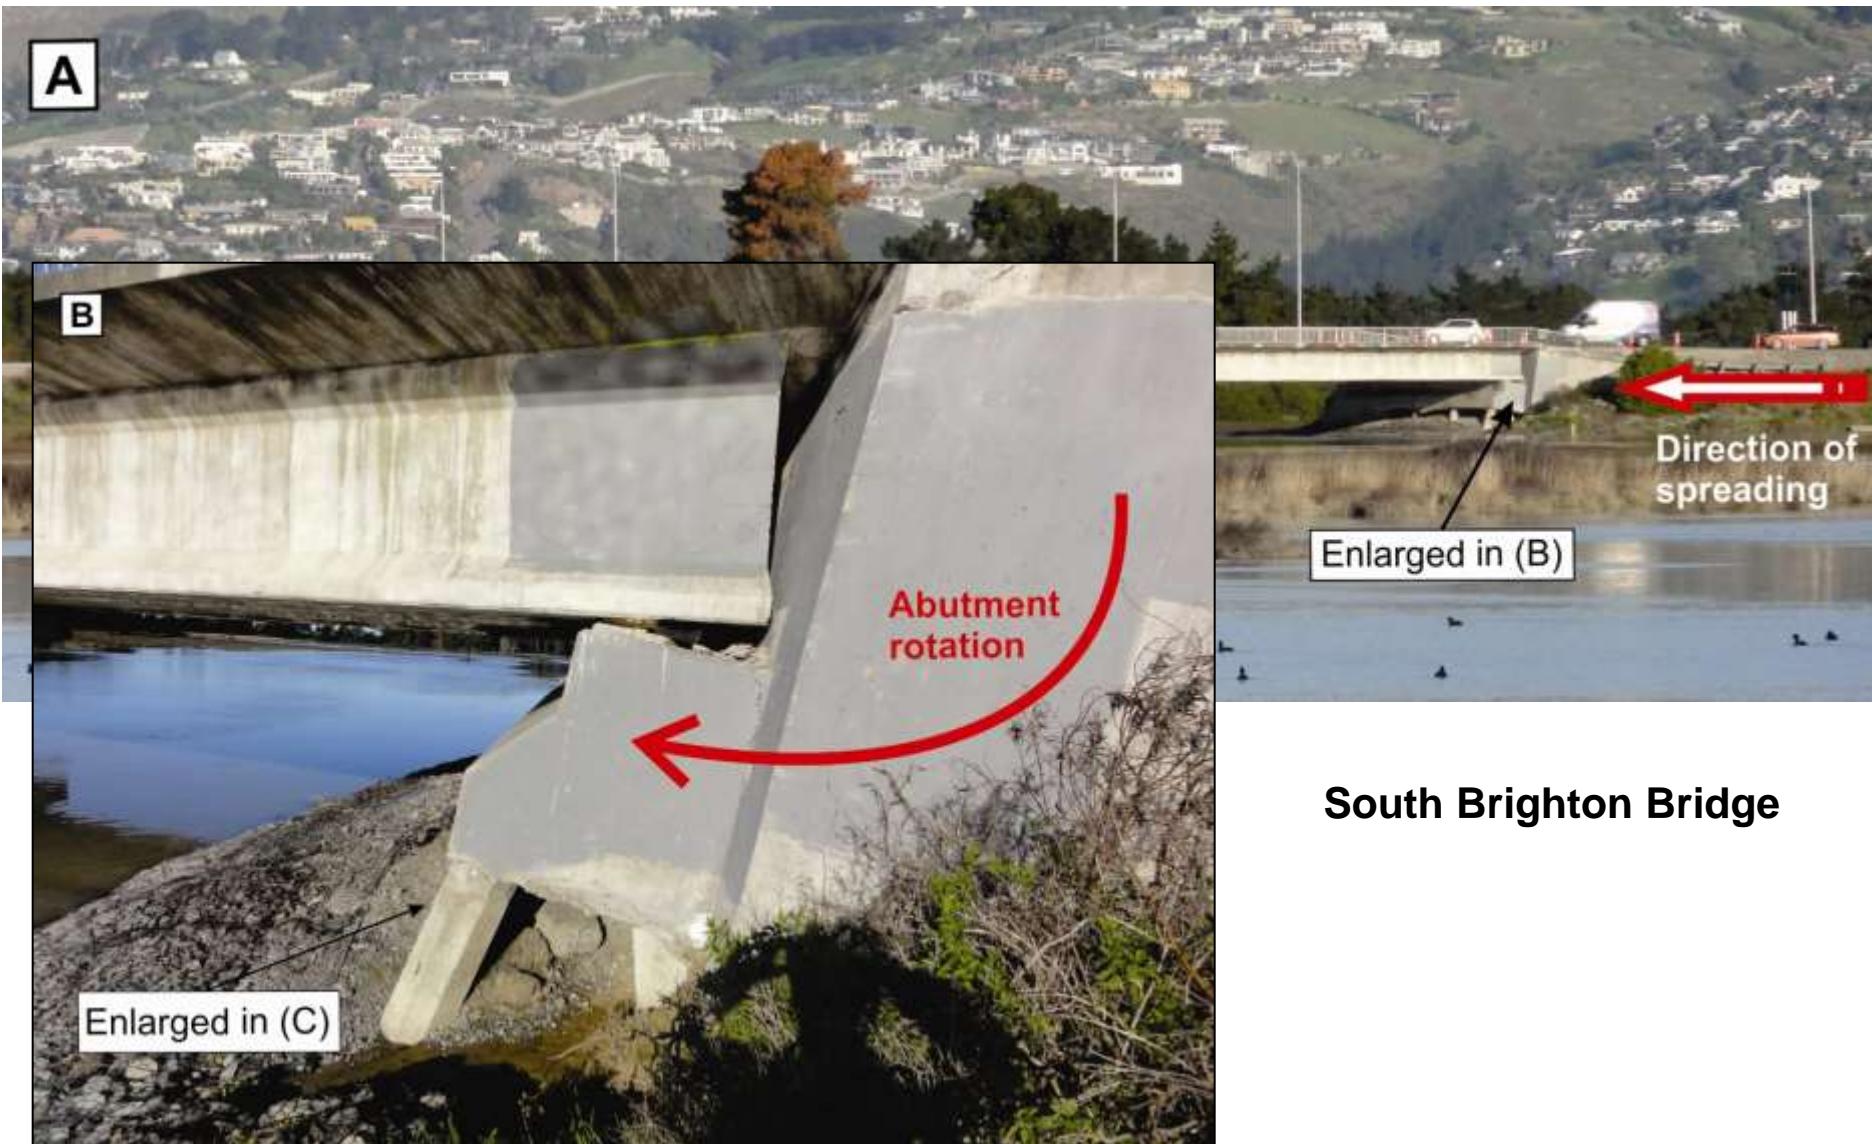
Lateral spreading – liquefaction-induced slumping of banks into rivers

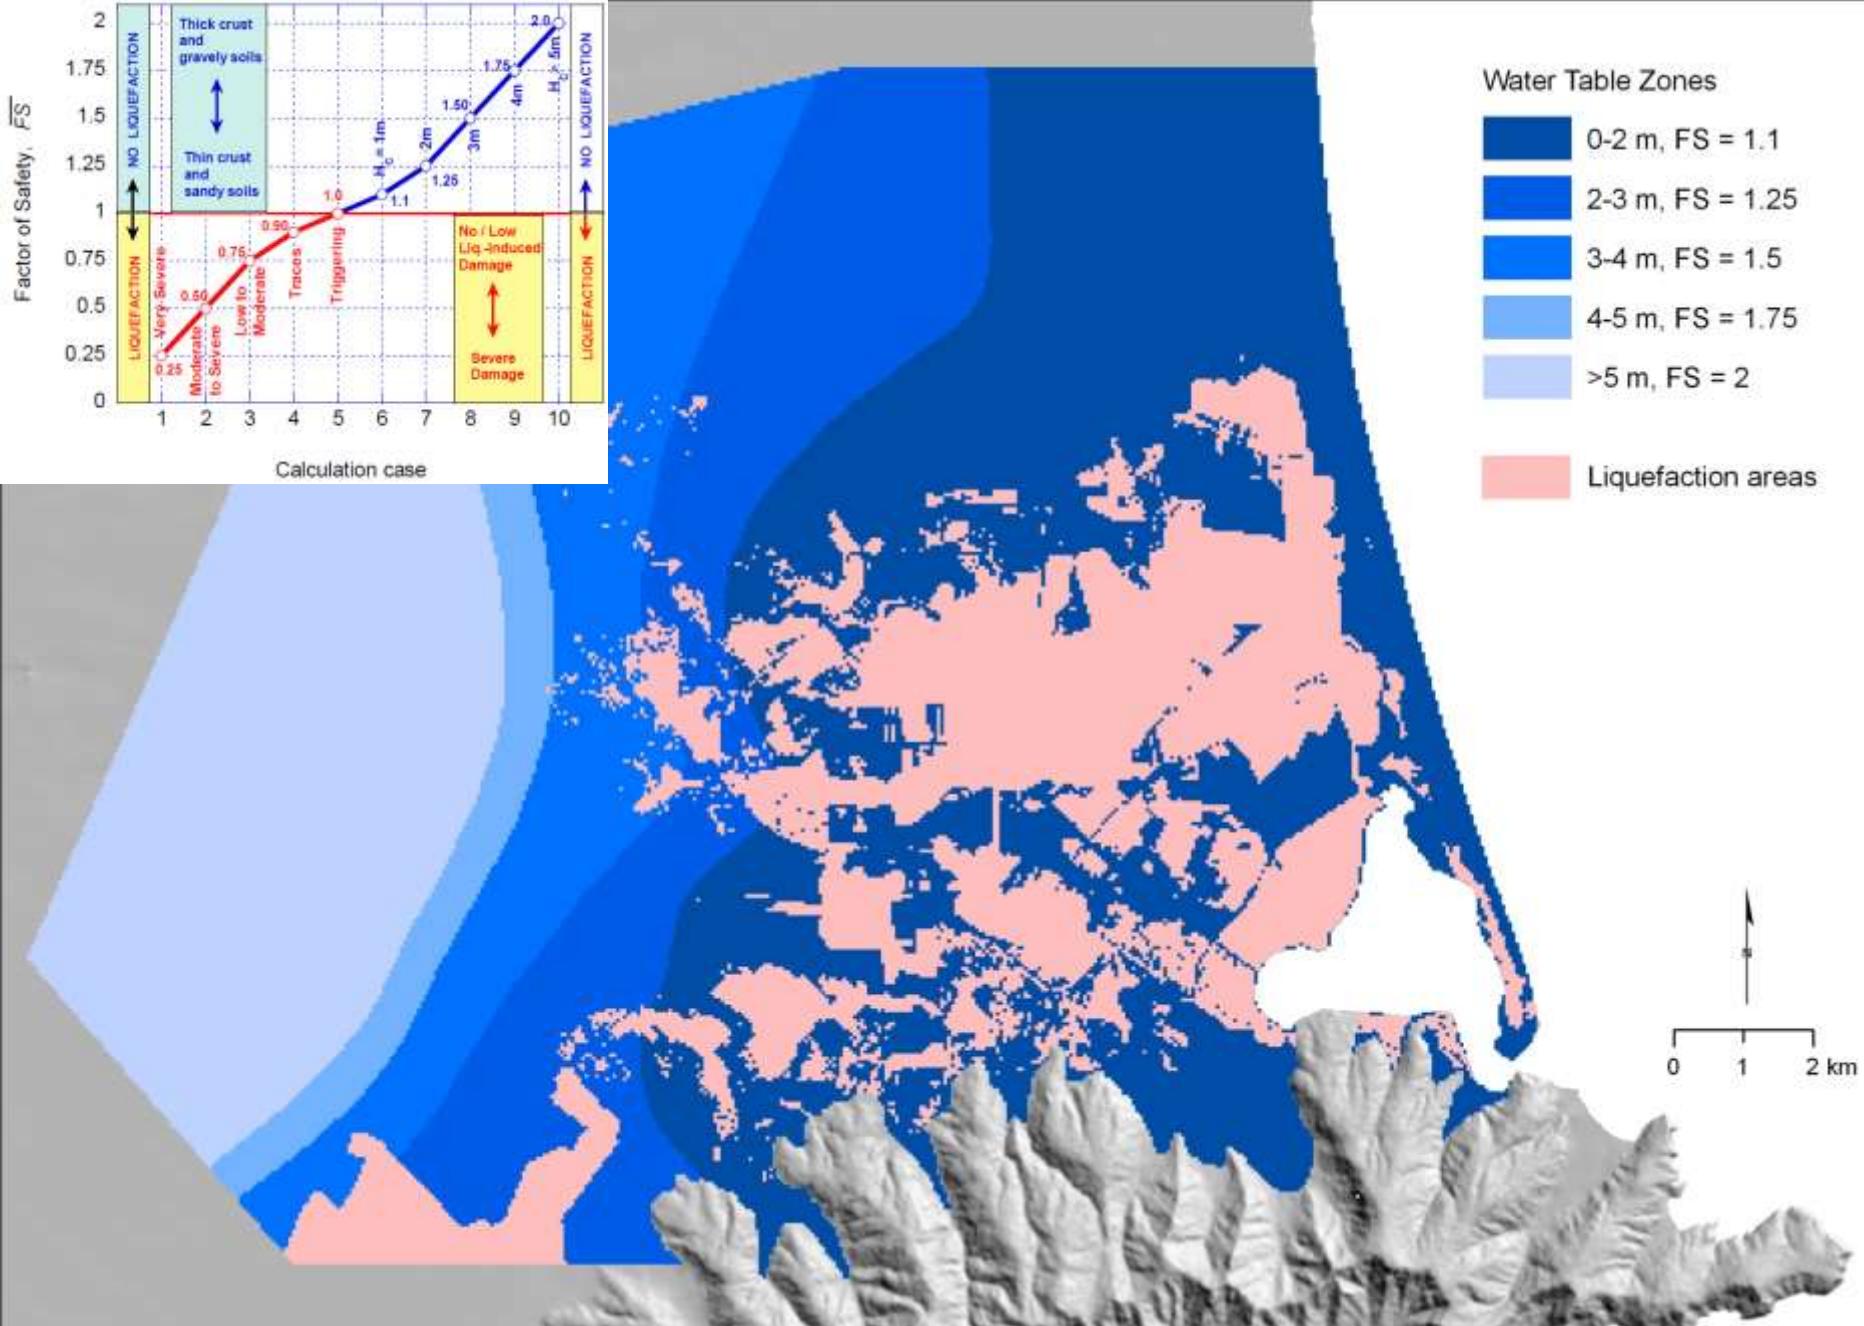
Water Table – Factor of Safety Against Liquefaction beyond areas of mapped liquefaction

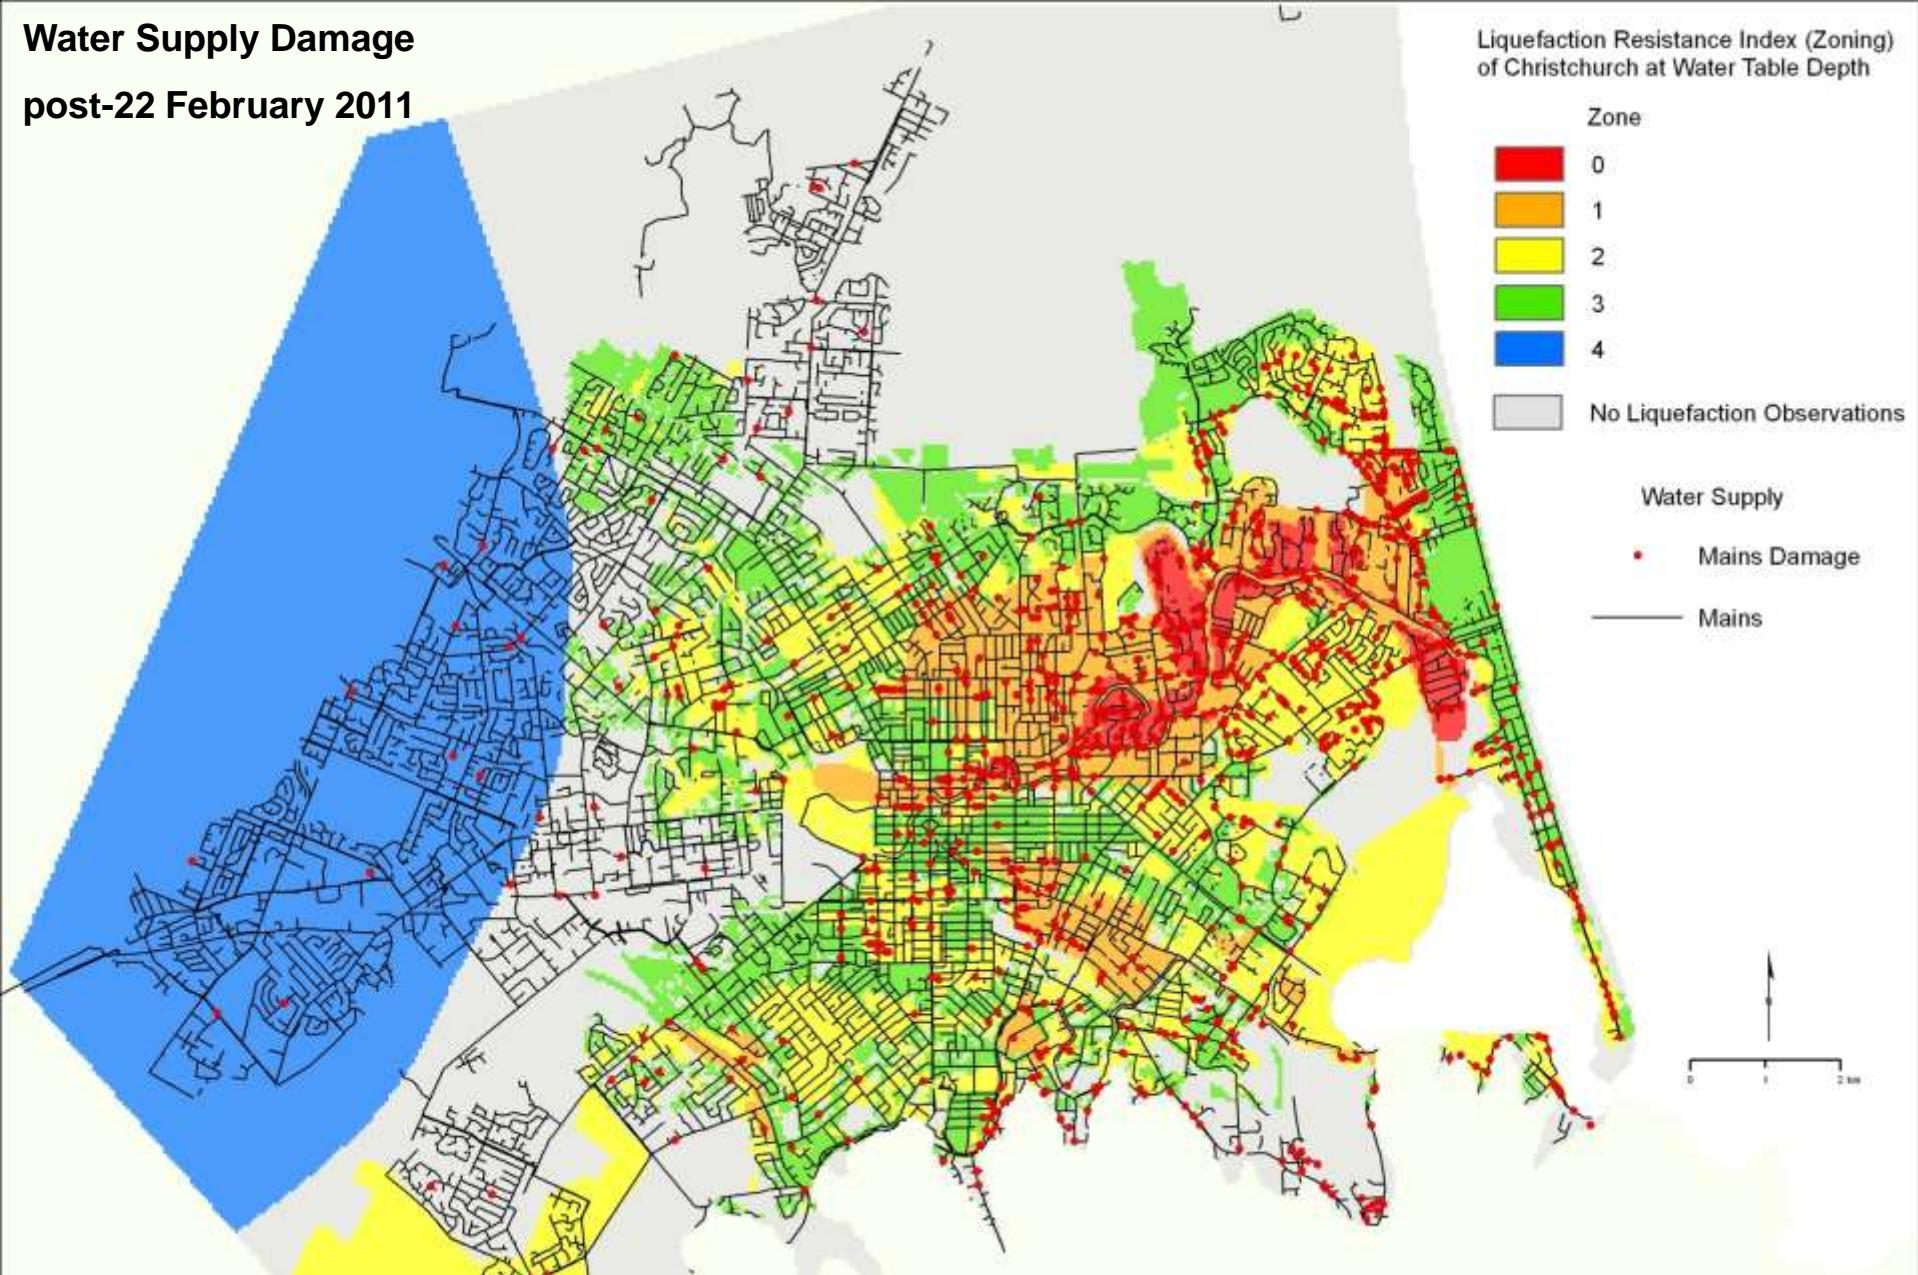
Water Supply Damage

post-22 February 2011

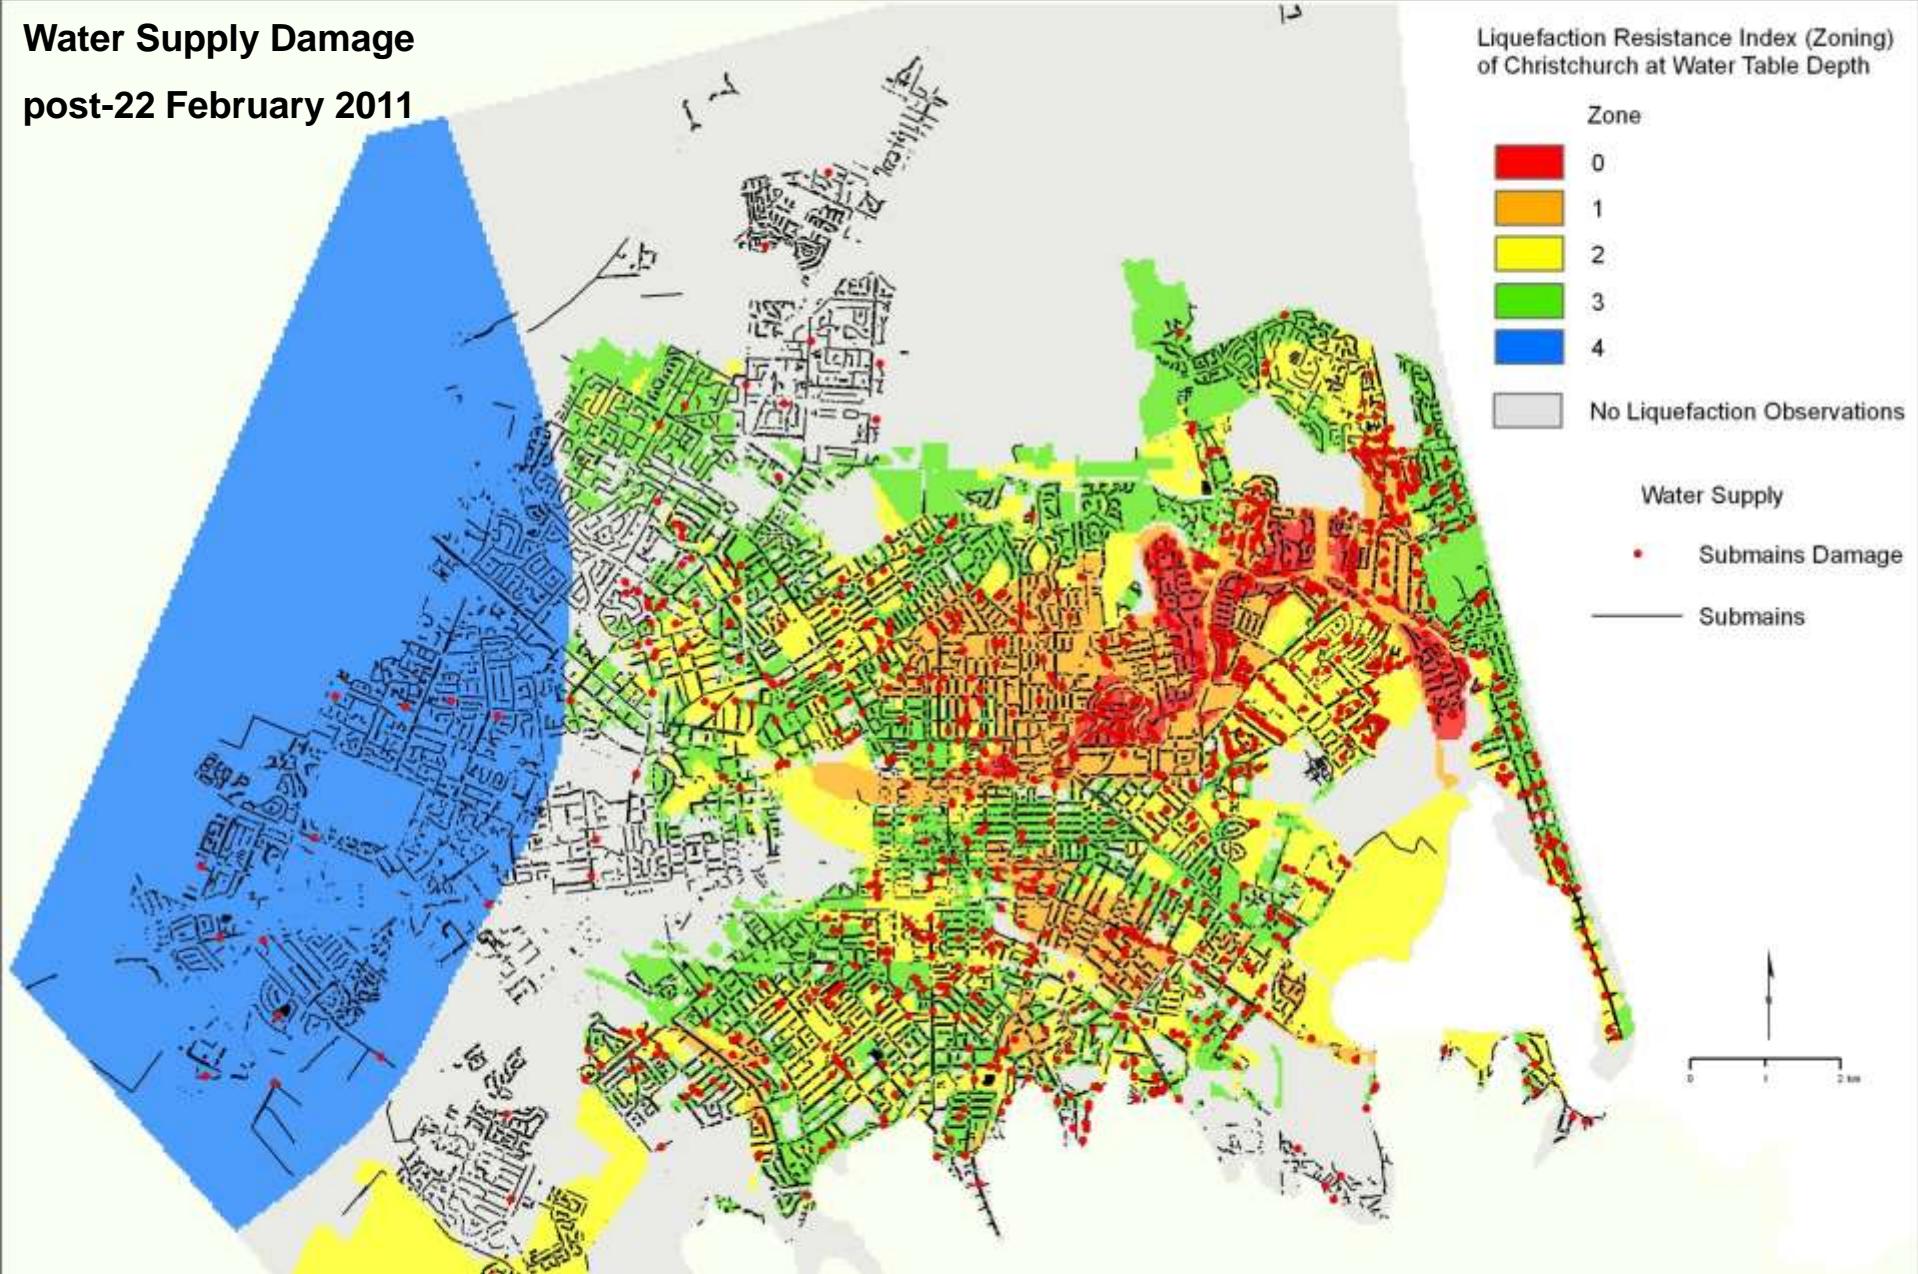
Cubrinovski et al. (2011). Liquefaction Impacts on Pipe Networks. Short Term Recovery Project No. 6, Natural Hazards Platform, December 2011, University of Canterbury

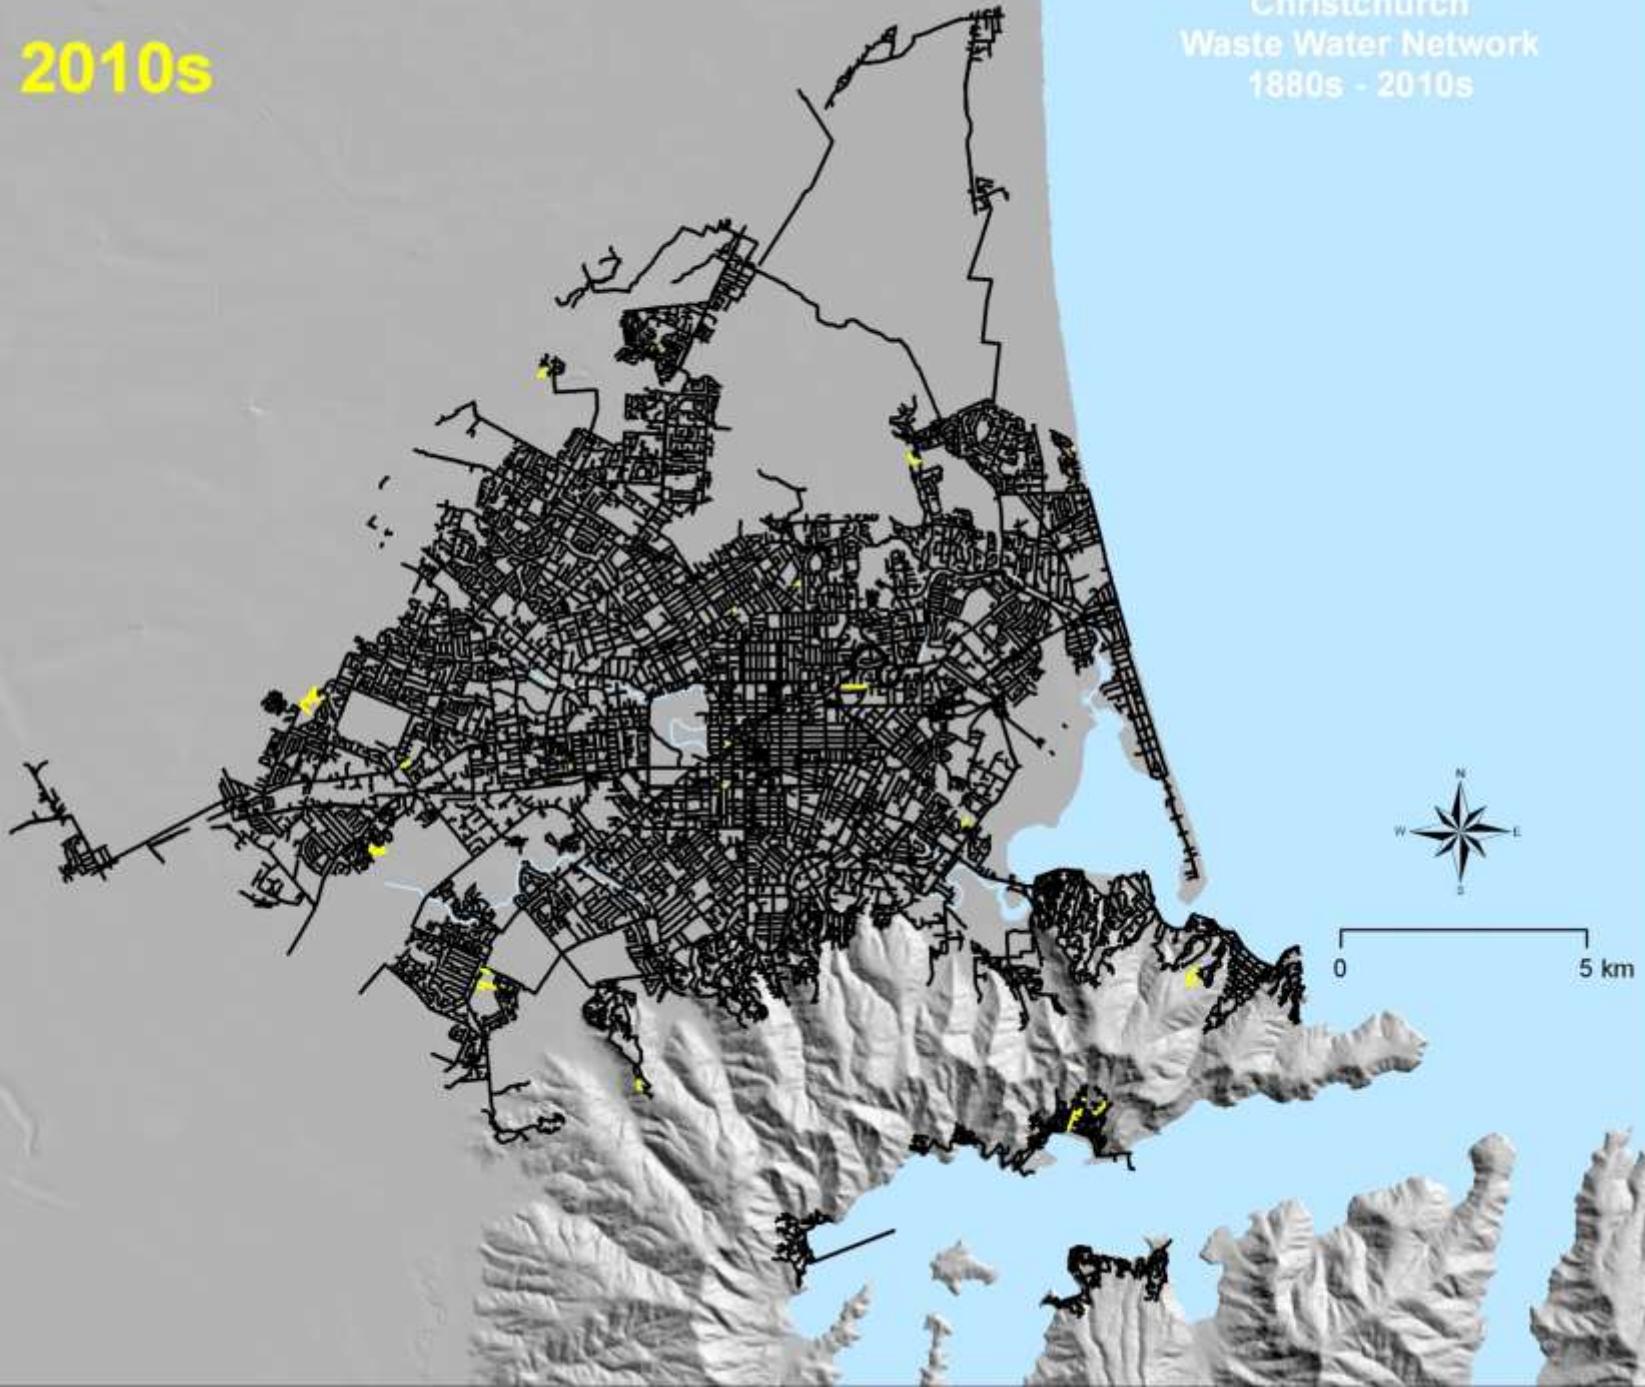
Christchurch
Waste Water Network
1880s - 2010s

- 1880s
- 1890s
- 1910s
- 1920s
- 1930s
- 1940s
- 1950s
- 1960s
- 1970s
- 1980s
- 1990s
- 2000s
- 2010s

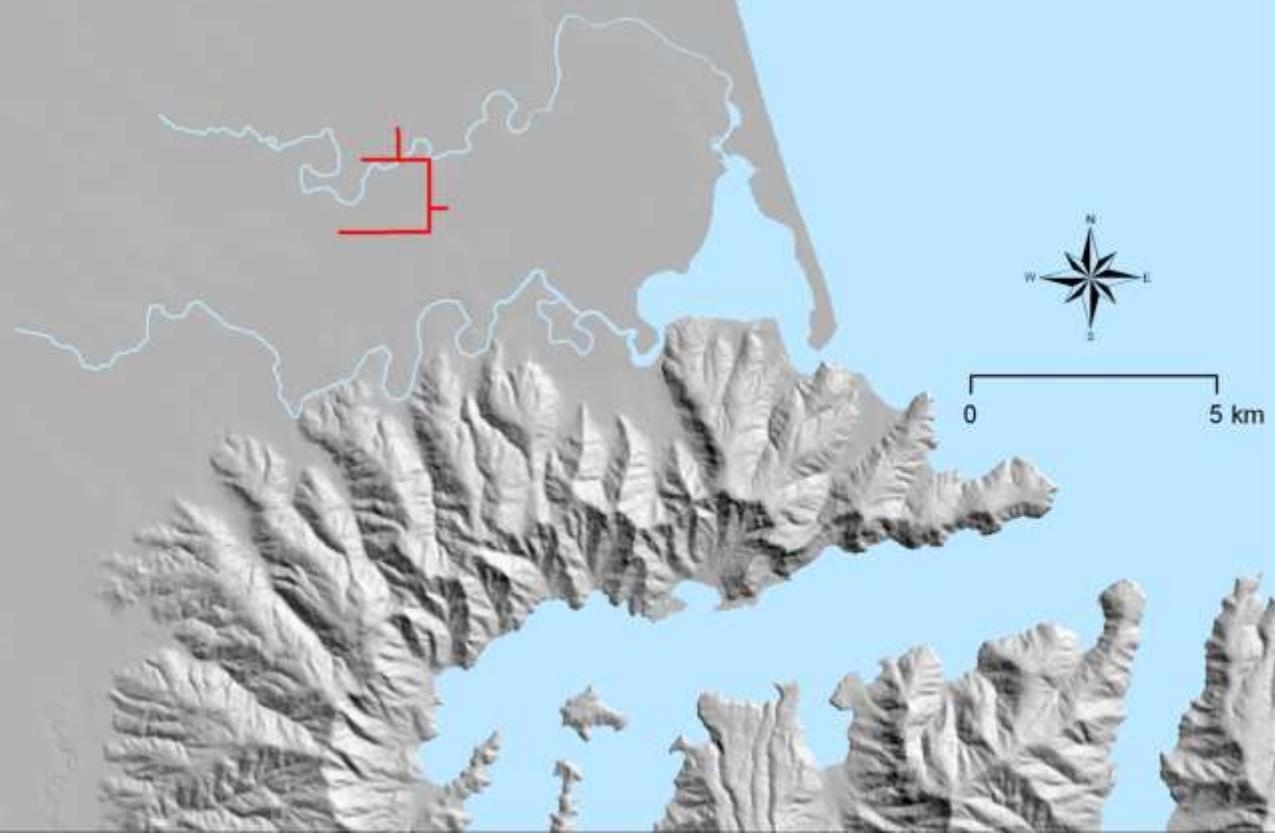
Christchurch
Waste Water Network
Pipe Materials

- Brick Barrel, 1882 - 1902
- Earthenware, 1882 - 2010
- Cast Iron, 1909 - 2006
- Asbestos Cement, 1920 - 2005
- Concrete, 1927 - 2009
- Polyethylene, 1929 - 2010
- Galvanised Iron, 1950 - 2004
- Polyvinyl Chloride, 1957 - 2011

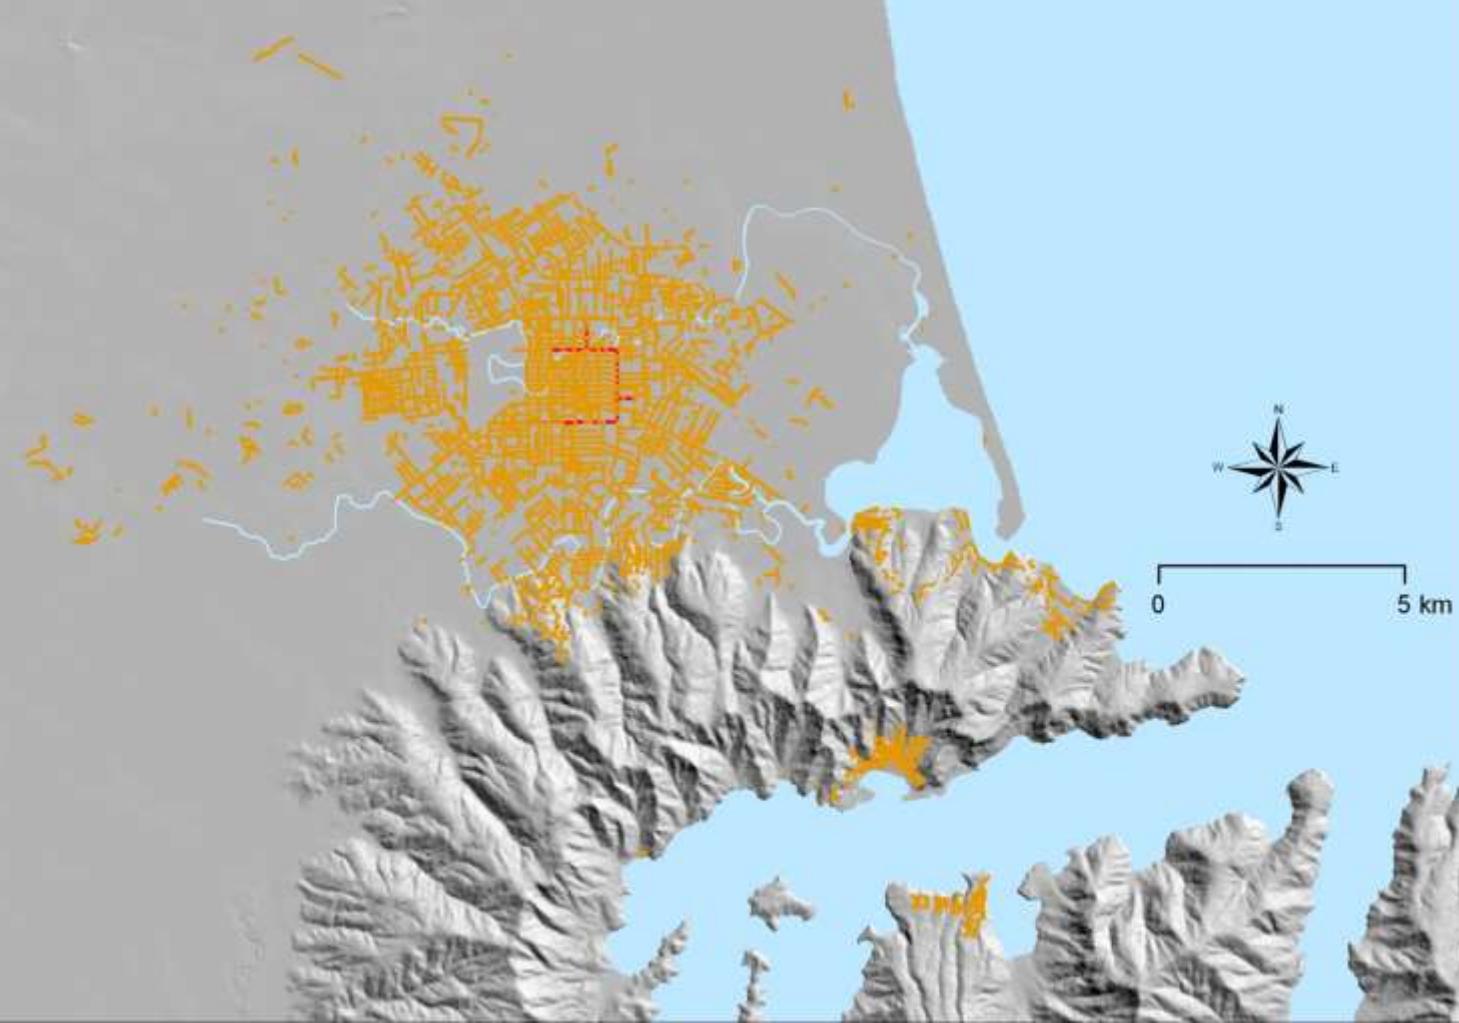
Christchurch
Waste Water Network
Pipe Materials

- Brick Barrel, 1882 - 1902
- Earthenware, 1882 - 2010
- Cast Iron, 1909 - 2006
- Asbestos Cement, 1920 - 2005
- Concrete, 1927 - 2009
- Polyethylene, 1929 - 2010
- Galvanised Iron, 1950 - 2004
- Polyvinyl Chloride, 1957 - 2011

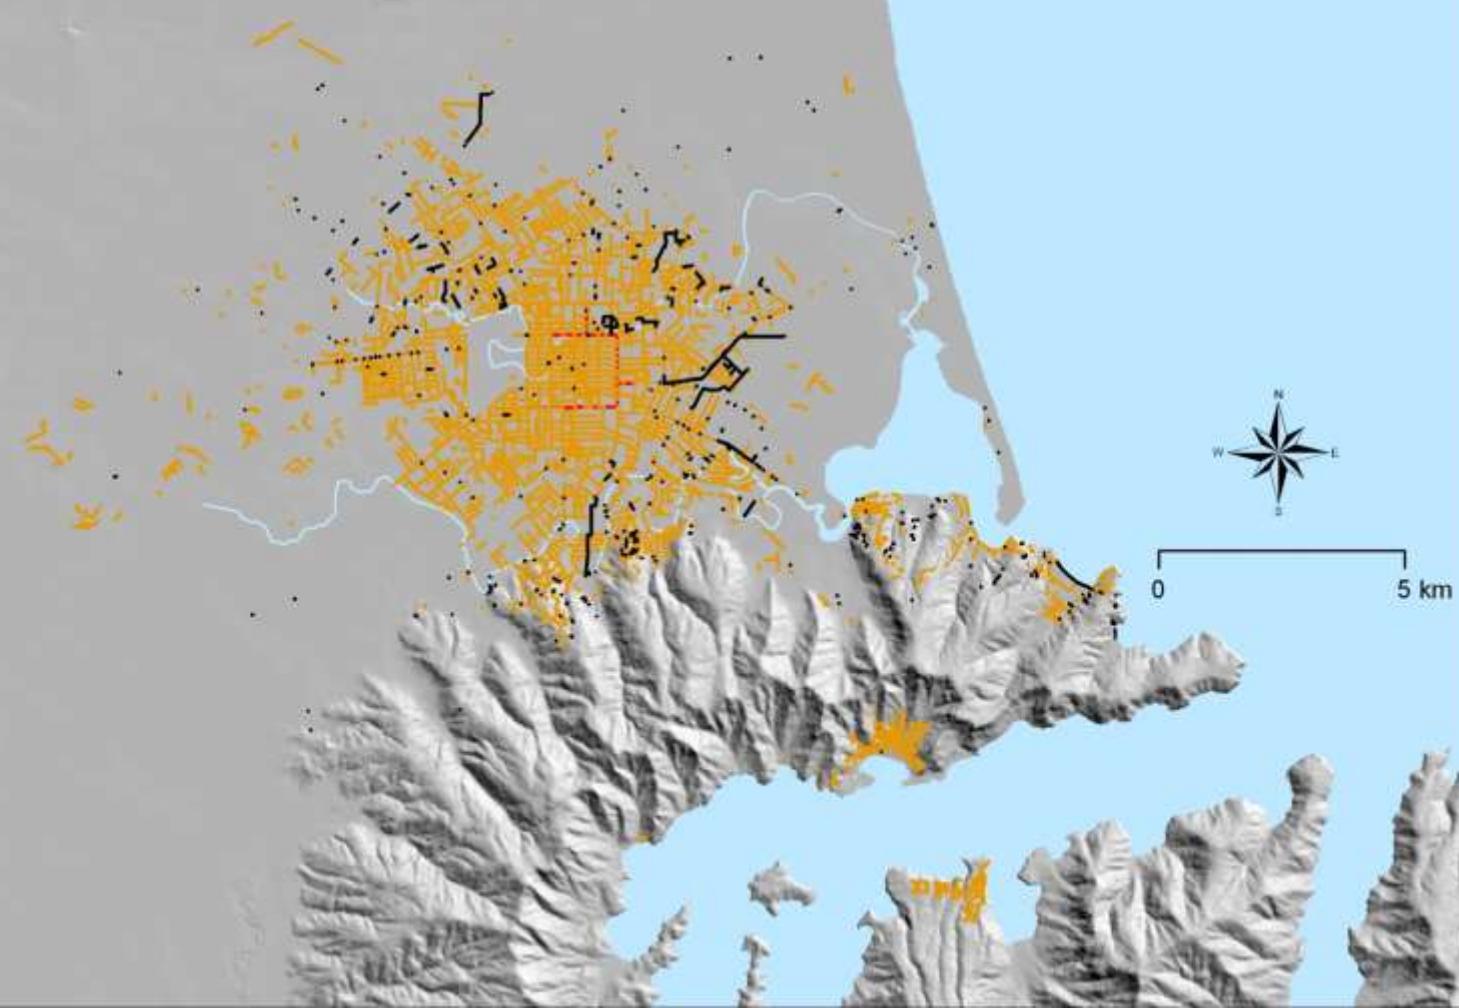
Christchurch
Waste Water Network
Pipe Materials

- Brick Barrel, 1882 - 1902
- Earthenware, 1882 - 2010
- Cast Iron, 1909 - 2006
- Asbestos Cement, 1920 - 2005
- Concrete, 1927 - 2009
- Polyethylene, 1929 - 2010
- Galvanised Iron, 1950 - 2004
- Polyvinyl Chloride, 1957 - 2011
