Earthquake Impacts in the Christchurch CBD

Prof Jarg Pettinga & Dr Tom Wilson

Dept. Of Geological Sciences

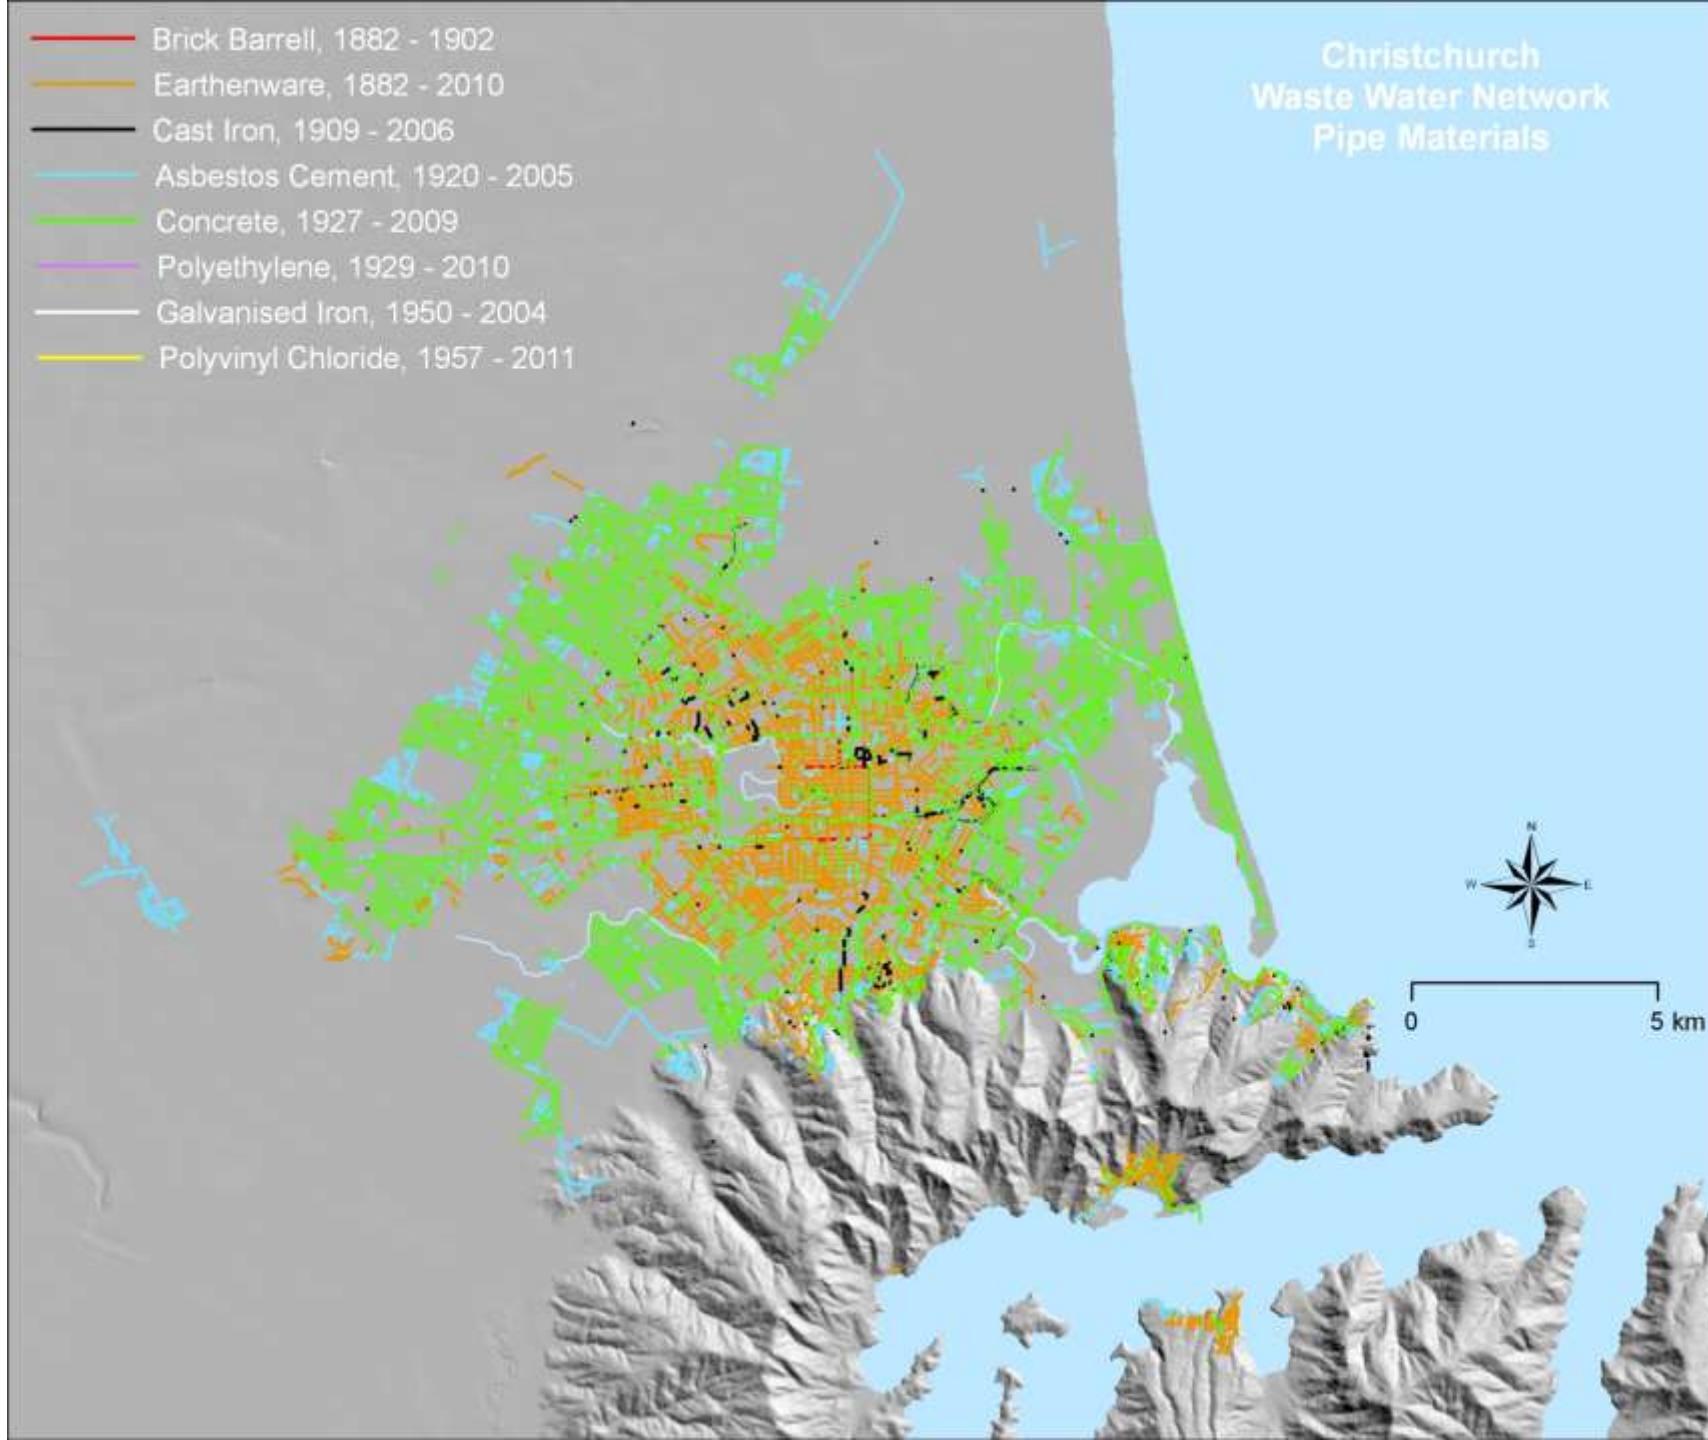
Christchurch
Waste Water Network
Pipe Materials

- Brick Barrel, 1882 - 1902
- Earthenware, 1882 - 2010
- Cast Iron, 1909 - 2006
- Asbestos Cement, 1920 - 2005
- Concrete, 1927 - 2009
- Polyethylene, 1929 - 2010
- Galvanised Iron, 1950 - 2004
- Polyvinyl Chloride, 1957 - 2011

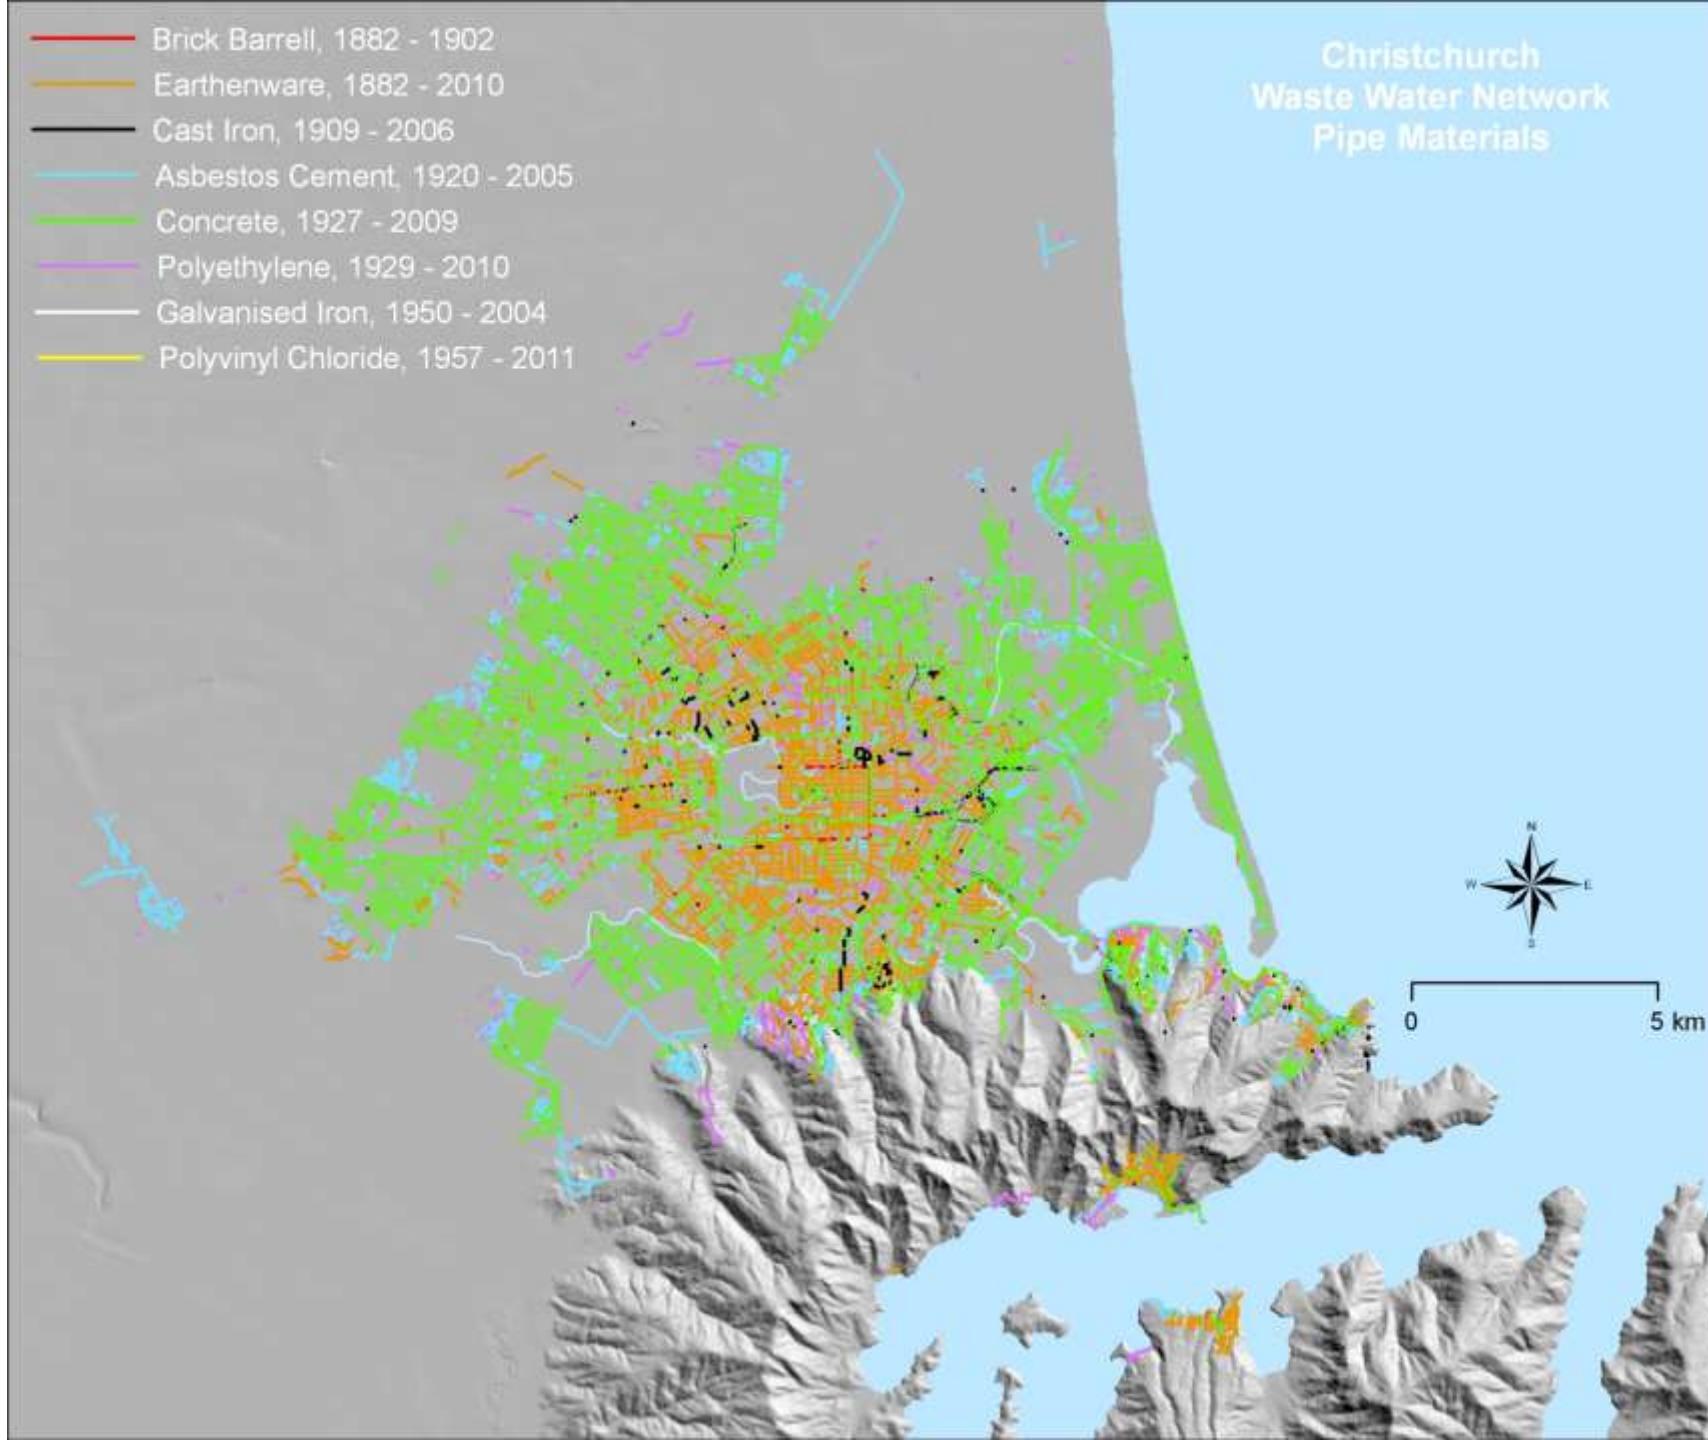
Christchurch
Waste Water Network
Pipe Materials

- Brick Barrel, 1882 - 1902
- Earthenware, 1882 - 2010
- Cast Iron, 1909 - 2006
- Asbestos Cement, 1920 - 2005
- Concrete, 1927 - 2009
- Polyethylene, 1929 - 2010
- Galvanised Iron, 1950 - 2004
- Polyvinyl Chloride, 1957 - 2011

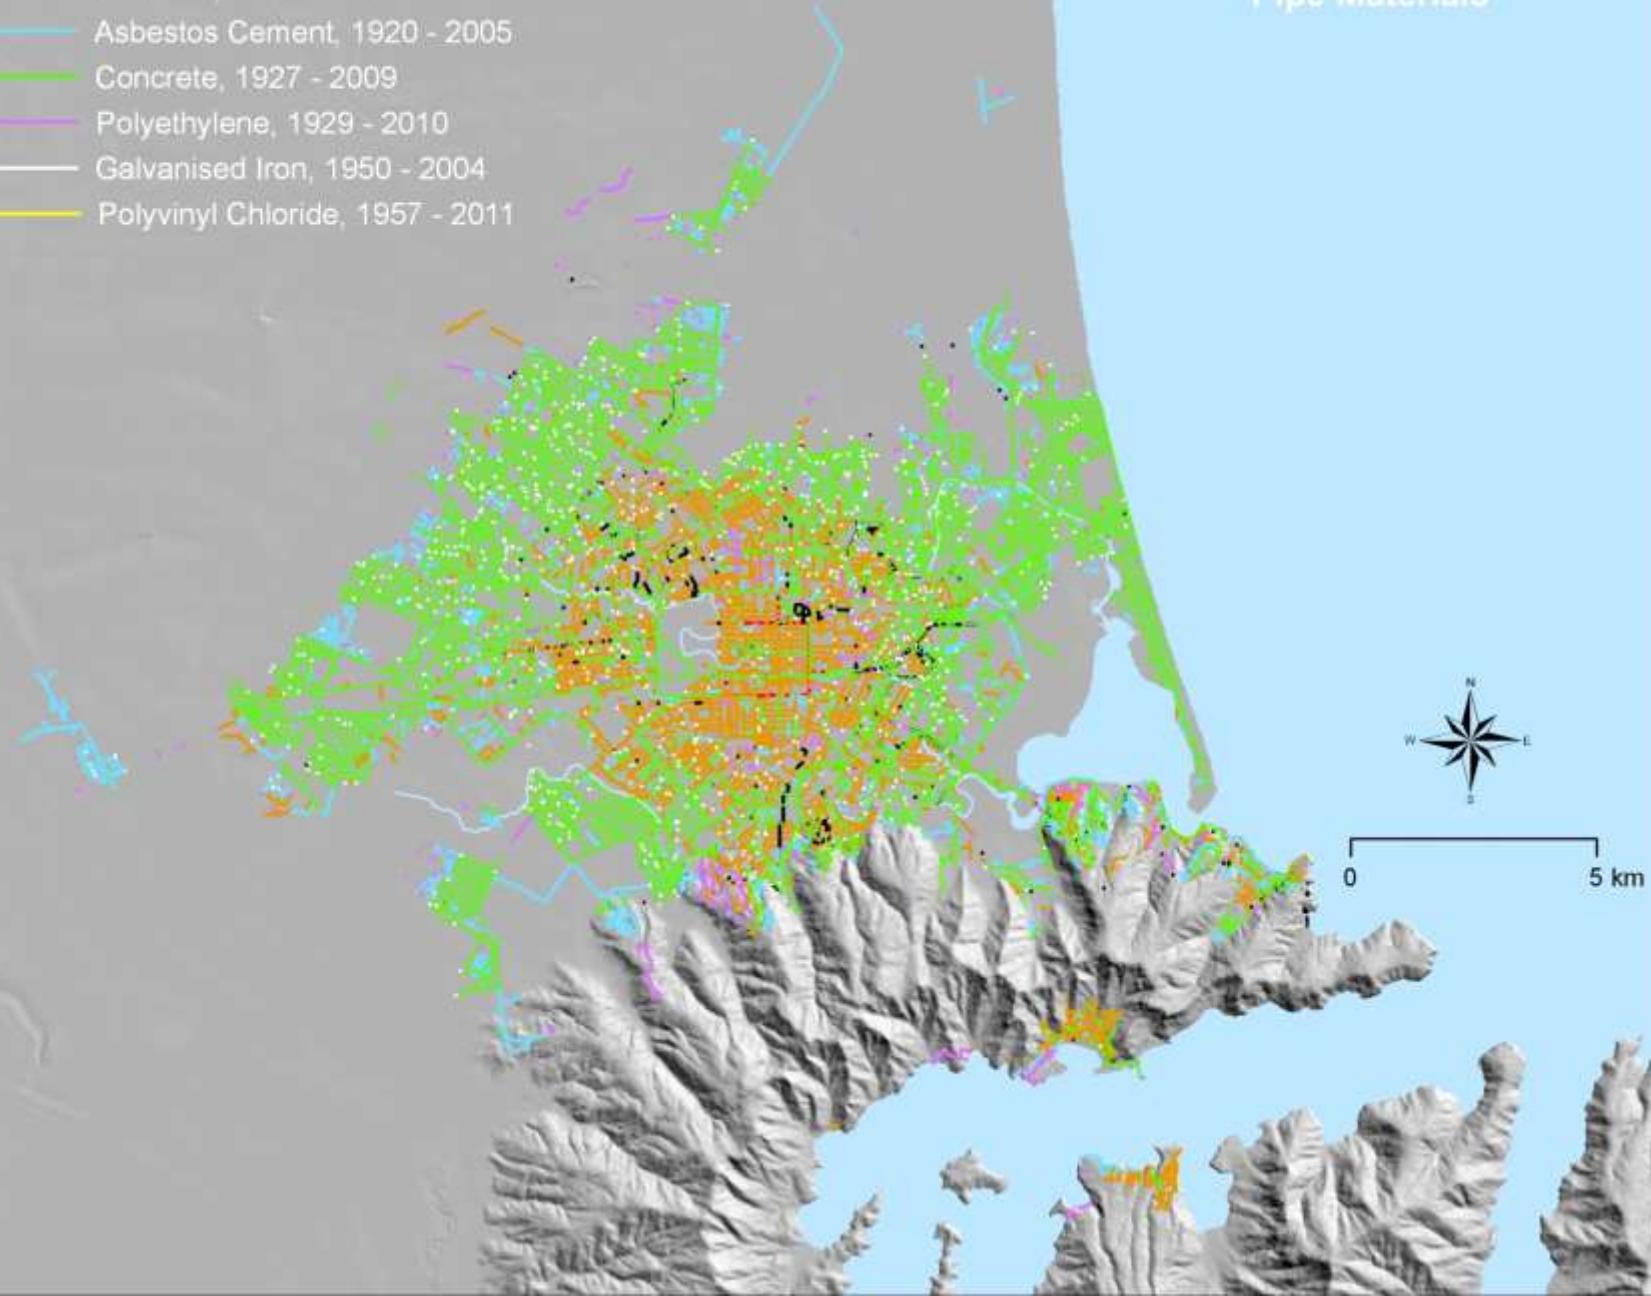
Christchurch Waste Water Network Pipe Materials

- Brick Barrel, 1882 - 1902
- Earthenware, 1882 - 2010
- Cast Iron, 1909 - 2006
- Asbestos Cement, 1920 - 2005
- Concrete, 1927 - 2009
- Polyethylene, 1929 - 2010
- Galvanised Iron, 1950 - 2004
- Polyvinyl Chloride, 1957 - 2011

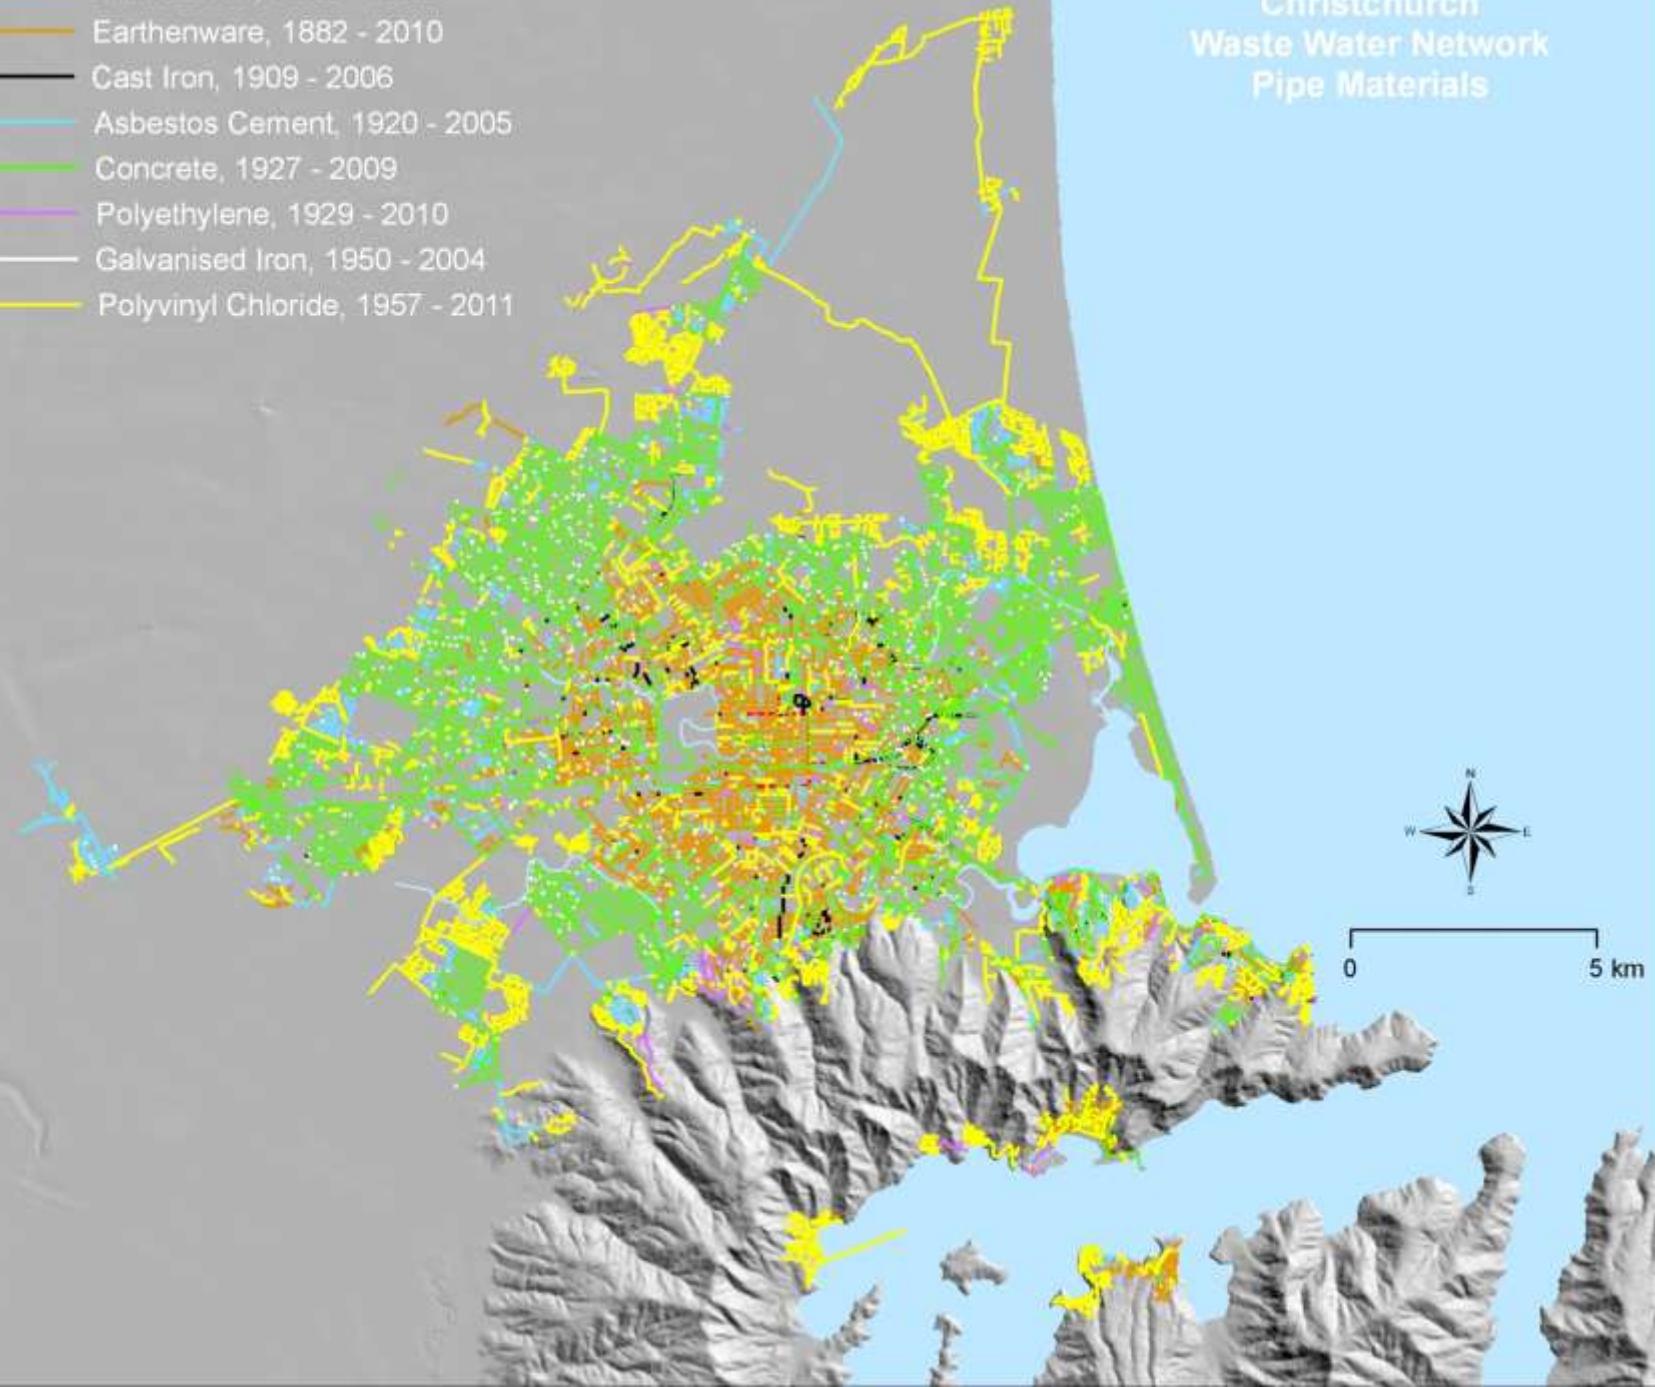
Christchurch
Waste Water Network
Pipe Materials

- Brick Barrel, 1882 - 1902
- Earthenware, 1882 - 2010
- Cast Iron, 1909 - 2006
- Asbestos Cement, 1920 - 2005
- Concrete, 1927 - 2009
- Polyethylene, 1929 - 2010
- Galvanised Iron, 1950 - 2004
- Polyvinyl Chloride, 1957 - 2011

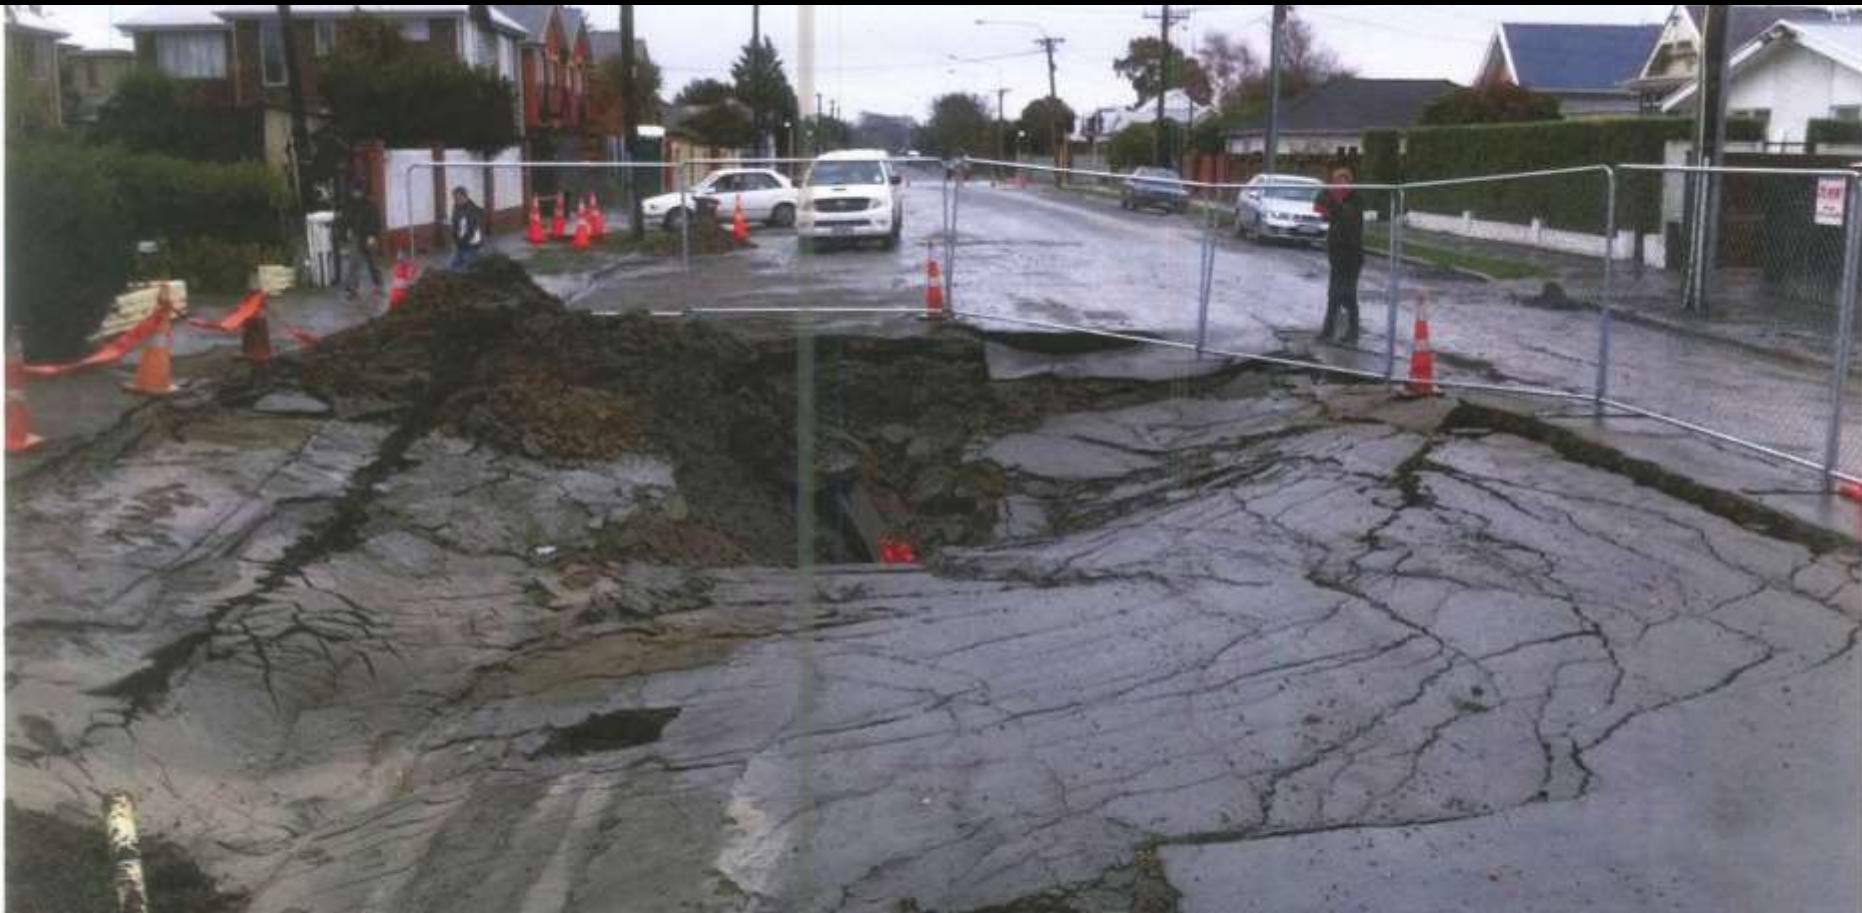
Waste Water Pipe Collapse and Ground Failure

Edgeware Road - Wastewater Northern Relief Trunk Main

- Large and fast flow (~1 cumec), large amount of sediment transported through broken pipe.
- This section of the Northern Relief caused ~3 months delay during construction due to poor ground conditions and groundwater issues.

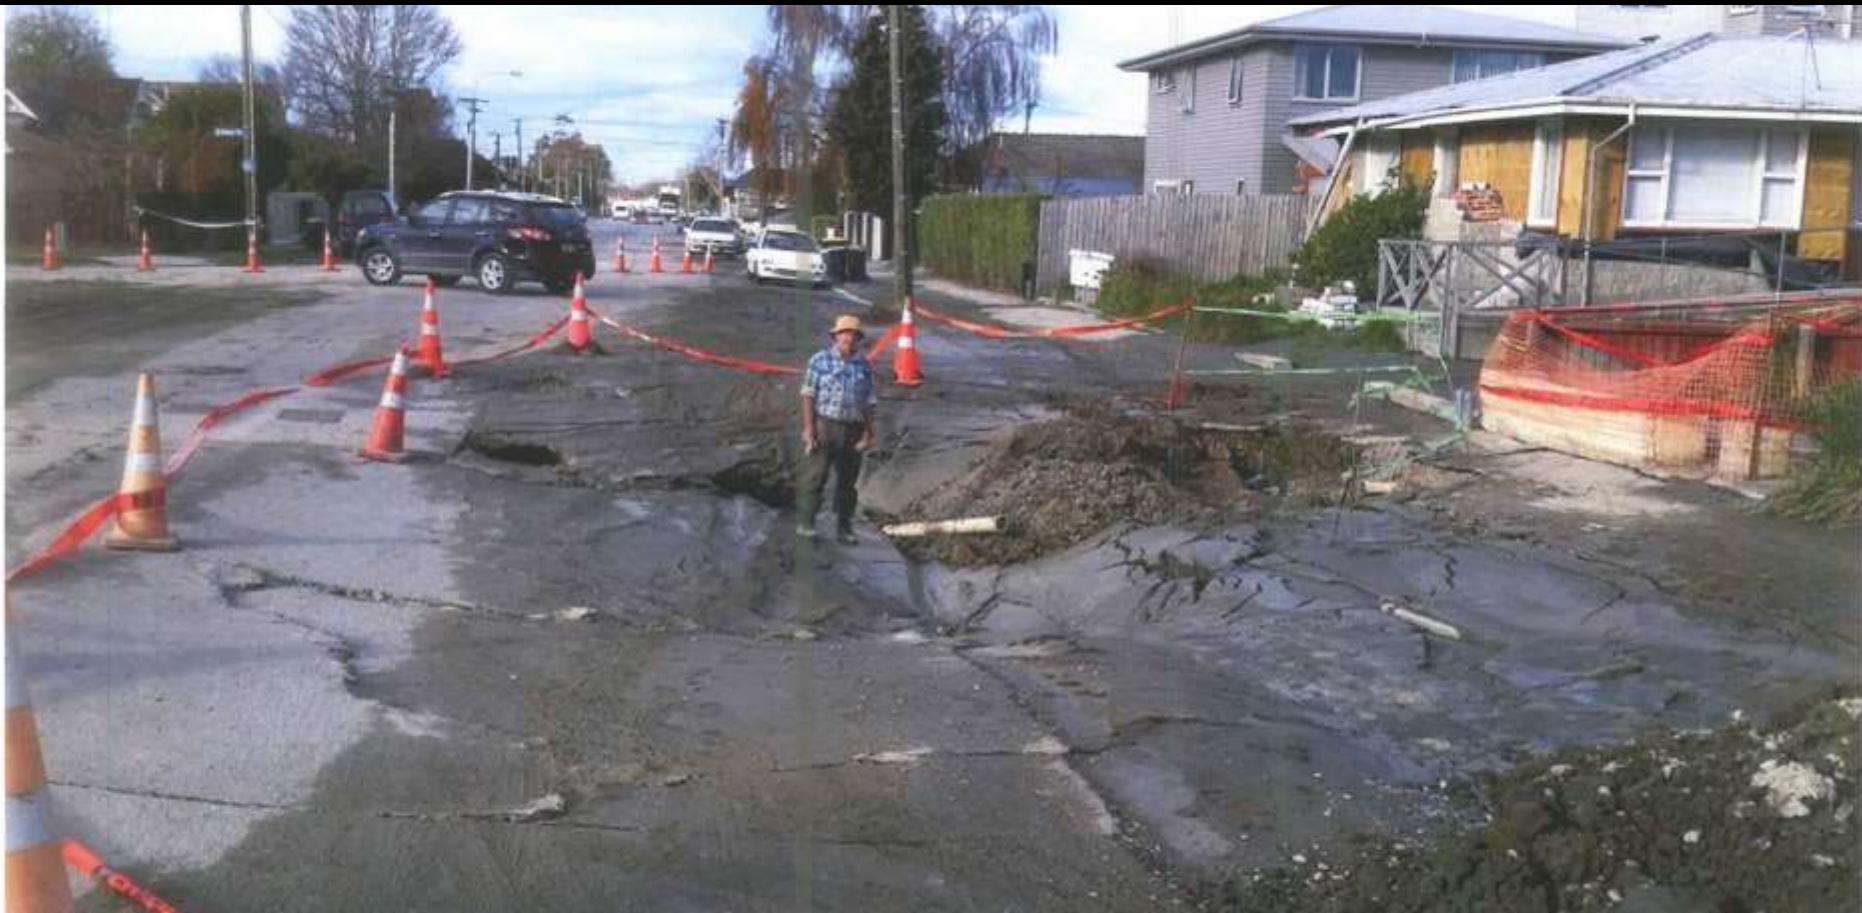
Waste Water Pipe Collapse and Ground Failure

Edgware Road - Wastewater Northern Relief Trunk Main

- Large and fast flow (~1 cumec), large amount of sediment transported through broken pipe.
- This section of the Northern Relief caused ~3 months delay during construction due to poor ground conditions and groundwater issues.

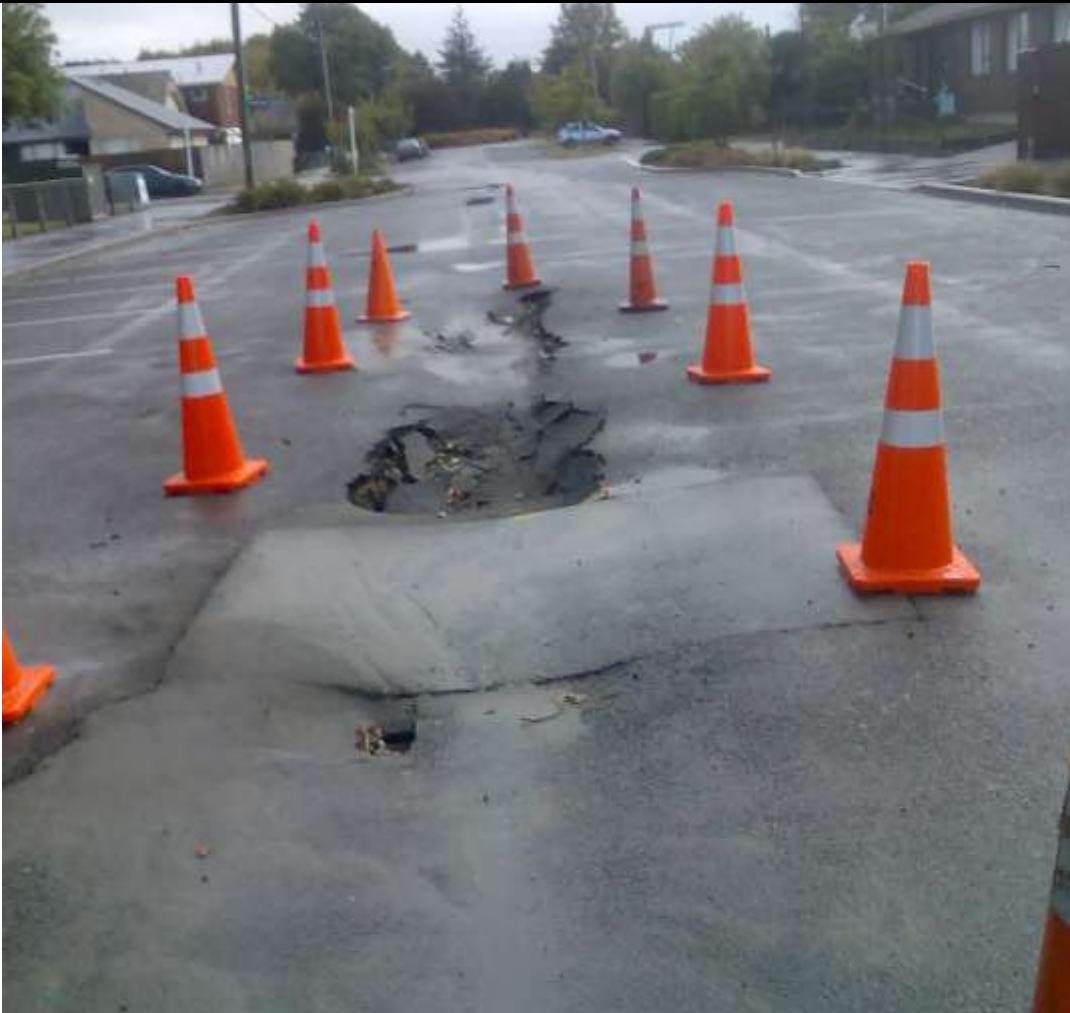
Waste Water Pipe Collapse and Ground Failure

Vienna St, Waltham, shortly after 22 February 2011

- Service to the large upstream catchment (most of Beckenham) was still able to be provided by pumping the downstream manhole – natural conduit formed due to high flows?

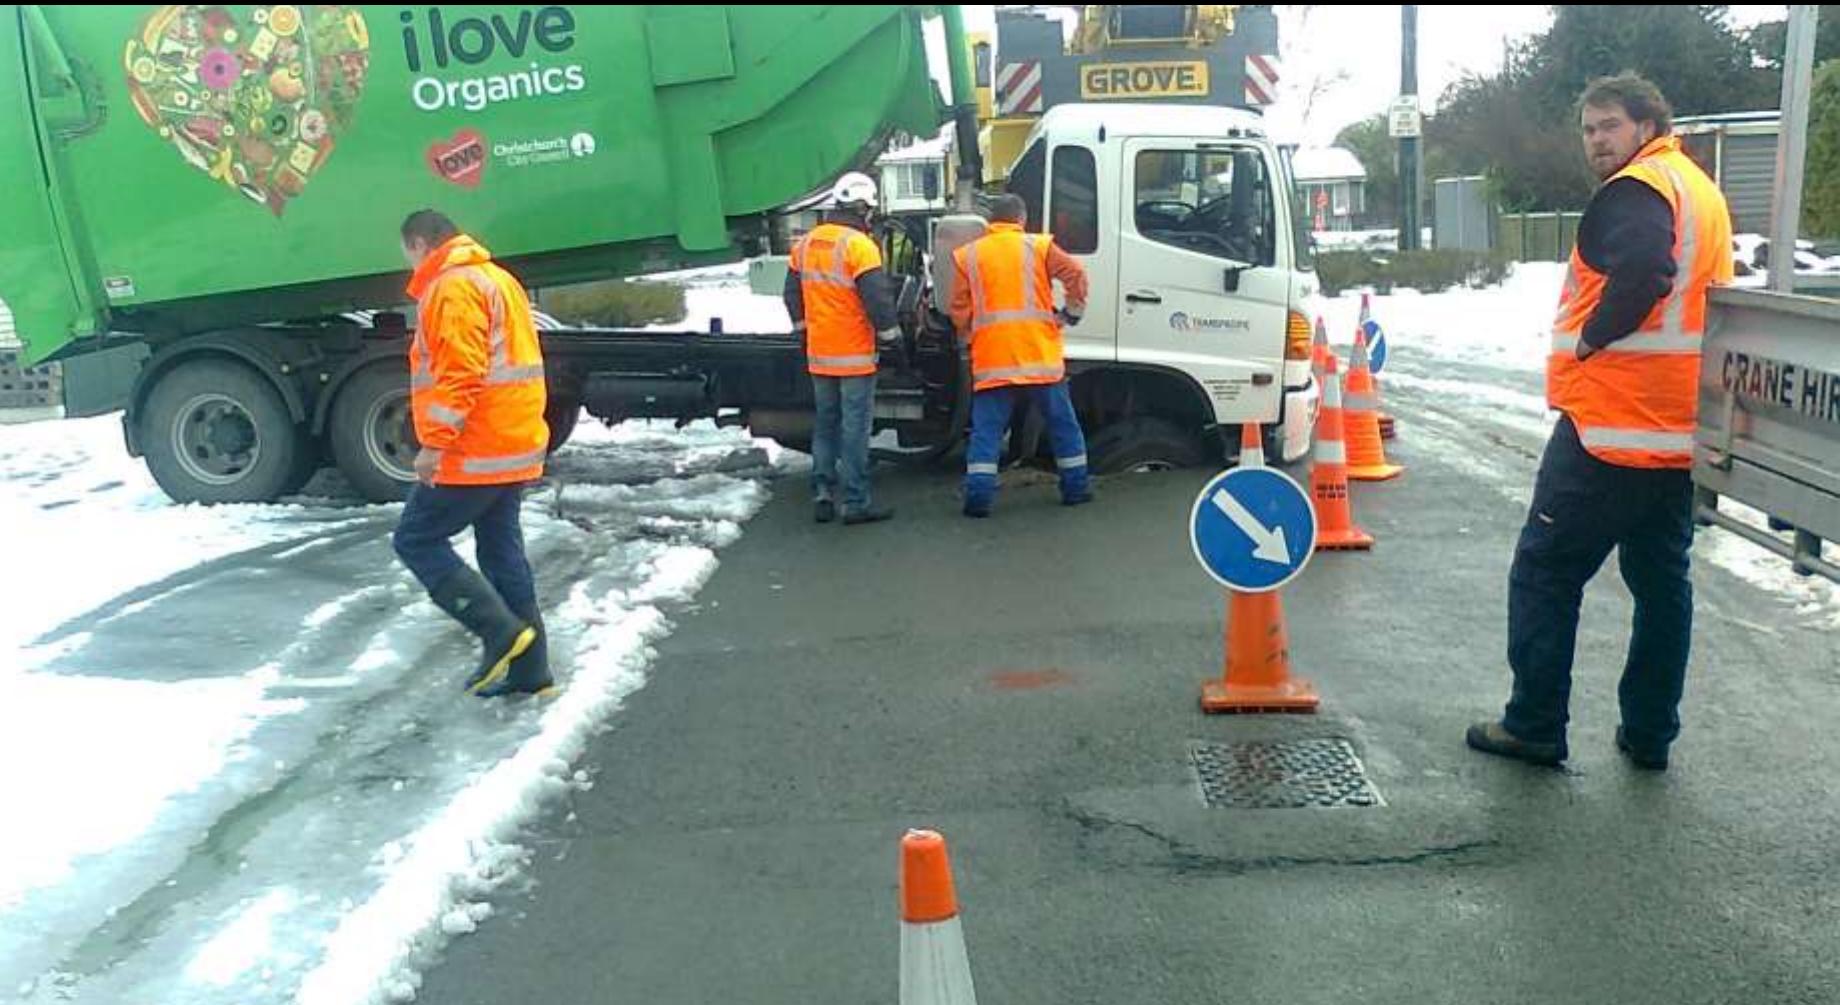
Waste Water Pipe Collapse and Ground Failure

Alexandra St, Lower Richmond during winter snowfall, 2011

Rain and snow events caused new holes/cavities to open up overnight.

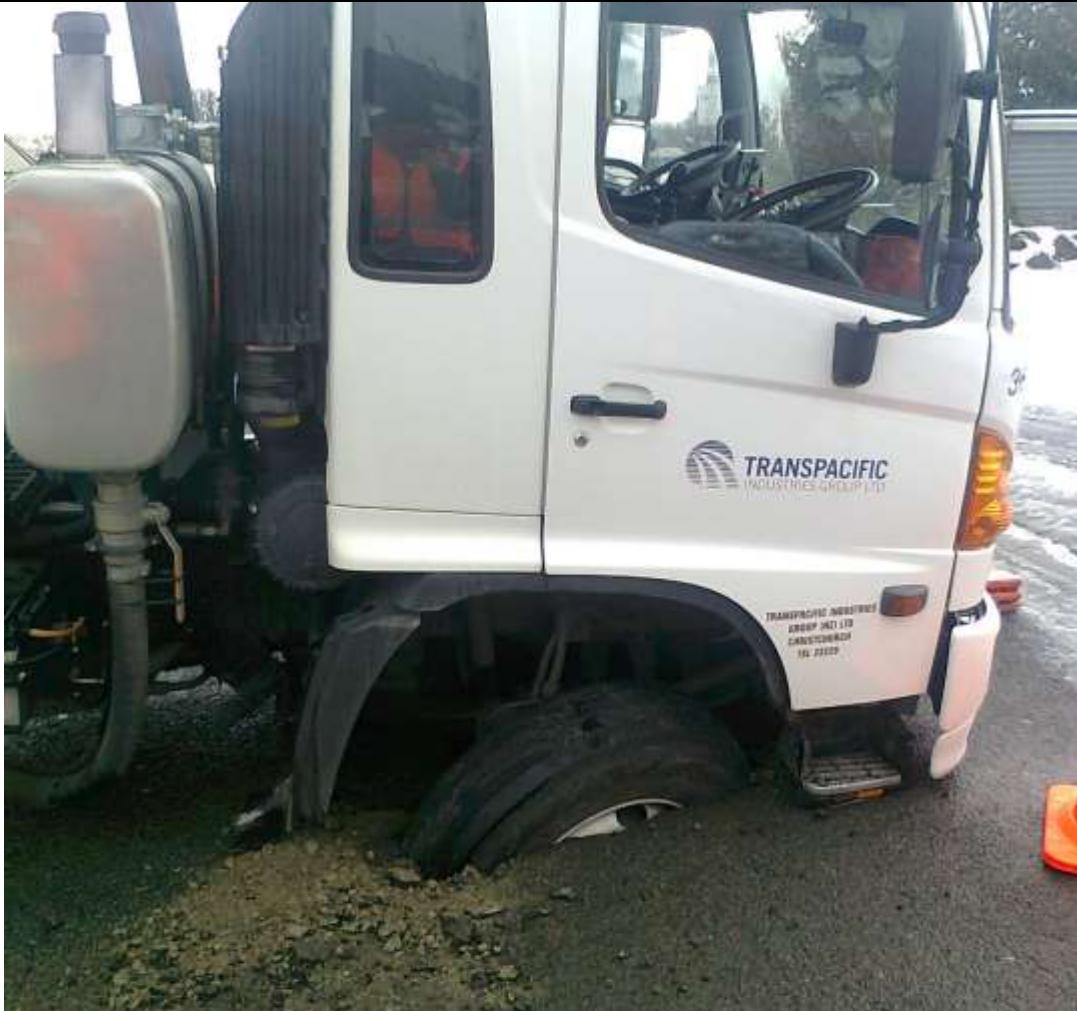
Waste Water Pipe Collapse and Ground Failure

Alexandra St, Lower Richmond during winter snowfall, 2011

Rain and snow events caused new holes/cavities to open up overnight.
